## Timber Bridge Inspection Project in Sweden

### スウェーデンにおける木橋の点検調査プロジェクト

POUSETTE Anna\*, FJELLSTRÖM Per-Anders\*, GUSTAFSSON Anders\* and MATSUDA Seiko\*  
アンナ・プセツト\* パールアンダーシュ・フィエルストルム\*  
アンダーシュ・ギュスタフソン\* ○松田青子\*

\*SP Träteknik : Technical Research Institute of Sweden, Building Technology and Mechanics,  
Wood Technology (Skeria 2, SE-931 77, Skellefteå, Sweden)

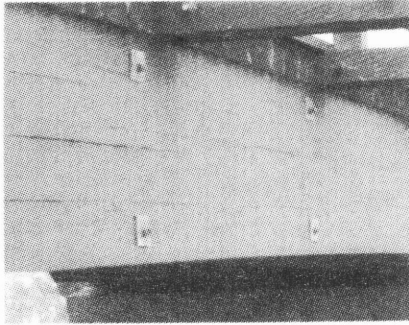
Influence of cracks on the service life of structures depends on the size and location of the cracks, the wood species, any chemical treatment, surface treatment, and the moisture content of the wood. Larger cracks should be measured during an inspection for future controls. Variations in moisture content will cause cracks in the wood and in surface treatments. The wood material shrinks when it dries, mostly in the direction perpendicular to the grain which give cracks along a beam. Cracks have a large influence on the moisture pickup. Water on a surface treated wood member can easily come into the wood through cracks in the treatment, but is difficult to dry out. Cracks have great influence on the moisture content, but not directly on the strength. High moisture content increases the risk of decay, which in the long run can influence the strength and durability. Larger cracks often develop in large wood members but more seldom in glulam. Exposed glulam often results in delamination, that is cracks along the glue lines.

Figure 3. Cracks and delamination

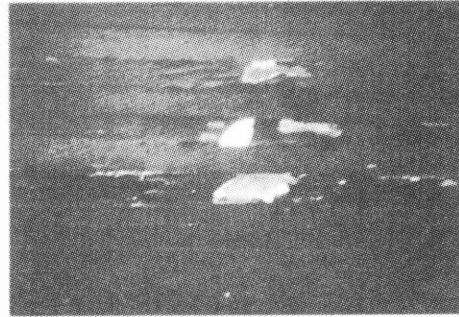
Figure 4. Delamination and scaling

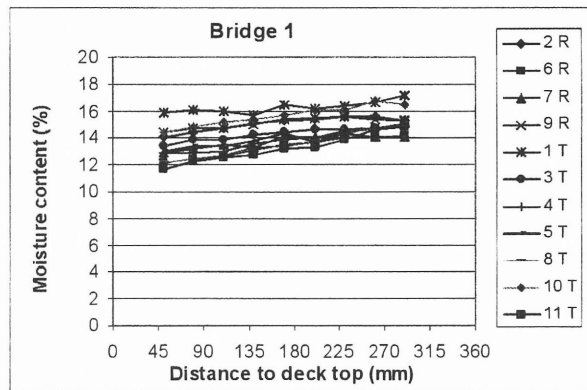
Two bridges were prepared in some points for manual moisture content measurements, both wood pieces for the oven-dry method (T) and pins for the resistive method (R). In one bridge wood pieces in seven places and pins for the meter in four places have been put in the deck plate since the bridge has been built in 1994 and were used to give the moisture content through the bridge deck, see figure 10. The deck plates had the lowest moisture contents at the top, and at the bottom the moisture content was about 16 %. The average moisture content had increased about 1.4 % during the last 8 years. Another bridge which has been also prepared in four places for moisture content measurements gave almost same results.

Figure 10. Moisture content in deck plate, prepared with moisture meters in 11 points
