Analysis of a RC Rigid-Frame Arch Bridge affected by Sichuan Earthquake, 2008

Zhongqi Shi¹, Kenji Kosa², Jiandong Zhang³ and Hideki Shimizu⁴

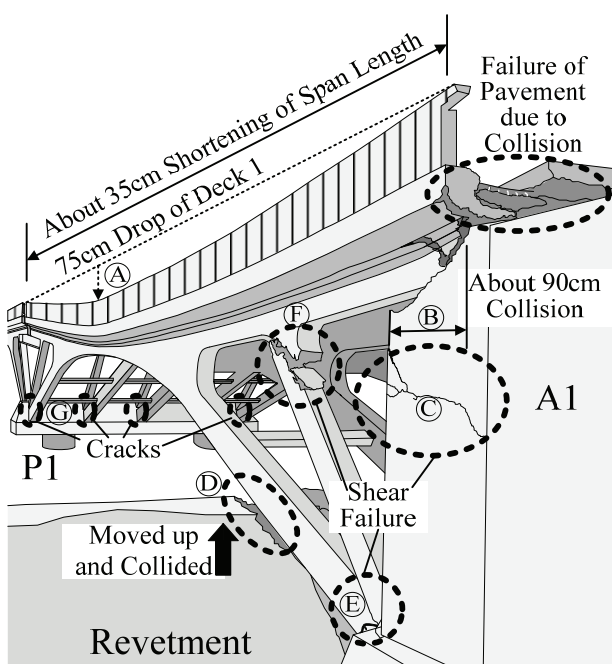
Fig.6 Damage Condition of Span 1

According to the field survey, shown in Fig.6, Span 1 moved about 75cm downwards at middle span (Point A) and the girder collided into A1 (Point B) about 90cm, which consequently caused the shear failure of side wall (Point C). Because the settlement of A1, the arch legs collided with the revetment next to A1 (Point D), great shear failures occurred to the bottom of arch legs (Point E) and the top of inclined legs (Point F). Besides, some cracks occurred to the bottom of the legs (Point G) on Pier 1.

When the earthquake occurred, the girders moved in the longitudinal direction due to the huge force of earthquake. This is one possible reason that caused the collision between A1 and the deck of Span 1. Besides, cracks occurred to the bottoms of legs on Pier 1 and Pier 2 probably due to the seismic effects.

The surface fault at about 10m behind the abutment mentioned before might cause A1 suffered a movement towards the girders and a downwards settlement. This movement towards the girders resulted in the shortening of Span 1 (the shortening finally reached at 347mm), and the collision between A1 and the deck of Span 1. As well, extensive shear cracks developed in the side wall, while damage occurred to the end of girder and the support at the abutment due to this collision. Thus, the enormous horizontal force from the girder caused the inclined legs suffered shear failures on the top. At the same time, the horizontal movement and the downwards settlement of A1 together caused the arch legs collided with the revetment, which contributed mostly to the shear failures at the bottoms of arch legs, and also partly to the shear failures on the top of inclined legs.

At last, three main damage was observed: firstly, because of the settlement of A1, and the decreases of supporting force from both the inclined legs and the arch legs, the deck of Span 1 dropt about 75cm in the middle span at last; secondly, the collision between A1 and the deck of Span 1 finally caused the girder moved about 0.9m against the abutment; thirdly, the deck in the middle of Span 2 raised about 10cm probably due to the seismic force and the effects from the neighborly spans, but not the surface fault.

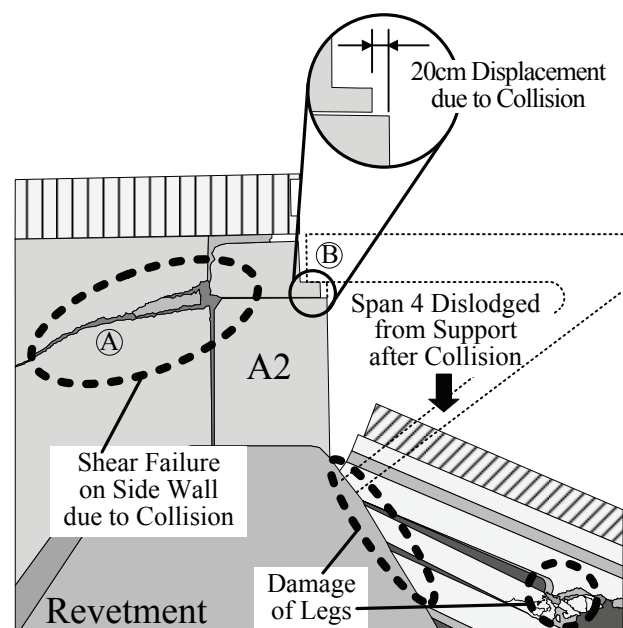
Fig.7 Damage Condition of Abutment 2

As shown in Fig.7, there are shear failure on the side wall of A2 (Point A in Fig.7), and a permanent displacement of the support about 20cm in the backsoil side (Point B) due to the collision between the deck of Span 4 and A2. Span 4 dropt from support, and the legs also failed.

Furthermore, it can be inferred from the damage condition shown in Fig.6 and Fig.7 that different designs or methods of construction had been used for A1 and A2. A1 was probably casted entirely, while A2 was combined by some big parts of concrete block. This casued their resistances against the collision differred greatly.

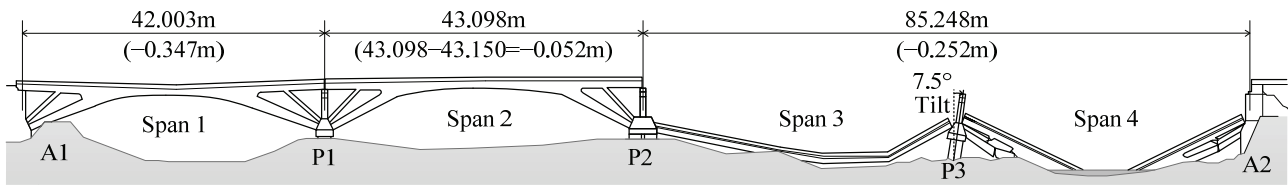
Fig.8 Changes of Span Length

As shown in Fig.8, Pier 3 tilted averagely 7.5° toward A2 (about 8.08° at the upstream side and 6.85° at the downstream side of the bridge, measured by the electronic total station). The piles under Pier 3 suffered great damage because of the tilt. Span 3 and Span 4 collapsed entirely, and the legs on them failed as well.

As illustrated in Fig.8, it has been found that the length of every span becomes 41.203 and 42.298m for the left two spans respectively, and 84.448m for the right two spans totally (by noticing the tilt of P3, the right two spans are judged together), based on the result of electronic total station as well. Considering the length of support (set as 400mm, as 1/2 of the width of the beam upon the pier), the length of them becomes 42.003, 43.098, and 85.248m respectively. By compared these lengths by total station with the lengths by measuring tape mentioned in Chapter 2.1, (taking Span 2 as an example, use 43.098m by total station to minus 43.150m by measuring tape, shortening of 0.052m can be got) the changes of span length have been got. Span 1 has an assignable shortening of 35cm (0.82% decrease), which is probably caused by the surface faults. Span 2 has a shortening of 5cm (about 0.12%). For the right two spans, the total length decreased 25cm (about 0.29%). Thus, the changes of span length from Span 2 to Span 4 are relatively small and therefore can be ignored.

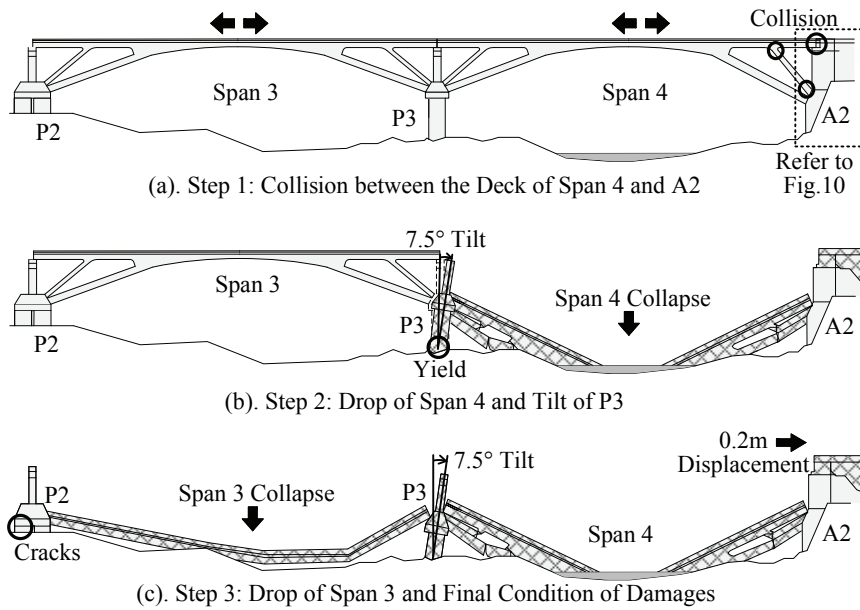
Fig.9 Failure Mechanisms of Span 3 and Span 4

On the other hand, as step 1 which is illustrated in Fig. 9 (a) and details in Fig.10, the decks of Span 3 and Span 4 moved longitudinally as well due to the earthquake effect, which led to the collision between the deck of Span 4 and A2. Most likely, the deck of Span 4 moved

towards A2 at the beginning. Due to the weakness of A2 against horizontal collision, this caused the parapet and the pavement on A2 slid about 20cm into the backsoil together with the deck, and also caused the shear failure at the side wall of A2 (shown in Fig.10 (b)). Then, the girder moved on reversal direction due to the earthquake effect as well, leaving the parapet and the pavement on A2 staying still. As shown in Fig.10 (c), once the displacement of girder towards left became greater than 20cm, Span 4 lost the support from A2 (as the supporting length being 40cm mentioned in Chapter 2.1 Bridge Structure). Thus, the inclined legs on A2 probably received much greater applied load due to seismic force, which caused the damage occurred to them. Then, Span 4 dropt into the river as a consequence of these two reasons

For Pier 3, the balance of horizontal force came from the legs of both Span 3 and Span 4 at the same time. After the lost of balance due to the drop of Span 4, Pier 3 was pushed by the seismic force and the forces from legs of Span 3 to tilt towards A2. Finally, averagely about 7.5° tilt occurred to Pier 3. This consequently resulted in the drop of Span 3 after lost the supporting force from Pier 3. However, the damage was probably fast chain reactions that there was no clear dividing line between these detailed steps.

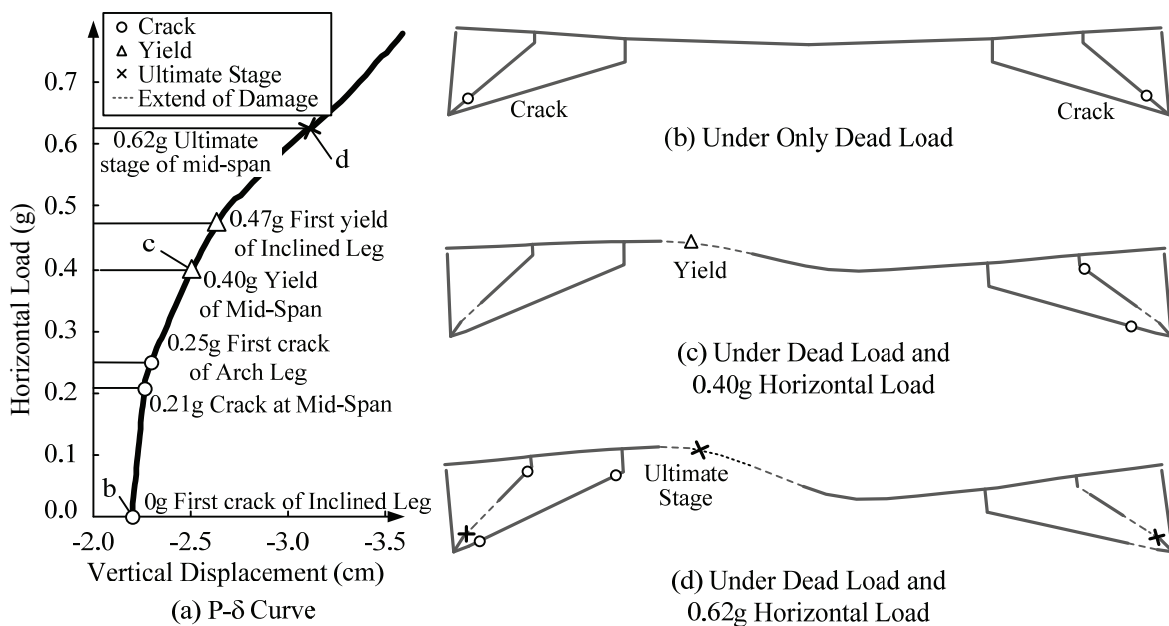
Fig.12 Analysis Result of Case 1

As illustrated in Fig.12, cracks will happen at the bottom of left inclined leg only under dead load. Cracks may develop due to the negative moment to the right of middle span at 0.21g horizontal load. As the horizontal load growing up to 0.40g, the tensile reinforcement at middle span will yield due to negative moment, and then reaches at the ultimate stage at 0.62g horizontal load. Because the negative failures happen relatively early, the positive flexural moments do not develop greatly in

elements at middle span. For the inclined legs, the first yield of tensile reinforcement occurs to the left bottom at 0.47g horizontal load. The same point will reach at the ultimate stage soon. Then the yield of tensile reinforcement and the ultimate stage will happen to the right bottom of the inclined leg after the horizontal load becomes greater than 0.53g. For the arch legs, the damage will happen to the left bottom at first among all parts: cracks occur at 0.29g, yield of reinforcement at 0.93g, and soon the ultimate stage. Under 0.62g horizontal load, when is the ultimate stage of middle span, the deflection about 3.1cm happens to the middle span.

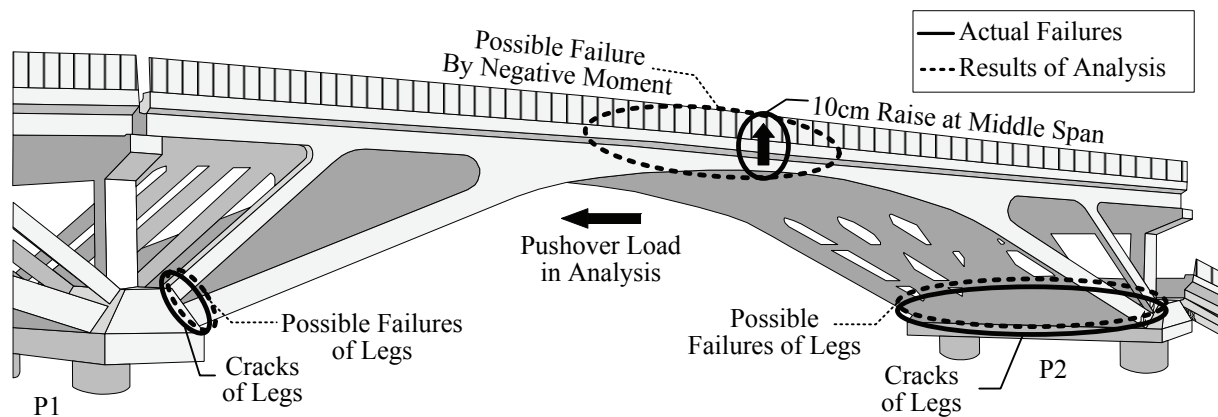
Fig.13 Comparison between Results of Case 1 and Actual Failures for Span 2

As shown in Fig.13, comparisons have been done between the results of Case 1 with the actual failure condition of Span 2 from field survey. We can see that the failure occurred to most of the weak points based on the analysis. In the field survey, cracks have been found at the joints of legs on the pile caps, which can be proved by the result of the analysis. On the other hand, however, the middle span had a raise about 10cm in the actual damage. Although the result of analysis shows that it is most likely for the middle span to suffer the negative moment, some downwards displacement happened according to the analysis. The single span model, without considering the effects from the other spans next to it, is probably the reason why the result of analysis differs from the actual failure for the displacement at middle span.

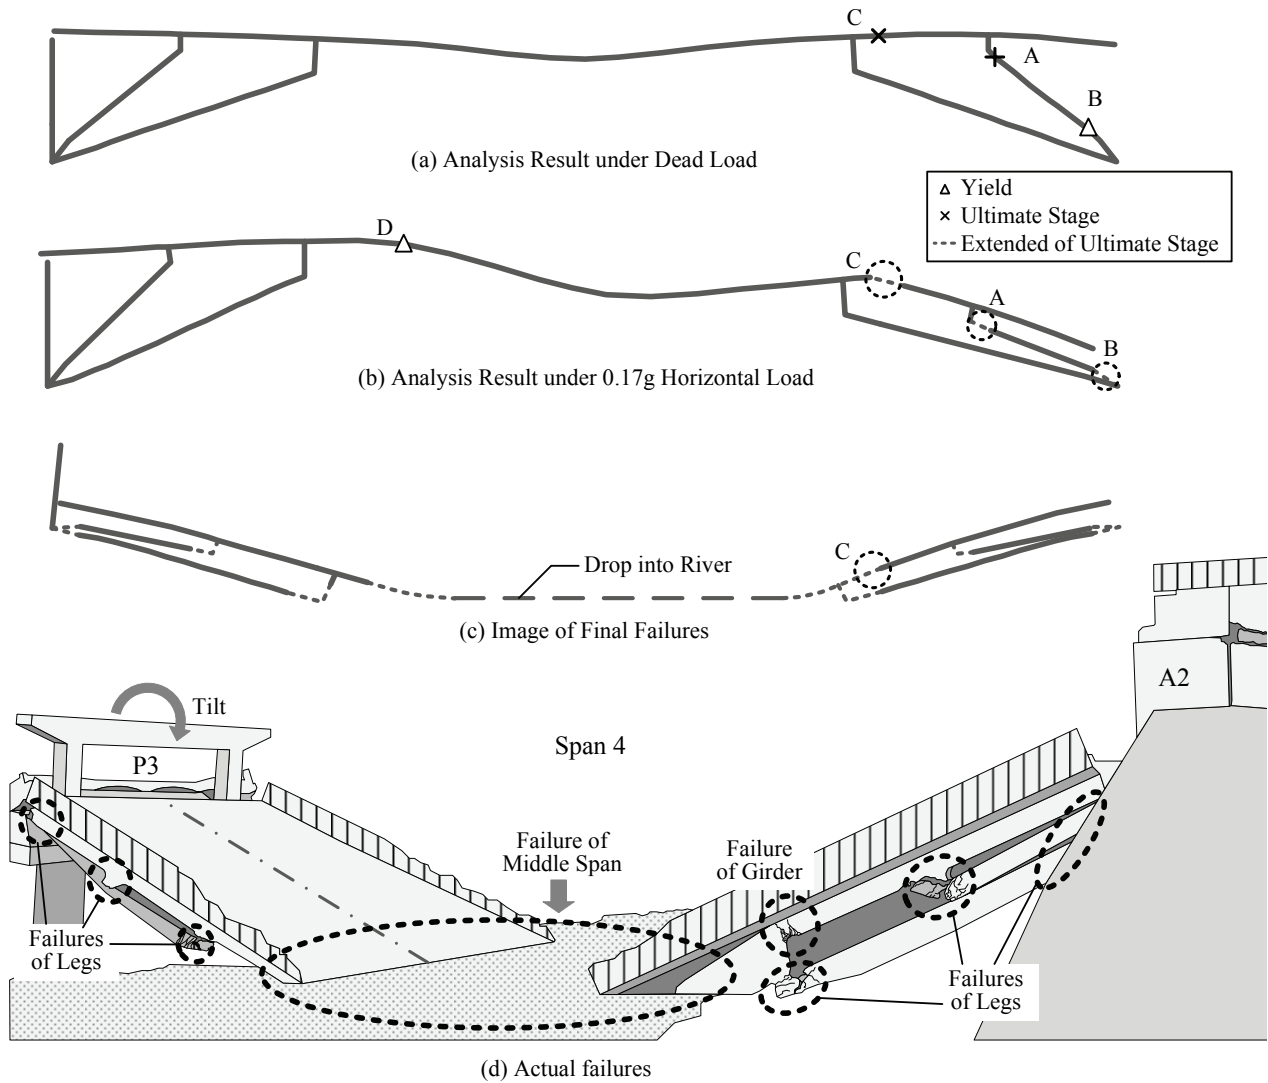
Fig.14 Comparison between Results of Case 2 and Actual Failures for Span 4

For Case 2, as a consequence of the removal of right support, damage occurs noticeably earlier than that in Case 1. As illustrated in Fig.14 (a), when under only dead load, the top of right inclined leg (Point A in Fig.14 (a)) will reach at ultimate stage (1.06g in Case 1), while the tensile reinforcement will yield at the bottom (0.47 in Case 1; Point B). The joint of girder and arch leg (Point C) will also reach at ultimate stage under only load (no failure in Case 1), as a result of the disability of right inclined leg. This suggests that once the girder dislodge from the support, serious failures are likely to occur to Point A, B and C shown in Fig.14 (a).

horizontal load (0.40g in Case 1; Point D in Fig.14 (b)). Failures at Point A, B and C will lead to the drop of girder at the right side. This will result in some further failures of the right arch leg due to collision. Additionally, the damage at Point A, B, C and D will cause the entire rigid-frame arch to lose its stability. These two reasons above, are likely to cause the failures shown in Fig.14 (c) that great damage occur to the tops and bottoms of legs at both side, while the failure of girder only happen to the joint with the arch leg at the right side (Point C in Fig.14 (c)) and in the middle span.

Compared this result of Case 2 with the actual failures of Span 4 (Fig.14 (d)), we found the failure of girder at a little right to the joint with the arch leg, but no similar failure at the left half span. This suggests that the support loss of the girder from A2 was probably the original reason of the entire failure of Span 4.
