CS-234

ADVERSE GEOLOGICAL CONDITIONS AND THEIR IMPACTS  
ON CONSTRUCTION PROGRAM AND COST FOR OVERSEAS DAM PROJECT

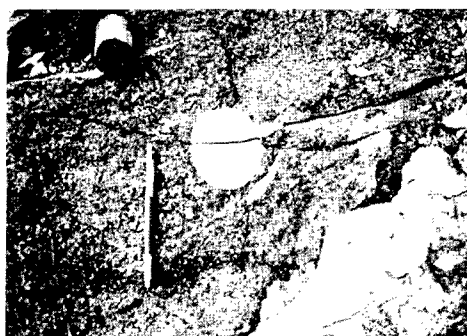
Photo 2 Crack occurrence after grouting treatment

- ① Diabase was generally hard and fresh when excavated and exposed. However, some rock masses had a tendency to weather easily and disintegrate into sand-like in a few weeks.
- ② Massive rock masses of Diabase had cracks and joints that gradually develop and open. Opening of cracks was found in foundation where grouting had been conducted as shown on **Photo 2**.

To treat the above geological phenomena encountered in the dam foundations, several measures such as additional excavation, shotcrete protection, slush grouting, backfill concrete and re-grouting were carried out. Furthermore, in the rock quarry, the rock surface lines were actually quite lower than those initially estimated and quantity of suitable rock materials was decreased drastically. Consequently, the Contractor had to remove substantial volumes of unsuitable materials from the quarry and extend the quarry area to obtain adequate quantities of rocks.

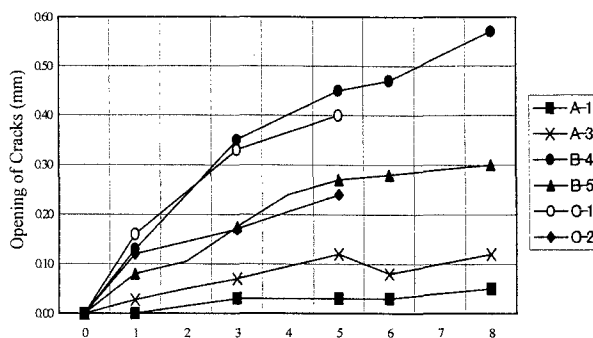
Fig.1 Results of the opening of cracks

**Fig.1** shows the monitoring results of the opening of cracks in Diabase foundation of dams.
