## Building damage evaluation in Bam City in the aftermath of the December 26<sup>th</sup> 2003 Bam Earthquake

Kimiro MEGURO, Regular Member, Institute of Industrial Science, University of Tokyo

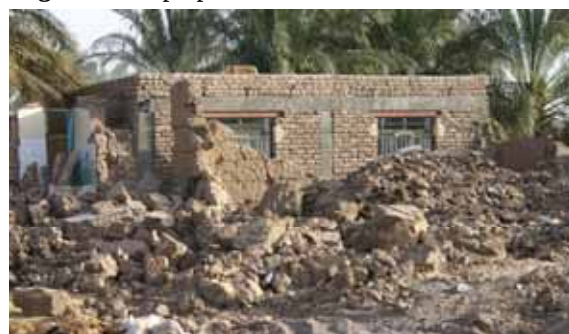
Adobe structures were badly damaged as in many previous experiences. Fig. 3 shows a completely collapsed adobe house in the front whereas in the back, a confined masonry structure stands almost undamaged. Some masonry structures are provided with horizontal ties only, i.e. collar beams, as shown in Fig. 4. Although the complete collapse is prevented, the lack of vertical ties causes the failure of the wall corners.

Fig. 3 Completely collapsed adobe house

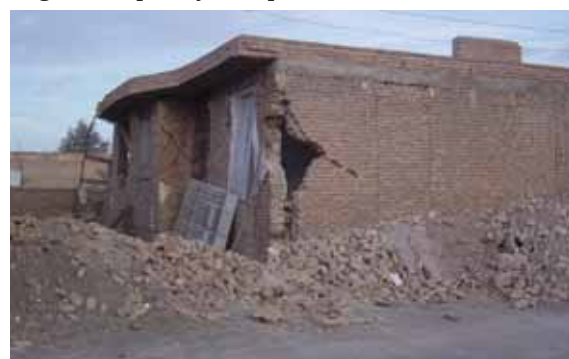
Fig. 4 Heavily damaged partially confined masonry house

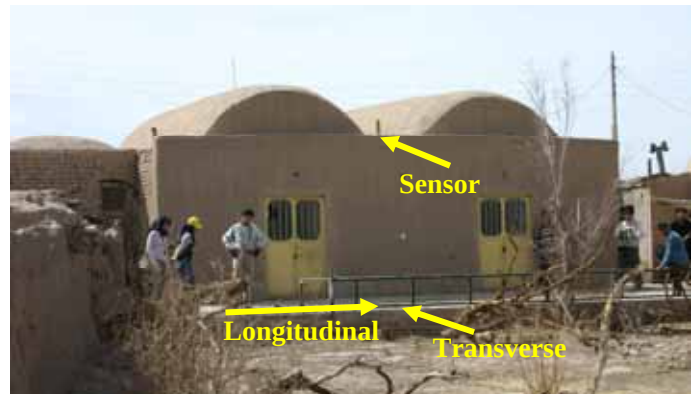
Figure 5 shows one of the surveyed adobe houses in Darzin City. The structure height is approximately 3.8m and the average wall thickness 800mm. The sensor was placed on top of the roof coinciding with a wall alignment.

Fig. 5 Measured adobe house in Darzin City

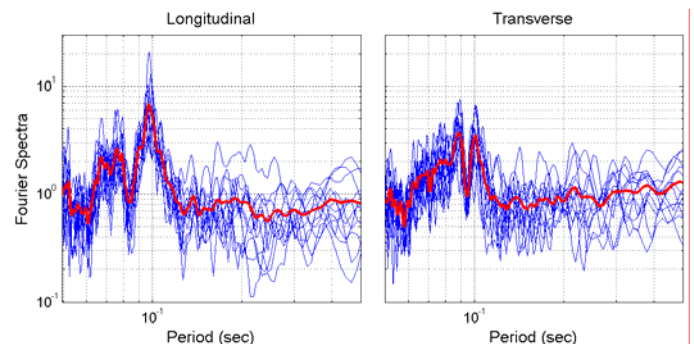
Figure 6 illustrates the analysis results. The blue lines show the spectra of different measurement windows whereas the red line represents the average. The fundamental periods in the longitudinal and transverse directions are 0.1 and 0.09sec, respectively. It is clear that the structure is slightly stiffer in the transverse direction along which several walls were aligned. The transverse direction spectrum shows a peak at 0.1sec, which coincides with the vibration period in the longitudinal direction. This may suggest some torsional vibrations in the structure.

Fig. 6 Typical adobe house microtremor Fourier Spectra

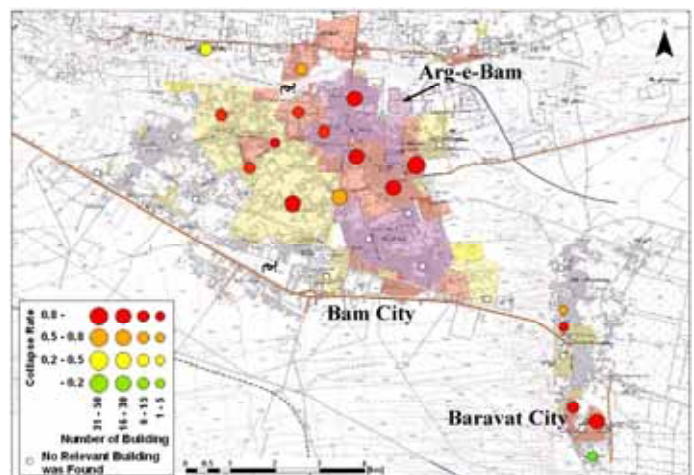
Figure 7 shows the results of the adobe house damage evaluation plotted on the damage distribution map published in [5]. From the graph it is clear that the adobe construction predominance is related to the city evolution. The closer the surveyed point is to Arg-e-Bam, the city origin, the larger the number of adobe houses. It can also be observed that the newer the structure, i.e. further from Arg-e-Bam, the lower the collapse rate.

As expected the adobe performance was poor. Among 18 observed points where these structures were present, 13 sustained more than 80% collapse rate and 16 sustained more than 50% collapse rate. Very few adobe houses survived the earthquake in the city downtown.

Fig. 7 Adobe building damage
