International bridge study on New Jersey reference bridges

| University of Tokyo | Member | ○ | Di Su |

1. Introduction

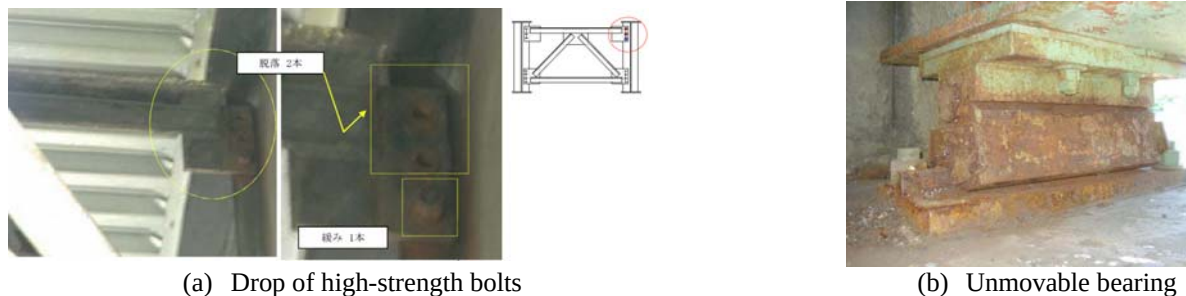
Figure 2. Local damage area

Japanese team found that the condition of the bridge after visual inspection is better than anticipated from the records. Deficiencies are mainly situated in dewatering and in the actual vibration intensities. However this assessment still indicated immediate or short-team countermeasure is necessary for some local members, which are shown in Figure 2.

The damaged location shown in Figure 2(a) has not been recorded in the inspection report from US side. It has been observed that the moveable bearings are cyclically moved by the vibration, shown in Figure 2(b). The modes contain considerable transverse elements providing additional stress to the bearings. Furthermore the response analysis below also indicates that the bearing has completely lost the movable function.

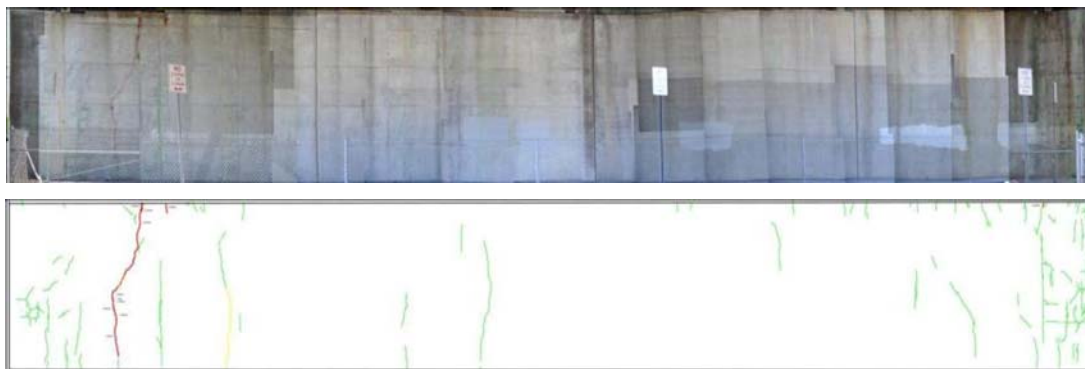
The cracks of the concrete columns and piers were identified using the image recognition technique. As shown in Figure 3, Crack width is detected approximately based on the width corresponding to 1 pix in the photo.

Figure 3. Width of concrete crack (Green:  $<0.5\text{mm}$ , yellow:  $0.5\text{mm}\sim 0.7\text{mm}$ , red:  $>0.7\text{mm}$ )

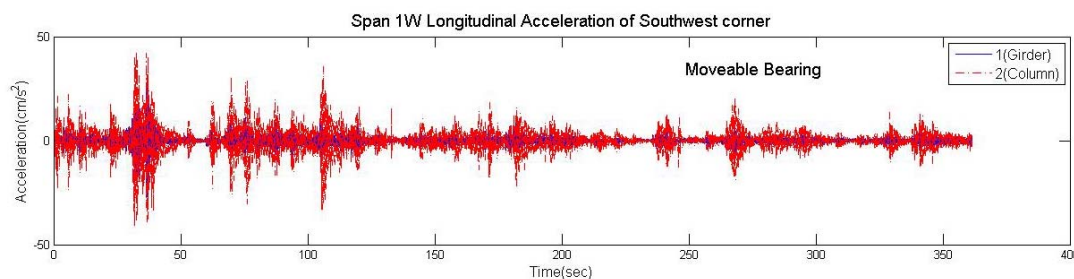
Figure 4. Comparison of acceleration results in the bearing

To capture the responses near the bearing pair of sensors is placed on the girder and on the column at each bearing. For the bearing shown in Figure 2(b), the longitudinal movement ability of the bearings has been lost completely. This is indicated by the almost similar acceleration (both in amplitude and phase) of the girder and column sensors in Figure 4.
