Damage Analysis of a RC Rigid-Frame Arch Bridge affected by Sichuan Earthquake, 2008

Graduate School of Kyushu Institute of Technology	Student Member	○Zhongqi SHI
Kyushu Institute of Technology	Member	Kenji KOSA
Jiangsu Transportation Institute	Member	Jiandong ZHANG
Nippon Engineering Consultants Co., Ltd.	Member	Hideki SHIMIZU

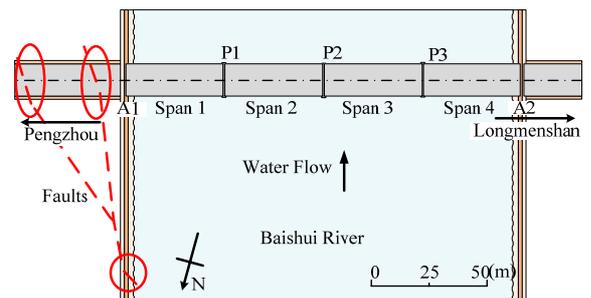
The overall damage condition is illustrated in Fig.1, from which we can see that Span 1 had the greatest shortening likely caused by the surface fault behind A1 in Fig.2. As Span 2 only changed slightly, the effect of the surface faults on Span 2, 3 and 4 is considered limited (the measure method is explained in Fig.3, Span 3 and 4 for example). However, the decks of Span 3 and 4 collapsed entirely, and Pier 3 tilted about 7.5°. As shown in Fig.4, a 20cm permanent displacement of the support on the top of A2 into backsoil, and shear failures on the side wall were found, from which we inferred the girder lost the support from A2. Besides, at the joints of the girder and arch legs, different types of failure occurred. On the left (see from downstream, Point A), by negative bending moment, rebars on upside of the girder resisted tension and downside concrete resisted compression. On the right (Point B), by positive moment, the girder was pulled to separate from the joint, which caused the obvious crack at the joint.

Fig.2 Surface Faults near Xiaoyudong Bridge

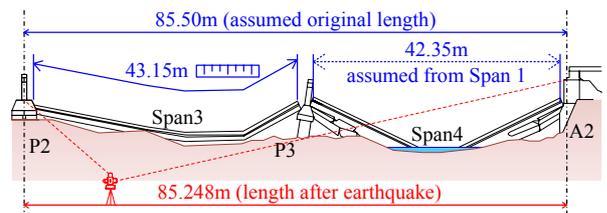
Fig.3 Measure Method (Span 3 & 4 from upstream)

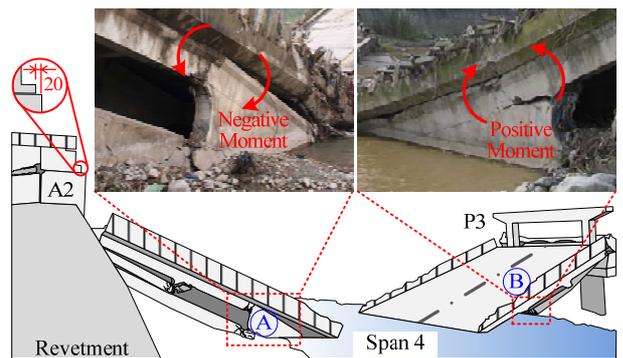
Fig.4 Failure Condition of Span 4 (upstream, unit: cm)

For Case 2, shown in Fig.5(b), due to the loss of support, the top of the right inclined leg (Point A) and the girder next to the right joint with the arch leg (Point C) will reach their ultimate stages, while rebars will yield at the bottom of the right inclined leg (Point B) under only dead load. Compared with Case 1, the yield of the tensile reinforcement at the middle span (Point D) occurs earlier at 0.17g. (the curvature of Section D is illustrated in Fig.6) Failures at Point A, B and C will lead to the drop of girder at the right side. This may cause further failures of the right arch leg due to collision. Thus, the damage at Point A, B, C and D will cause the entire rigid-frame arch to lose its stability. These two reasons above, are likely to cause the failures shown in Fig.4 that joints of girder and arch legs suffered moment in different directions.

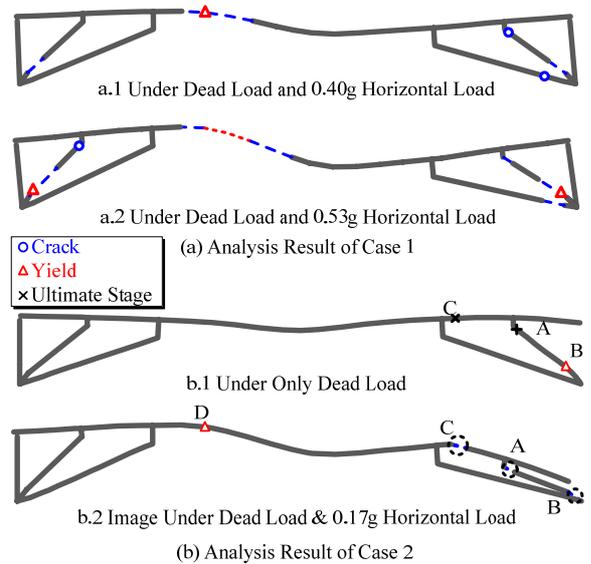
For Case 1, shown in Fig.5(a), as the horizontal load growing up to 0.40g, the tensile reinforcement at middle span will yield due to negative moment, and then reaches at the ultimate stage at 0.62g

horizontal load. For the inclined legs, the first yield of tensile reinforcement occurs to the left bottom at 0.47g horizontal load. The same point will reach at the ultimate stage soon. Then the yield of tensile reinforcement and the ultimate stage will happen to the right bottom of the inclined leg at 0.53g. After this, considering the entire capacity may lose after serious failures occur to these three points, 0.53g is thought to be the capacity of this bridge.

Fig.5 Analysis Result

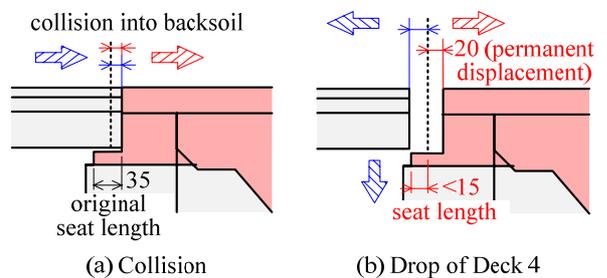
Fig.6 Support Lost of Deck 4 (unit: cm)

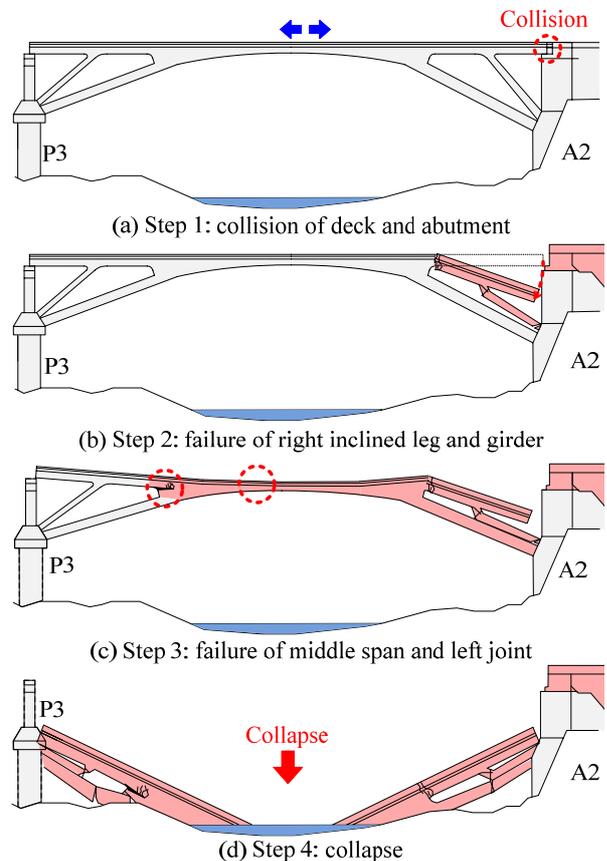
As step 1 shown in Fig.7(a), the earthquake effect and the move of foundation caused the deck of Span 4 moved longitudinally, which led to the collision between the deck of Span 4 and A2. Most likely, the deck of Span 4 moved towards A2 at first and caused the parapet and the pavement on A2 slid into the backsoil (Fig.6(a)). Then, the girder moved on reversal direction also due to the earthquake (Fig.6(b)). Considering the original seat length on A2 was about 35cm (by field survey), this 20cm backward move likely caused the seat length remain only less than 15cm, and made the girder considerably easily lose support by any vibration. Thus, based on result of Case 2, inclined legs and the girder at right side received greater applied load, and caused the damage here. Then, failure would happen to middle span soon (Fig.7(b)). As the pier and inclined leg still supported the girder at left but failures already occurred to the right half span, the girder was pulled to separate from the left joint with the arch leg by positive moment (Fig.7(c)). Thus, the left half also failed and the entire span collapsed into the water. Consequently, Pier 3 was pushed to tilt by the force from Span 3, which caused the enormous chain failure of Span 3.

Fig.7 Failure Mechanisms of Span 4(upstream)
