EVALUATION OF DAMAGE CONDITIONS IN ASR-AFFECTED STRUCTURES

Graduate School of Kyushu Institute of Technology
 Kyushu Institute of Technology
 Sumitomo Osaka Cement

Student Member ○Yulong ZHENG
 Member Kenji KOSA
 Member Nobuo UEHARA

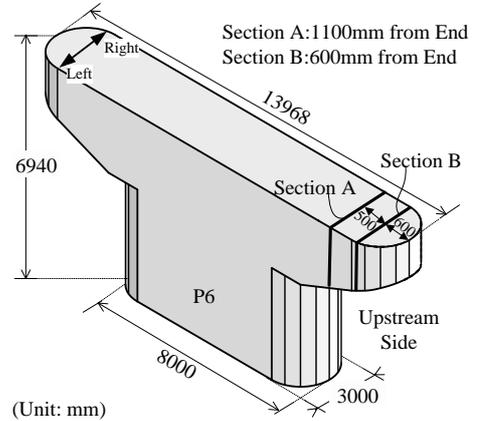
Fig. 1 Objective Bridge Pier

Fig. 1 shows the objective pier from the bridge located in the Hokuriku Region of Japan. The ASR deterioration becomes obvious in this bridge after 17 years of services. During 5 years after the maintenance of surface coating, cracks appeared again on the surface coating materials, which indicates the great deteriorative degree. As shown in Fig. 1, the objective pier is an oval shaped overhanging RC type structure with the length of beam part as around 14.0m and the width as 3.0m. The section A and B in the overhanging part of beam is the cutting position for investigating interior cracks (refer to next chapter).

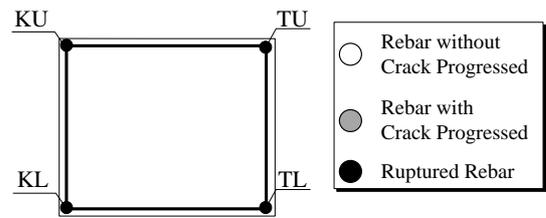
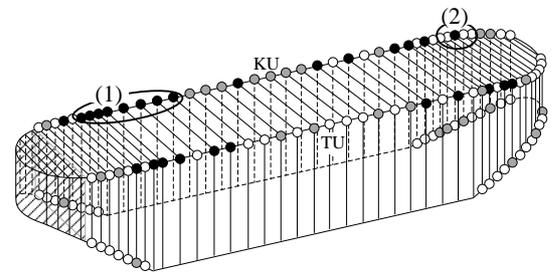
Fig. 2 Fracture of Stirrups in P6

Herein, the fracture conditions are stated. Fig. 2-(a) illustrates the reinforcements of the cross section. The bent part of stirrup is named like TU, KU for the following descriptions. Three damage types are defined based on the visual observations. As shown in Fig. 2-(b) (viewed from the right side, refer to Fig. 1), along with the beam axis, many rebar are confirmed to suffer damages. There are rebar damaged continuously as illustrated in (1) of Fig. 2; while there are also rebar damaged individually as in (2) of Fig. 2. As for the damage ratio (ratio of number for damaged rebar to the total number), 69%, 46%, 25% and 20% is counted for the KU, TU, KL and TL side, respectively. The upper side of beam has greater damage ratio relatively. In general, the total damage ratio of this pier is around 46%, from which, great deterioration is confirmed to occur.

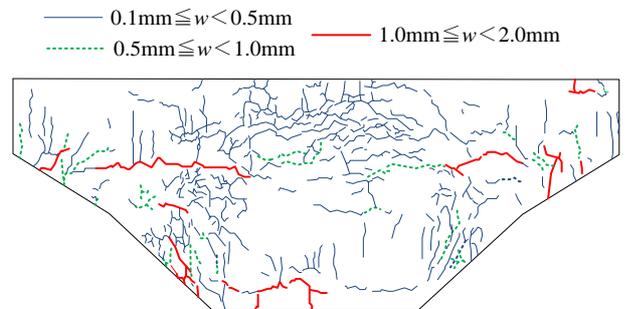
Fig. 3 Cracks in Profile

Fig. 3 illustrates the crack conditions in the right profile. The data was recorded on the surface coating material. The general crack density in profile is 3.38m^2 and the maximum crack width is around 2.0mm. In the web part of the profile, it is observed that cracks are notable in horizontal direction. Though after the surface coating, crack with width greater than 1.0mm generated. The notable crack in horizontal direction is located in around 1500mm below the upper surface; while the maximum thickness of covering layer is 300mm. Thus, it is known that the bent part of stirrup has roughly 1000mm height difference with the horizontal cracks. It is difficult to conclude that the occurrence of great cracks is correlated with the damage of rebar. For studying the connections with cracks in profile, the interior crack conditions are evaluated in the next chapter.

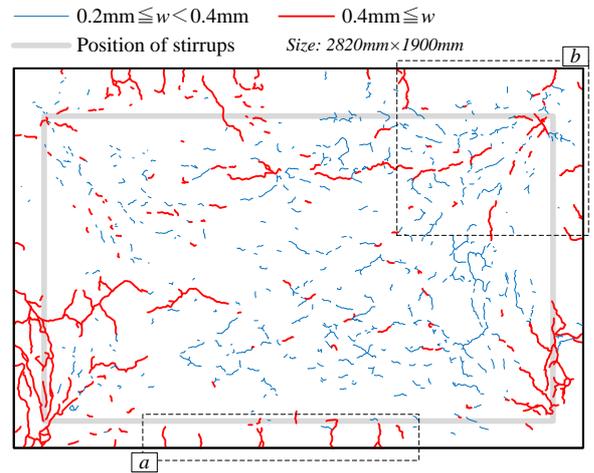
Fig. 4 Inner Cracks in Section A

As illustrated in the former Fig. 1, two sections were cut in the overhanging part of the beam. As representative, the interior crack conditions of section A is evaluated in Fig. 4. The maximum crack width is near 2.0mm, being similar to that in profile. However, the average crack density in the section is 6.13m^2 being greater than the 3.38m^2 in profile. Thus, it is found that the interior section has suffered enough deterioration. Cracks in inner of the section seem to have smaller width than those in outer. In peripheral central area of the section (a of Fig. 4), cracks have the trend to stop at the position of stirrups. However, in the corner area (b of Fig. 4), cracks are much like to spread across the stirrups. By general view, it is considered that cracks in different areas have different trends. Therefore, the crack directions in the section are evaluated in the following.

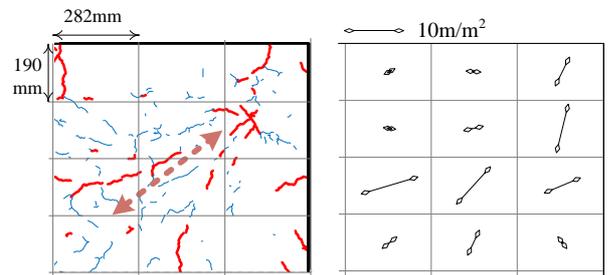
Fig. 5 Detail of Cracks in Part b

Fig. 5 and Fig. 6 present the vectors of cracks considering the crack density for the part b (Fig. 4) and the general section. 10 divisions are conducted for the two directions with the mesh size as $282\text{mm}\times 190\text{mm}$. Cracks with widths greater than 0.2mm in each mesh are divided into two types by their positions as in 1, 3 quadrants and 2, 4 quadrants. Thus, by compositions, the direction is obtained.

As illustrated in Fig. 5, the crack in corner area has the rough trend to progress at around 45° . Great density near 10m^2 occurs in this area. Further, as shown in Fig. 6, this trend can also be found in other corner areas. When cracks in corner progress deeper, directions become along with the stirrup as illustrated in (1) of Fig. 6. Due to greater restrains, the crack density is smaller in the inner of the section. As presented in (2) of Fig. 6 (corresponding to a of Fig. 4), cracks in peripheral central area have trends to progress perpendicularly to profile.

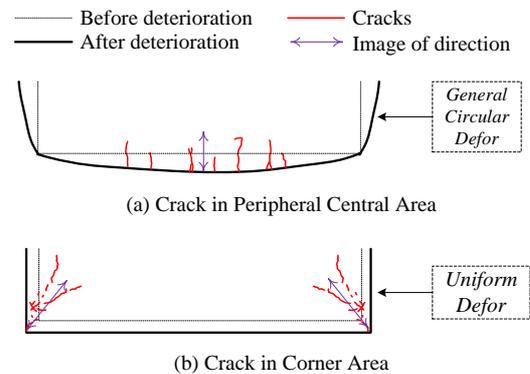
Fig. 7 Image for Mechanism of Cracks

For studying the differences of crack directions, Fig. 7 shows estimation of the mechanisms. Cracks in peripheral central area of the section have smaller length and progress vertically from the profile. This type of crack is considered to be caused by bending effect together with the general circular deformation of the section (Fig. 7-(a)). Besides, for cracks in corner area, the development length is relatively greater and the direction is around 45° . This type of crack is considered to be caused by the uniform tension due to ASR expansion and accompanies with the uniform movement (Fig. 7-(b)).
