PRELIMINARY FIELD SURVEY OF TRAFFIC BRIDGES WITH SHORT SPAN IN NORTHERN VIETNAM BY NON-DESTRUCTIVE METHODS

Saitama University Student member o Kien Trung Nguyen
Saitama University Nirmal Raj Joshi
Saitama University Regular Member Shingo Asamoto
National University of Civil Engineering Giang Hoang Nguyen

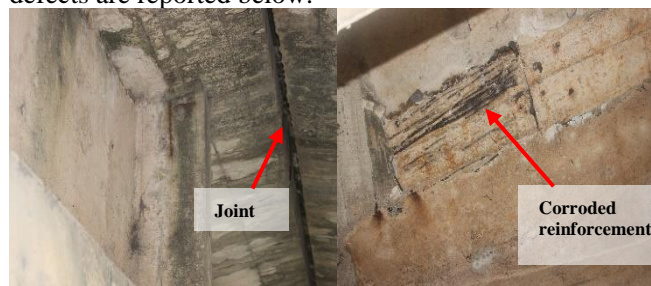
Fig.3.Corrosion of reinforcement in slab and column

In Fig.3, it is interesting to note the spalling of concrete around the joint connection of precast-concrete slab. In slab, undesirable water from rain through the joint

drastically accelerated the corrosion of reinforcement. Since slabs are directly subjected to the moving load of vehicles, defects of structure from corrosion could result in serious incidents.

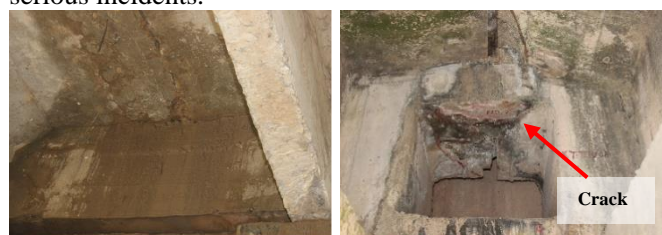
Fig.4.Spalling at the connection of slab and wall column

Fig.4. shows that corrosion of reinforcement at the connection between slab and wall column at which stain caused by leakage water could also be clearly observed. Failure of expansion joint can be attributed to increased traffic loading, component fatigue, construction error, or several other factors, which results in the leakage of water.

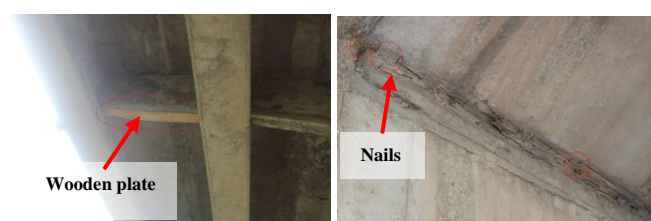
Fig.5.Embedment of objects in bridges.

A variety of defects of the structure caused by poor construction work were widely observable. In some bridges, the embedment of wooden plate, or nail inside the slab and beam was found as shown in Fig.5. The embedded objects are usually small and may not affect the load carrying capacity of concrete.

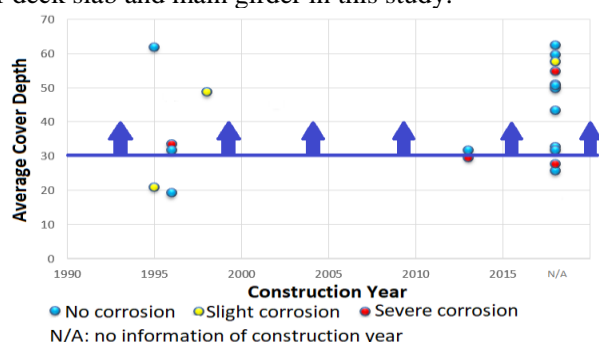
Fig.6.Measurement of cover depth in North-side Vietnam

Fig.6. shows the relation among cover depth, construction year and degree of corrosion. According to the Vietnamese design code, TCVN 9346:2012, the minimum cover depth requirement of protection against corrosion is 30mm for bridge working in brackish water and 40mm in seawater. In this study, 44% of investigated bridges complies with

TCVN 9346:2012. From measurement as shown in Fig.6, if the minimum cover depth is over 30 mm, corrosion was hardly observed regardless of construction year.

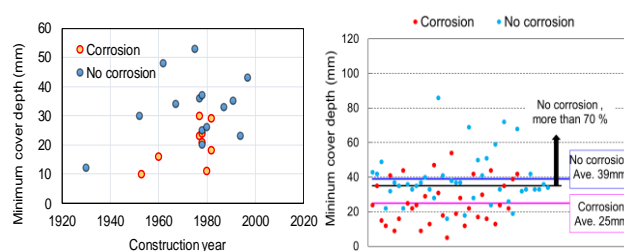
Fig. 7. Measurement of cover depth in Japan (Uwajima) and Thailand (Bangkok)

Fig.7. and Fig.8. showed the relationship between cover depth and corrosion according to the survey in Japan and Thailand. In Uwajima-Japan and Bangkok-Thailand, if cover depth is over 40 mm, corrosion hardly occurs regardless of construction years and regions. It might be suggested that the water to cause the corrosion may not follow the simple one-way diffusion and not penetrate into deep steel position under wetting and drying conditions due to water retaining in fine pores. Increased cover with water also inhibits the diffusion of oxygen which is necessary for the corrosion. According to the survey in Vietnam, Thailand and Japan, it is implied that the threshold cover depth to cause the spalling by the steel corrosion would be from around 30 to 40 mm regardless of construction year and environment.
