Investigation on Corrosion Pit Characteristics of Severe Corroded Weathering Steel

Kyushu University Student member ○ Qidi WANG
Kyushu University Regular member Muye YANG

Kyushu University Fellow member Shigenobu KAINUMA

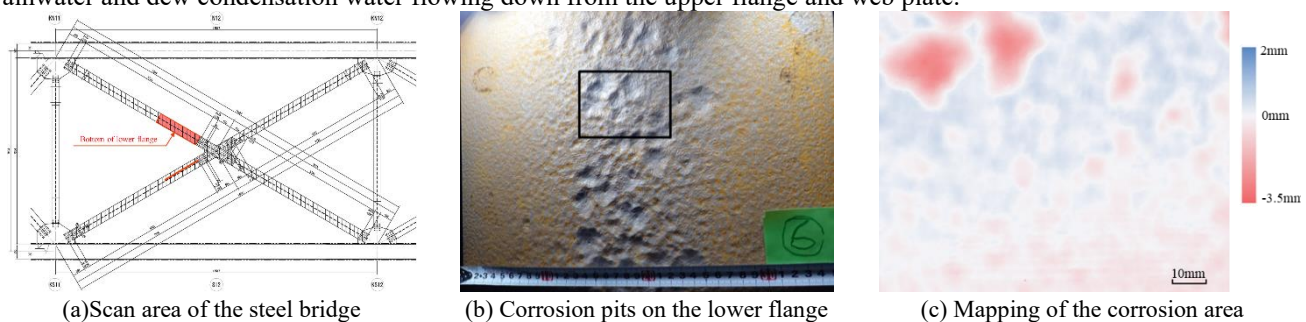
Fig.1 Corrosion pits of weathering steel structure

During this investigation, scanned the shape of the corrosion pits on the upper flange, the web, and the lower flange as shown in Fig.1(a), and summarized the characters of the corrosion pits of weathering steel. The surface parameters of the corrosion pit are measured by the 3D LED scanner (decomposition energy as 0.01mm) based on the structured projection phase shift method^{3,4)}. The measured scanning step is 0.2mm. The chosen scan area is the center of the corrosion area with 100mm in length and 80mm in width. The scanned area is shown in Fig.1(b), and the scan result is the spatial coordinates of the corroded surface, drawn as a 2D image as shown in Fig.1(c).

The corrosion pits of weathering steel are almost independent pit and do not overlap with each other, as shown in Fig.1(b). The most severe corrosion occurred at the bottom of the lower flange plate, mainly in the middle of the flange, where rain and dew are always concentrated. The width of the lower flange plate of the steel bridge is 360mm, and the width of the corroded area is about 120mm, accounting for 1/3 of the entire lower flange plate. The corrosion degree of the inner side of the upper flange plate of the lateral bracing is lower only by the bottom of the lower flange plate, and the corrosion pits are also in the middle part of the flange, but more concentrated in the area close to the web, which is caused by the flowing tendency of water. On the web, obvious corrosion pits only be found in the upper part. The corrosion pits at the web should be formed by the rainwater and dew condensation water flowing down from the upper flange and web plate.

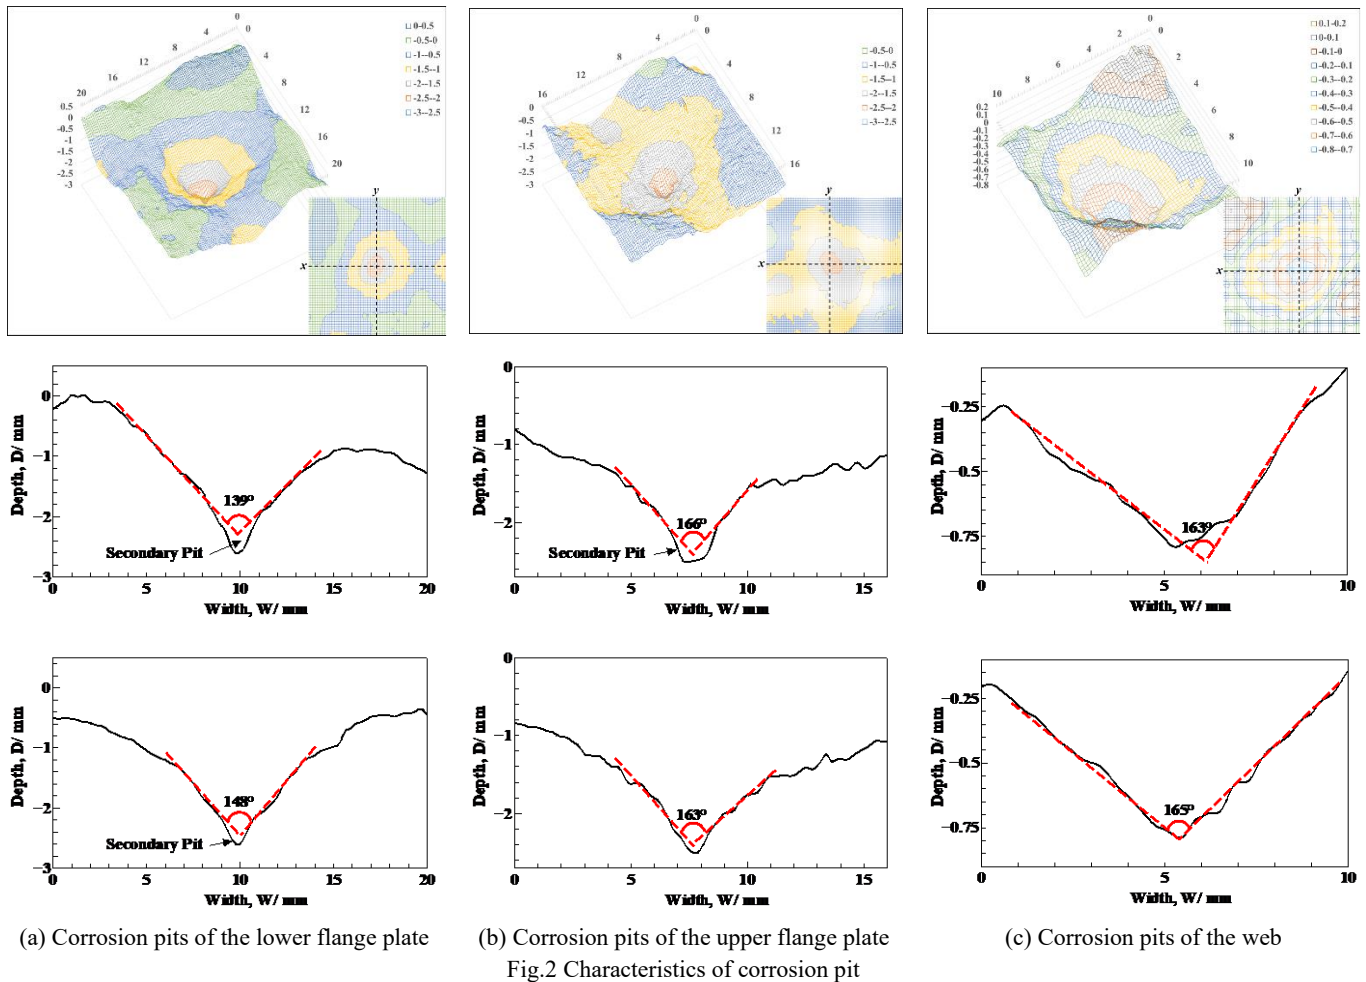
3. Test results In the investigation of the lower flange, scanned the middle part of the bottom side of the lateral bracing, where the corrosion pit mainly concentrated, and chose 19 independent corrosion pits for analysis. The depth of these corrosion pits ranged from 0.85mm to 4.15mm. Secondary corrosion is found at the bottom of eight corrosion pits, and the corrosion depth of these corrosion pits all over 2mm. As shown in Fig.2(a), it is a corrosion pit with a secondary pit and has a cone shape like the corrosion pit of ordinary steel. The relationship between the depth and angle of the corrosion pits as shown in Fig.3, it is found that the cone angle of the weathering steel corrosion pit has no relationship with the corrosion depth, and the average cone angle is 156° .

In the investigation of the upper flange, scanned the surface of the inner side of the upper flange of the lateral bracing, chose 16 corrosion pits from this area for analysis. The corrosion depth of these pits is from 1.10mm to 3.39mm, smaller than the pits on the lower flange. Among these corrosion pits, only five of them have secondary corrosion pit. The corrosion depth of these corrosion pits also exceeds 2mm. As shown in Fig.2(b), corrosion pits of the top flange are also cone shape, and their average corrosion angle is the same as that of the bottom flange, which is 156° as shown in Fig.3.

The corrosion pits on the web are significantly smaller than the flange. Scanned the upper part of the web and chose 14 corrosion pits for analysis, the maximum corrosion depth the chosen pits is 1.14mm, and no secondary corrosion pits in them. As shown in Fig.2(c), the corrosion pits on the web are also cone shape. The average angle of the corrosion pits on the web is 166° as shown in Fig.3, larger than the pits on the flange.

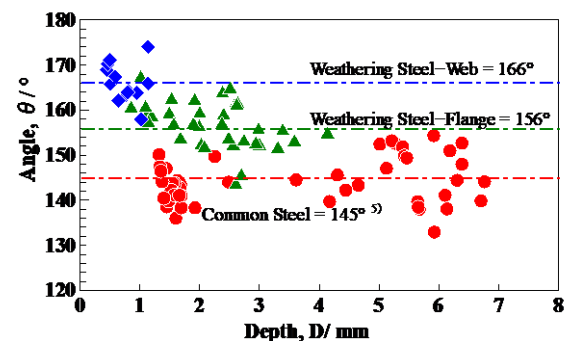
The previous research analyzed 27 corrosion pits from two corroded components from a common steel bridge in Kitakyushu expressway⁵⁾. These corrosion pits appear on the upper side of the steel beam, and most of them overlap each other. The average cone angle is around 145° like shown in Fig.3.
