AN INVESTIGATION ON FATIGUE STRENGTH FOR TRANSVERSE CHORD OF STIFFENING TRUSS

By Kenji SAKAMOTO*, Masahiko YASUDA*,
Makoto FUKAZAWA** and Chitoshi MIKI***

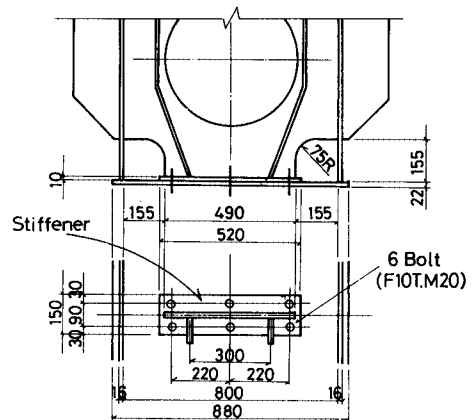
Fig. 4 Connection of diaphragm to bottom flange.

the terminating of the fillet welds of the transverse stiffener and the scallop of the diaphragm. In order to obtain the detail which prevents the out-of-plane distortion of the web plate, two details were examined. In the original detail, the diaphragm was attached to the bottom flange and in the improved detail, the diaphragm was connected to the bottom flange with six high strength bolts as shown in Fig. 4.

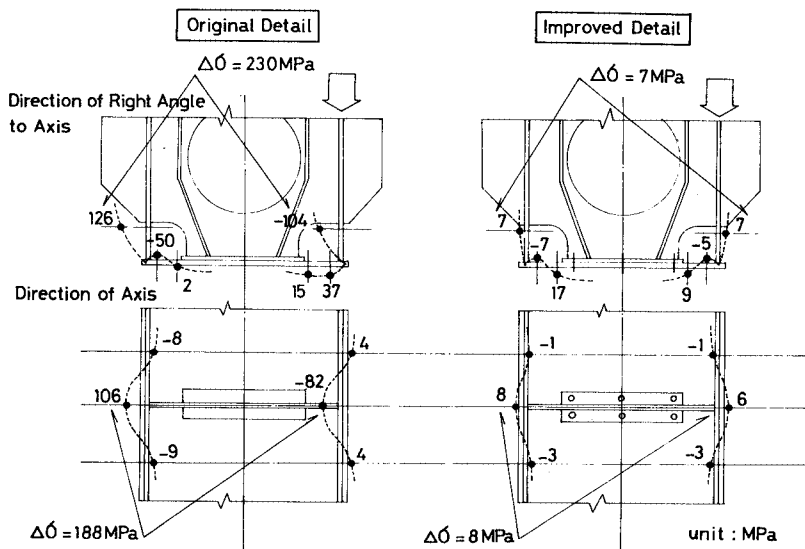
Fig. 7 Distribution of out-of-plane bending stresses.

In the original detail, out-of-plane bending stresses are large in the direction of both the specimen axis and it's right angle. Bending stress at the unloaded side web is converse to that of

the loaded side web. Stringer reaction is alternately applied to each web to simulate the passage of a train. Thus, the bending stress range at one particular point is considered to be the sum of the stress at these two points. So, bending stress range at the terminating of the fillet weld at the scallop is expected to be $\Delta\sigma=230$ MPa, and $\Delta\sigma=188$ MPa.

From previous studies on the transverse fillet weld^(3,4), it is known that the bending fatigue strength is almost equal to axial fatigue strength in nominal stress, and stress concentration at a distance of 10mm from the fillet weld toe is nearly 1.0. Measured bending stress ranges in this specimen are sufficiently high to result in the origination of the fatigue crack. On the other hand, in the case of improved detail, the out-of-plane bending stresses are small in both directions. It is clear that when the diaphragm is bolted to bottom flange, there is no significant out-of-plane web bending stress.

The result of a torsional loading test, disclosed that the diaphragm should be connected with the bottom flange. In practical fabrication, connection by the fillet weld was applied for the purpose of doing it water-tight. Consequently, allowable fatigue strength at the side of the tention bottom flange was reduced by two degrees from category A to C.

Accordingly, to reduce the applied maximum bending stress, the bottom flange plate was thickened from 22mm to 28mm, or a cover plate 16mm thick and 450mm wide was added almost the full length of the lower stress region.

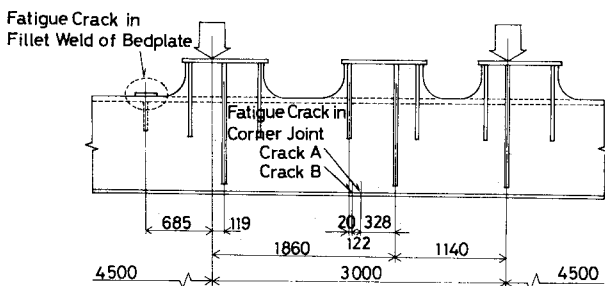
Fig. 10 Fatigue cracks in specimen.

After fatigue test, cracks on the surface of the specimen were observed by the magnaflux inspection method. Furthermore, in order to detect concealed cracks which originated at the roots of the fillet welds and the partially penetrated groove welds of corner joints, the roots of these welds were exposed along the weld line. Several cracks were found throughout this specimen. The location of the cracks are summarized in Fig. 10.

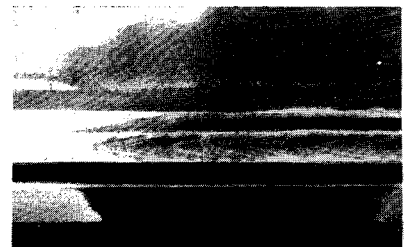
Photo 3 Fatigue crack at corner joint (Crack A).

A fatigue crack was discovered at 1 948 000 cycles in the partially penetrated groove weld of the bottom flange. This crack penetrated the web plate at 2 000 000 cycles (Crack A). Photo. 3 shows the appearance of this crack.

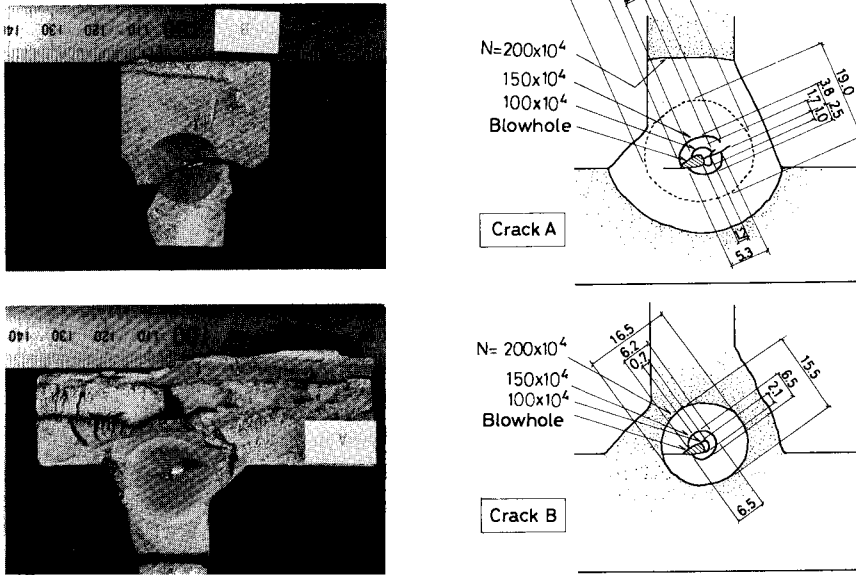
Photo. 4 Fatigue crack surfaces.

In order to observe weld defects and fatigue cracks which originated at the root of the corner joint, the root of outside welds were exposed along the weld line. This examination was conducted on areas where weld defects were indicated by ultrasonic inspection. The inside fillet weld was not examined because no defects were indicated by the ultrasonic inspection. As a result of this examination, in the region of maximum bending stress, two fatigue cracks originated from blowholes of 2mm wide×4mm high (Crack A), and 1.5mm×4.5mm (Crack B). Both blowholes are over the tolerable size of 1.5mm wide and 4mm high⁵⁾, regulated for a class A truss chord member made of quench and tempering type high strength steel. Photo. 4 shows these fracture planes. Beach marks at 1 000 000 cycles and 1 500 000 cycles were left on the fracture surfaces.

The relation among the initiation of crack, size of blowhole and applied stress range is shown in Fig. 11. Only two cracks are not enough to derive apparent relation. Fatigue cracking however, tends to originate from relatively large blowholes at a higher applied stress range region.

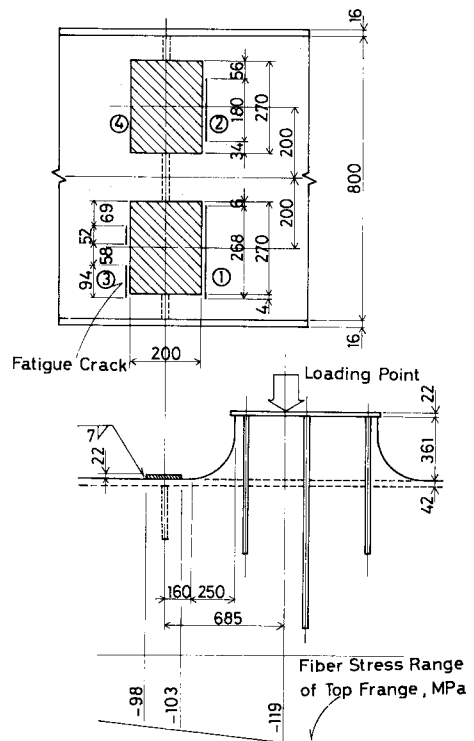
Fig. 14 Fatigue cracks in fillet welds of bedplates.

Fatigue cracks were discovered along the fillet welds of the bedplate on the top flange for the sidewalk at 1 938 000 cycles. The location of these cracks is shown in Fig. 14. The cracks appeared in three of the four front fillet welds. Appearance of a typical crack is shown in Photo. 5. A crack was found in the root of the fillet weld

The bedplate for the sidewalk were on the top compression flange where a bending fiber stress range of 0 ~103MPa was applied. Allowable design stress range of this weld joint, which is classified in Category C, is 134MPa. This suggests that the transverse fillet weld of the attachment cause a substantial reduction in fatigue strength. There are many reports about fatigue strength of the plate with welded attachment⁷⁾. However, the crack initiation at the root, and especially the crack on the compression side, have received little attention.

- (a) The diaphragm was welded to the bottom flange
- (b) The bottom flange plate was thickened from 22mm to 28mm, or a cover plate 16mm thick and 450mm wide was added, almost over the full length of the flange.
- (c) Size of fillet weld to the bedplate for the sidewalk was increased from 7mm to 12mm.

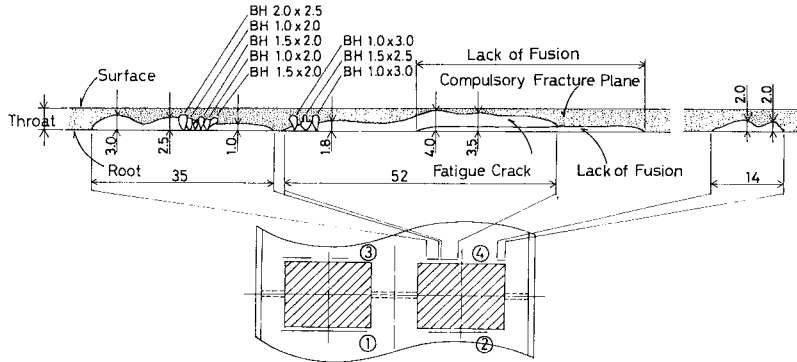
Fig. 15 Sketch of fatigue crack at root.

with no surface crack, as sketched in Fig. 15. However, no relation is apparent between crack origination and weld defects, such as blowholes and slag-inclusions at the root. The exposure of every crack surface confirmed that the cracks propagated through the weld throat from the root.

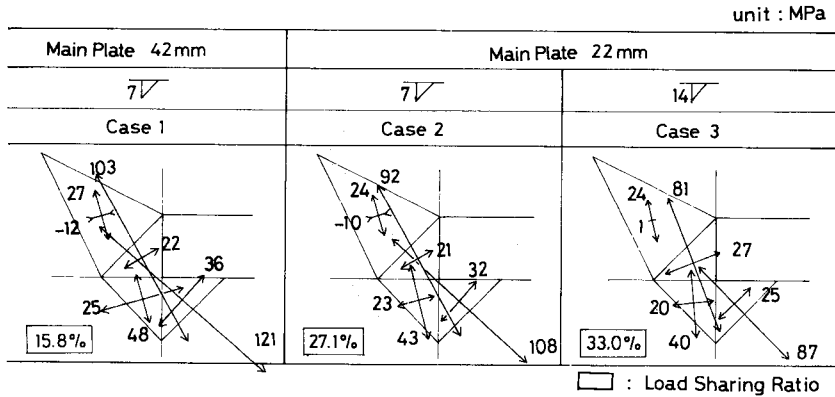
Fig. 17 Principal stress diagram about root.

The following results were proved by these analysis. When the main plate is under the compressive axial force, the gap between the main plate and the attachment plate is enlarged, and tensile stress acts on the root of the fillet weld. A principal stress diagram of the root is shown in Fig. 17. The load sharing ratios which were calculated by the supporting reaction in y-direction are given in this figure. In case-1, corresponding to the test specimen, the maximum principal stress at the root is 103MPa. The relationship between the direction of the actual crack, which penetrated through the throat, and that of calculated

principal stress can not be clearly explained. It is supposed that the direction of the principal stress could be changed by the modelling of the element at the root, and that cracks originate due to this tensile stress.

In comparison with this case, maximum principal stress decreases with the thinner main plate in case-2 and with the larger fillet weld size in case-3.

As the actual member will be under the same stress of -98MPa as the specimen, enlargement of the fillet weld size would increase fatigue strength.
