WELD REPAIR OF CRACKED BEAMS AND RESIDUAL FATIGUE LIFE

By Kentaro YAMADA*, Yoshinaga SAKAI**, Akimasa KONDO***
 and Yoichi KIKUCHI****

Fatigue cracks often initiate at as-welded toe of various attachments where stress concentration is high. Bending fatigue tests were carried out on two beams with welded cover plates and gussets. About forty fatigue cracks were observed, when the cracked parts were successively repaired with stopholes and splice plates. The fatigue test results were compared with previous test data. The cracked beams were further repaired with groove welds and fatigue tests were continued. Fatigue cracks initiated and propagated from weld defects near the end of the attachments. Fatigue life of repaired parts was somewhat longer than that of as-welded one due to grinding the weld toes after weld repair.

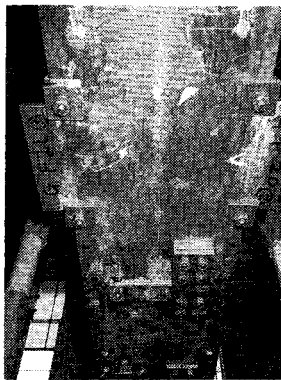
Photo 1 Fatigue cracked tension flange looking underneath. Stopholes drilled at leading edge of cracks are stiffened with high strength bolted splices.

The stophole was further strengthened by a pair of splice plates bolted from both sides of the cracked details. Fatigue tests were then continued to observe fatigue cracking from other details. Practically all gusseted details exhibited fatigue cracking. Photo 1 shows the tension flange of the test beam where high strength-bolted splices were attached to stiffen the cracked parts.

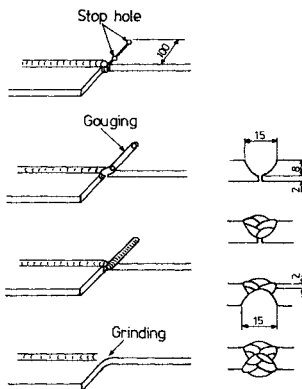
Fig. 7 Repair procedure of crack at gusset end by groove weld.

G-type Gussets : As shown in Fig. 7, an original crack was extended to 100 mm long by drilling and gas cutting. First, groove were made on both sides of the plates by arc air gouging in flat position. It was groove-welded in four or five passes. At the drilled holes, a penny shape disc of 3 mm thick and 8 mm diameter was tack-welded in order to avoid the melting down of the weld metal.

The groove weld was then back chipped from underneath. Dye check was applied to ensure no weld crack was left at the weld, before groove weld was made in the overhead position. The reason to why the final repair weld was made in the overhead position was to simulate the unfavorable site condition where the weld repair must be made from underneath. This welding position is believed to cause more weld defects than the flat position. The weld reinforcement was then ground flush, and the end weld of the gusset was ground to the radius of about 20 mm.

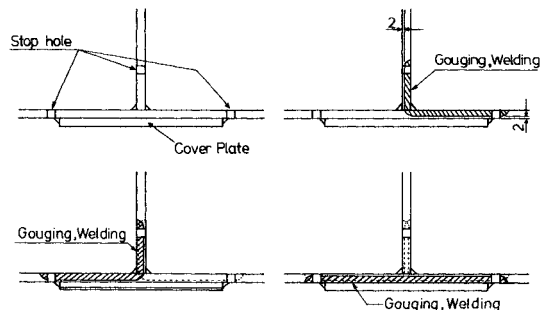
Fig. 8 Repair procedure of crack at cover plate end by groove weld.

Cover Plate : Fatigue cracks at the end of the cover plate of A 2 beam propagated through the tension flange and penetrated into the web. As shown in Fig. 8, the weld repair was made first on one side of the web and flange by arc air gouging and groove-welding. Then the other side was repaired. The flange plate was back-chipped from underneath, and groove welded in the overhead position. The weld reinforcement was removed by grinding, and the welds at the cover plate ends was ground to about 20 mm radius.

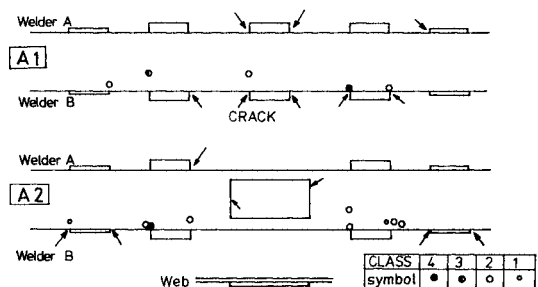
Fig. 9 Non-destructive test results at the groove weld repair by ultrasonic test.

In order to verify the weld quality of the groove weld repair, ultrasonic test and X-ray radiographic test were carried out based on JIS Z 3060 and JIS Z 3104, respectively. The test results are shown in Figs. 9 and 10. The arrow indicates that fatigue cracking was observed when fatigue tests were carried out after the repair. The welders A and B indicate who made the repair welds. Numerous weld defects were detected in the repair weld due to the fact that the welding condition was relatively unfavorable. No additional repair was made, even though large defects were detected by the non-destructive tests.

Classification of Weld Defects : Majority of the repaired welds were classified into class 3 or class 4 by the X-ray radiographic test. The ultrasonic test, however, failed to detect such defects and only a few were classified into class 3 or 4. It may be due to the fact that the ultrasonic test had some difficulty to scan near the end of the gussets where weld defects were significant. Both tests showed that the experienced welder introduced less weld defects than the unexperienced one. This was especially significant on the repair weld of T-type gussets.

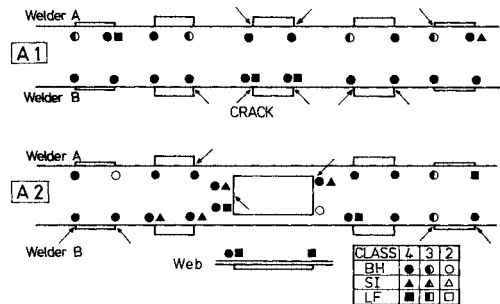
Type of Weld Defects : The X-ray radiographic test revealed that blowholes (BH) frequently existed in many repair welds while a few slag inclusion (SI) and lack of fusion (LF) were observed. These weld defects were mainly observed at or near the drilled holes and near the edge of the flange plates. It implies that the plug welding of the drilled holes and the start-stop position tend to cause weld defects.

Fig. 10 Non-destructive test results at the groove weld repair by X-ray radiography.

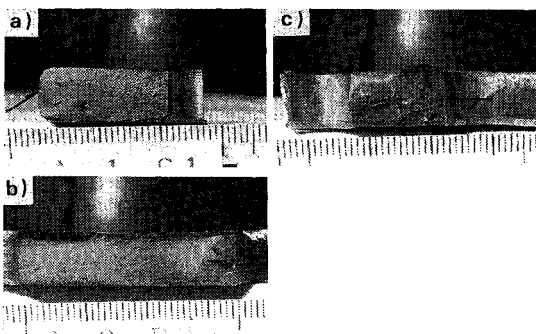
G-type Gussets : Eight out of 20 repair welds exhibited fatigue cracking. The fatigue crack initiated from the fillet of the gusset ends and propagated in the direction perpendicular to the principal stress. Typical fatigue fracture surfaces are shown in Photo 2. Photo 2 a) shows a fracture surface with few weld defect. Fatigue cracking seems to occur from grinding marks at the fillet, and it showed the longest fatigue life among the failed details. In Photo 2 b), blowholes exist near the fillet, and the fatigue crack initiated from these blowholes. It resulted about an average fatigue life of the failed data. The most harmful to the fatigue resistance was large and numerous defects near the fillet, as shown in Photo 2 c). Fatigue cracking seems to occur from these defects and coalesced to a large crack. It showed the shortest fatigue life.

Compared to the previous test data of the gussets with ground ends of 20 to 30 mm radius⁷⁾, it revealed that the present test data showed somewhat shorter fatigue life. It may be due to the weld defects near the fillet, which seems to trigger early fatigue cracking and thus reduce fatigue life.

Photo 2 Typical fatigue fracture surfaces of groove welded gusset ends (G). Weld defects were visible on the surfaces.

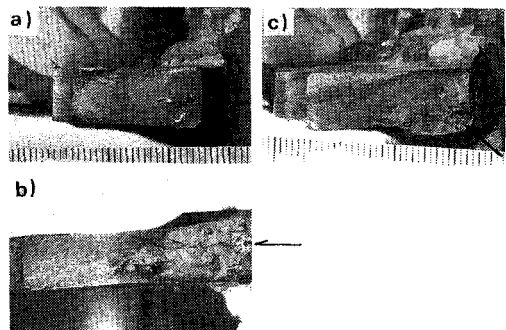
Photo 3 Typical fatigue fracture surfaces of fillet welded gusset ends (T). Numerous weld defects were visible near the end of gussets (left).

propagated from the weld defects near the fillet. Typical fracture surfaces are shown in Photo 3. A number of weld defects such as blowholes, slag inclusion and lack of fusion can be seen on the fracture surfaces, as shown in Photos 3 a) and 3 b). Fatigue cracks initiated from these weld defects, and it resulted relatively short fatigue life. In Photo 3 c), a number of small and spherical defects can be seen near the fillet, where the fatigue crack initiated. The fatigue life of this detail was one of the longest among the failed T-type gussets.

As shown in Photo 3, relatively large weld defects were introduced near the fillet of the T-type gussets, because of the unfavorable welding condition. The stress concentration due to the gussets was superimposed to these weld defects, and it yielded to low fatigue strength, despite the ground fillet at the end of the gussets. This detail can be classified into detail class G, if it is as-welded. It may be appropriate to use the same detail class for the repair weld, provided that the gusset ends are ground to achieve smooth transition.

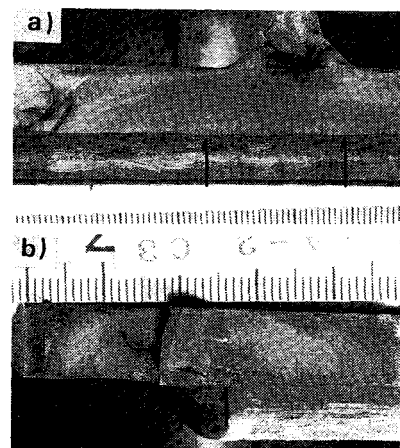
Cover Plate : Photo 4 a) shows the fracture surface of the cover plate ends, where a crack of 4 mm long was observed at 630 000 cycles. Several cracks initiated at the transition from the flange to cover plate, and propagated in semi-elliptical shape. The radius of the fillet of this side was relatively small and the grinding marks were left on the surface. This may cause early fatigue cracking. The fracture surface revealed that sizable weld defects existed at the junction of the flange and the web, where the repair weld was placed from three sides. These weld defects, however, were not the major crack initiation points. Photo 4 b) shows the fatigue cracking occurred from the plug welding of the stophole near the end of the transverse fillet weld. A few cracks initiated in the different plane and joined together as they propagated.

Photo 4 Fatigue fracture surfaces of tension flanges at the end of cover plates. Repair was made by groove weld.

data of the repair weld showed somewhat lower fatigue strength than the cover plated details with tapered end welds. The weld defects introduced by the repair weld may have caused the reduction of fatigue strength. Therefore, it may be safe to use the same allowable stress ranges for the repair weld with ground end weld of cover plate, although the cover plates with tapered end welds to 1 : 2 was classified into detail class C in the JSSC recommendation⁹.
