FATIGUE STRENGTH OF WEATHERED AND DETERIORATED RIVETED PLATE-GIRDER

By Koei TAKENA, Hiromichi KAWAKAMI*, Seiichi TANIFUJI**
and Chitoshi MIKI****

In this study, a detailed review of the fatigue test results of riveted joints which have been performed in Japan, is conducted. A fatigue test is carried out on a plate-girder bridge which has been used in a railroad about 70 years. The fatigue strength and the initiation and propagation behavior of fatigue cracks of weathered and deteriorated riveted plate girder is discussed.

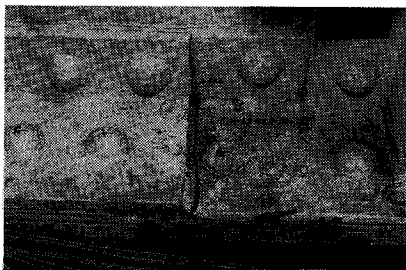
Fig. 6 illustrates the loading history. At about 10^4 cycles a crack (L_A crack) initiated near the edge of a corroded groove of the horizontal angle leg (reduction of sectional area was about a half that of the original shape) at the end of the splice angle in the vicinity of A-A section of the left girder. Photo 1 shows the ultimate state of this crack. This crack was observed to coalesce into new ones which developed later.

Photo 1 Crack which initiated from Edge of Corroded Groove (Crack L_A).

L_A crack (Photo. 1 and Fig. 13) is differently characterized from the above three types of cracks. One feature is that the crack in the flange angle starts not from the rivet hole but from a corroded surface. Another feature is that L_A crack starts from the rivet holes in two symmetric sections with respect to the connection of P_2 plate, whereas the other types invariably start from the rivet holes in the same section (Fig. 9). In the outside flange angle a number of cracks initiated from notches on the rough irregular surface of its horizontal leg where the sectional area had been reduced to half the original area as a result of corrosion, and they coalesced into one, leaving seven beach marks which were as many as the load reductions with no cracks starting from rivet holes. In the inside flange angle no cracks initiated. L_D crack in the flange angle behaves just like L_A crack in the flange angle; that is, the crack initiated at the surface

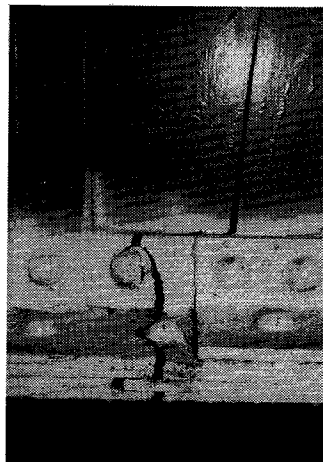
At 68.6×10^4 cycles, the crack near A-A section of the right girder had grown so large that the testing was interrupted. As seen from Photo 2, the right girder then had all its flange cut through, with the crack

Photo 2 Crack which penetrated through Lower Flange (Crack R_A).

advancing up to near-half of the web (R_A crack). Photo 3 indicates that in the left girder the cracks on the upper cover plate and the splice plate had developed respectively from the rivet holes in two symmetric sections with regard to the connection of the lower cover plate (L_A crack). The splice plate completely failed, while the upper cover plate was not cut through. As shown in Photo 1, the crack of one flange angle propagated up to about 1/3 length of the vertical leg, but no crack was observed on the other flange angle opposed to it across the web. This seems to be an accelerated failure, because no crack was observed in a visual examination which was done 1.6×10^4 cycles earlier.

Fatigue testing was resumed after the repairing of failure sections by splices with high-strength bolts. At 79.3×10^4 cycles, a crack was observed to initiate from a rivet hole of the splice plate near C-C section of the left girder (L_c crack). At 83.9×10^4 cycles, with the flange failure and the crack propagating up to half the web, the testing was terminated. Immediately thereafter, the right girder had its paint film stripped at a symmetric position to the failed section of the left girder, revealing that, as indicated in Photo 4, the surface of the flange had been cracked and the upper cover plate had been cracked up to the end of its plate (R_c crack). In the presence of painting film, no crack can yet been revealed in such a case. The painting film was 7 years and 5 months old.

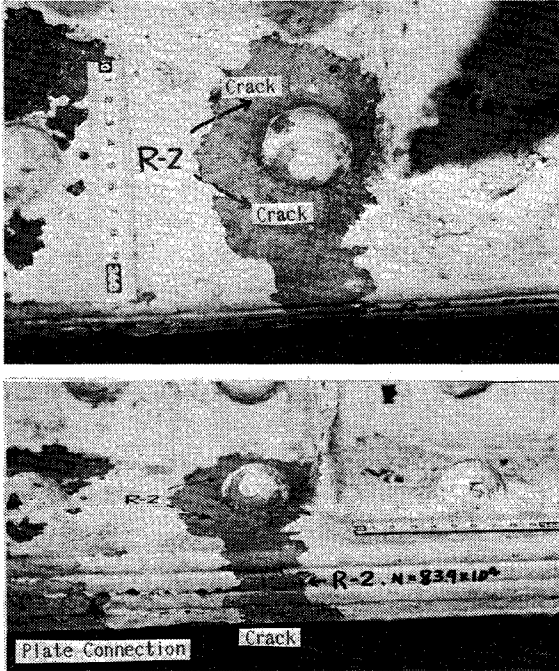
Photo 4 Crack found by Stripping Paint Film (R_c).

R_C crack [Fig. 12] is one which was found just after the fatigue test is interrupted and it can be exposed with removal of the paint film. The beach marks revealed were seven on the left side of a hole in the outside flange angle; three on the right side of it; five on the left side of a outside hole of P_3 plate; and six on right side of it. No cracking occurred in P_1 plate which had been most heavily stressed. From the observation of these beach marks, it can be speculated that cracks initiated nearly at the same time before 37×10^4 cycles at the left top edge of a hole in the outside flange angle, and at the left and the right bottom edge of a hole in P_3 plate, followed with a little delay by a crack at the right top edge of a hole in the flange angle. And just before the test was finished, the crack on right side of a outside hole of P_3 plate arrived to the right end of P_3 plate. These cracks propagated with relatively stable manner.

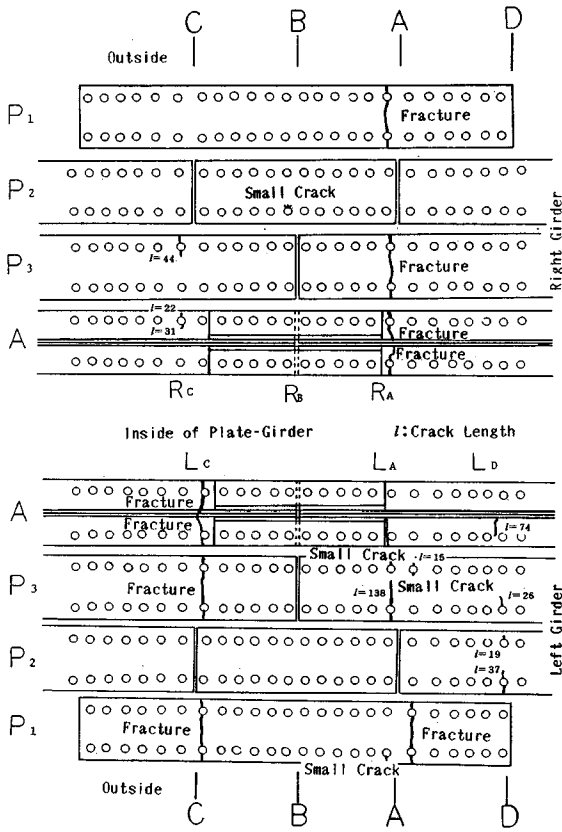
The results of crack observations are summarized in Table 1 and Fig. 9. In the figure the outside and the inside mean respectively the inside and the outside of the bridge with respect to the web. A, P₃, P₂, and P₁ represent the flange angle, the upper cover plate, the lower cover plate and the splice plate respectively. Near A-A and C-C sections at the connections of the lower cover plate, cracks were found during the fatigue test (L_A crack, R_A crack, L_C crack and R_C crack). Near B-B section at the midspan of the right girder a single tiny crack of less than 1 mm long was discovered at the rivet hole edge by the crack observation after the fatigue test (R_B crack). Near D-D section at the end of the splice plate, the same observation revealed a crack in the left girder (L_D crack). These cracks in tension flanges invariably initiated from the rivet hole closest to the plate connection of the spliced part and from the position where the sectional area had been reduced to less than one half of the original area on account of corrosion, but no cracking was observed at other rivet holes. In the compression flanges, cracks initiated from four spots of heavily corroded cover plates at the end of the splice plate.

Fig. 9 Results of Crack Observations.

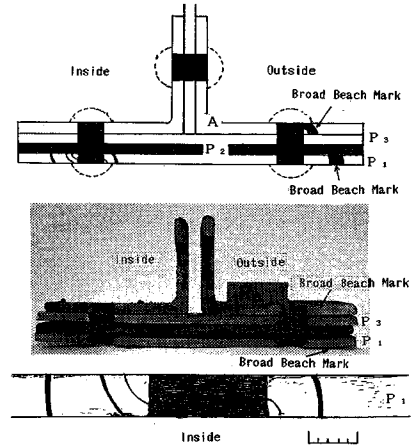
The beach marks of R_A crack were found to be three on the left side of a inside rivet hole of P₁ plate, two on the right side of it, and one with broad width on the right side of an outside rivet hole of P₁ plate. In the outside flange angle a broad beach mark was observed on the right side of a rivet hole. These broad beach marks are evidence that the crack rapidly propagated even when the load range was reduced to half. P₃ plate and the inside flange angle exhibited no beach mark. Considering the number, spacing and breadth of beach marks, the fatigue crack is likely to initiate and propagate in the following process. First, a fatigue crack initiates at the left top edge of a inside rivet hole of P₁ plate. Next a crack initiates at the right bottom edge of the same hole. Then the left crack arrives at the left edge of the plate, while the right crack

Fig. 10 Failure Surface of Crack Rc.

rapidly propagates beyond the outside rivet hole until P_1 plate is wholly broken, leaving the last beach mark. In the outside flange angle, by the time that P_1 plate almost fails, a crack starts from the right bottom edge of a rivet hole and rapidly causes a failure, leaving a broad beach mark. And at the 1.6×10^4 cycles after final half-reduced load the inside flange angle and P_3 plate quickly come to a failure. Number of half-reductions of the load is 7 in total till the cracks are repaired and the total number of beach marks recognized on the failure surface is four. From this it follows that the first beach mark emerged at 37×10^4 cycles.

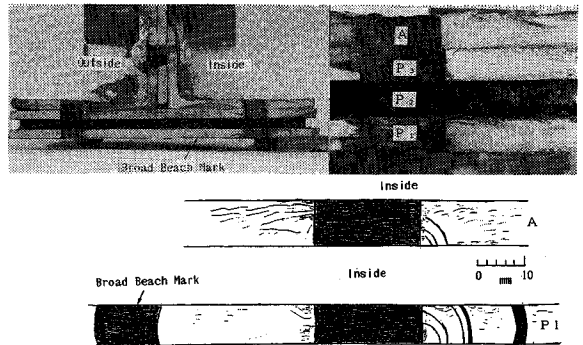
Fig. 11 Failure Surface of Crack Lc.

The beach marks of L_c crack [Fig. 11] were found to be five on the right side of a inside hole of P_1 plate, one with broad width the left side of it, and three on the right side of a hole in the inside flange angle. There were no beach marks recognized on the P_3 plate and on the outside flange angle. From the detailed observation of beach marks, the initiation and propagation behavior of fatigue cracks in this failure surface are considered as follows. A fatigue crack happens at the right bottom corner edge of a inside hole of P_1 plate, leading to a failure of the right section. By that time, a crack starts from the left side of the hole, causing a sudden failure of the whole section of P_1 plate leaving a broad beach mark. The beach marks on the right side of a hole of the inside flange angle are three and the half-reductions of the load after repairing of A-A section are three, indicating that a crack has started from the right bottom edge a short time before the repairing. This crack propagated with relatively stable manner up to the final half-reduction of the load and then quickly advanced to a failure during the succeeding 5.3×10^4 cycles, and in the meantime the outside flange angle and P_3 plate came to a sudden failure. In other words, after the time that the whole section P_1 plate had failed, the cracks in the other elements of the flange suddenly extended, causing a failure of these elements. The half-reductions of the load of these cracks were ten and

the beach marks observed were six in total. Therefore it can be said that the innermost beach mark has emerged at 47×10^4 cycles.

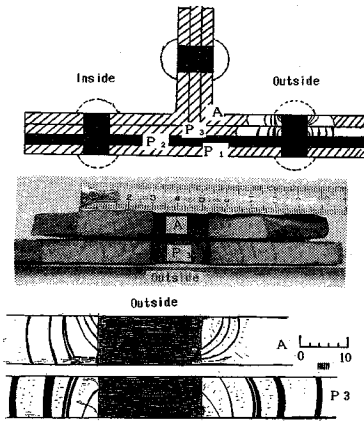
Fig. 12 Failure Surface of Crack R_C .

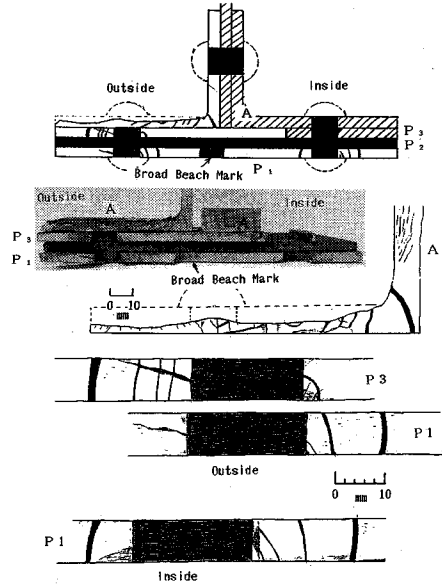
Fig. 13 Failure Surface of Crack L_A .

where the sectional area has been corroded to less than half the original area.

Observations of failure surface of L_A and L_D cracks indicate that (a) when the sectional area has been reduced to a half by corrosion, as the stress concentration results in being large at the notches on the rough irregular surface, a crack is more liable to start there than in the riveted part and (b) a crack which initiates from the corroded surface behaves more stably than one initiated from the riveted part and the former is a little easier to detect than the latter, accordingly more likely to be detected and repaired at the time of inspection in service.
