A Study on Natural Disasters Added to the Non-Lining Tunnels of Tatsumi Waterworks*

by Haruo AOKI** and Masaru KITaura***
Abstract

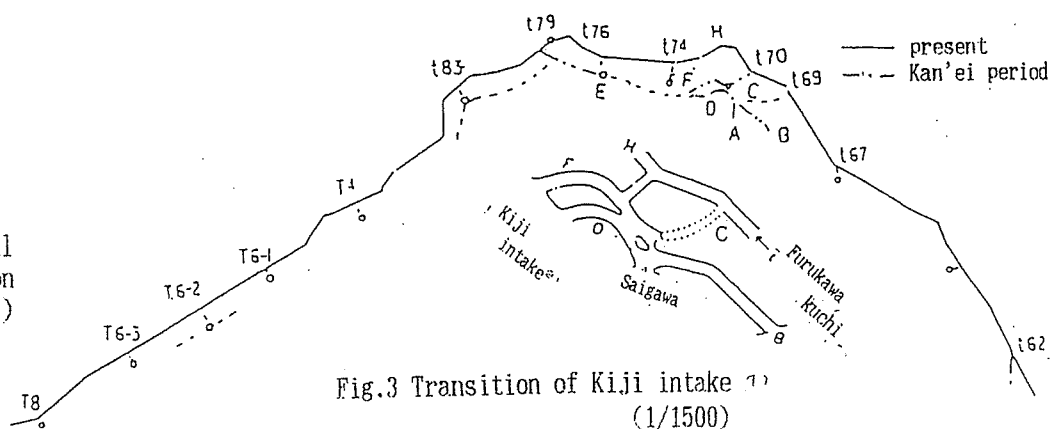
Fig.3 Transition of Kiji intake (1/1500)

2) According to Fig.3 (ruins of the Kiji intake), waterways were transferred from routes A-D-E to B-F-E, and to C-F-E. Site A or B was the intake in possibility, however, site B might be an adit.

3) If site A was adit, waterways routes were transferred from B-D-E to B-F-E, and to C-F-E.

4) C waterway existed in roundabout route.

It is close to the present bypass tunnel where the tunnel bottom level is 0.3 m below C waterway. The tunnel bottom might be dugged down in 1950.

5) Waterways D and F were not connected to E by any tunnel. This reason might be the earthquake or a cave-in due to plastic deformation just after the completion of the tunnel before the earthquake.
