A Study on the Survey of Levee Deformation around Sluices

Akihisa SEGAWA¹ and Yuuki MAHIRA²

Against this background, this paper proposes a survey method to accurately understand the actual conditions of levee deformation around sluices.

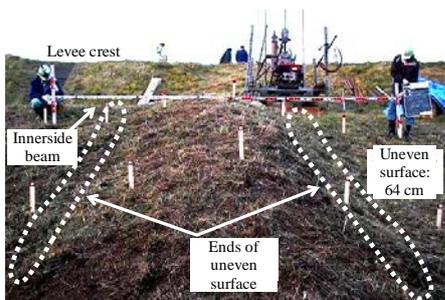
Photo 1 shows a case of levee surface deformation right above a box culvert. After removing grass, observation and measurement must be made to clarify the location of uneven surface, and deformation, loose soil and cracks at the ends of the uneven surface.

Photo 1 Measurement of uneven surface of a levee

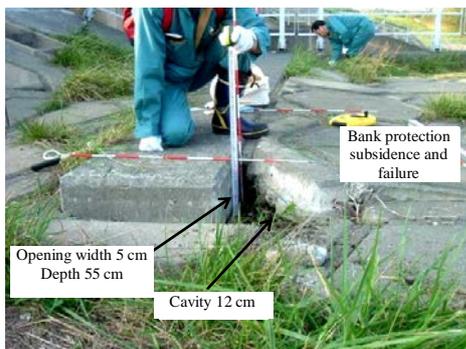
Photo 2 shows a deformation at the end of a parapet. After removing grass and debris, observation and measurement must be made to clarify the openings and loose soil around the structure, subsidence of and damage to the bank protection, cavities under the bank protection and other conditions.

Photo 2 Measurement of parapet end

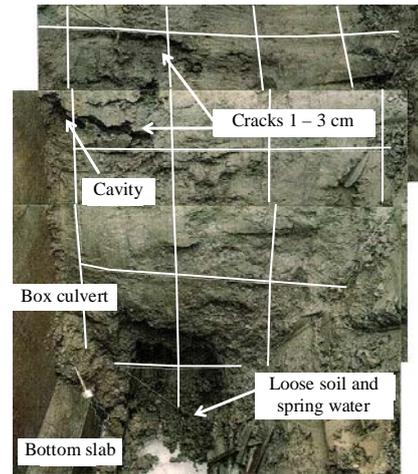
Photo 3 shows a deformation under soil layers. Strings are tied in a grid pattern (1.0 m × 1.0 m) to identify the location of the deformation. Bonding between the box culvert and the soil layers, loose soil, cracks, cavities, spring water, water paths, soil properties and other conditions must be observed and necessary measurements must be taken.

Photo 3 Measurement in soil layers

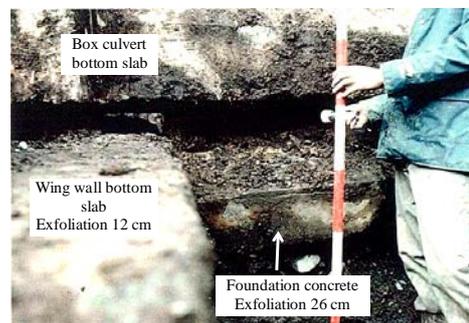
Photo 4 shows a deformation below the bottom slab of a box culvert. Soil is dug up to approximately 0.5 m below the bottom slab to observe soil separation, loose soil, cracks, cavities, spring water, water paths and other disturbed soil conditions and to take necessary measurements.

Photo 4 Measurement of box culvert bottom slab

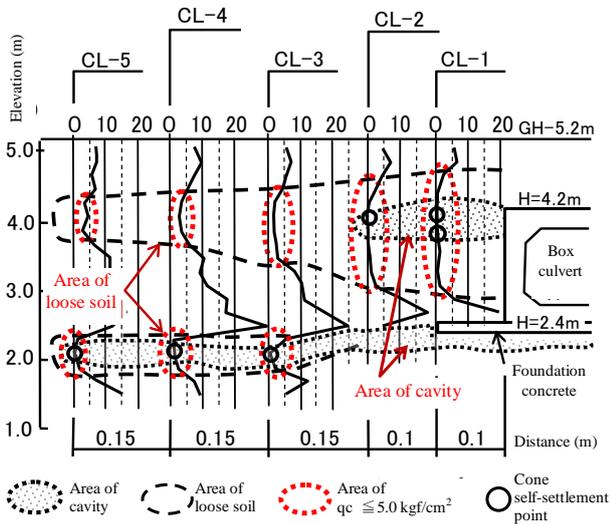
Figure 1 shows a qc value distribution map obtained through a 2-t Dutch double-tube cone penetration test, in which the proposed survey techniques were used, overlapped with a soil layer observation map obtained through an open-cut survey.

The areas enclosed with the dotted lines in the figure indicate spots where cavities were observed, and the areas enclosed with the dashed lines in the figure indicate estimated areas of loose soil, the areas enclosed with the bold dotted lines indicate areas where $qc \leq 0.5M/m^2$, and the circles indicate cone self-settlement points.

In terms of qc value, cone self-settlement points, which were considered to have cavities, and an area where qc was $0.1M/m^2$ or less were observed at measurement points CL-1 and CL-2 above the box culvert and at CL-3, CL-4 and CL-5 lateral to the bottom slab..

Areas where qc was measured to be $0.5M/m^2$ or less, which were considered to have loose soil, were CL-1 through CL-5 lateral to the box culvert and the bottom slab at upper and lower levels.

These measurement results agreed with the areas of cavities and loose soil estimated based on soil observation.

Accordingly, it was proposed that $qc \leq 0.5M/m^2$ should be the criterion for determining loose soil and $qc \leq 0.1M/m^2$ for determining cavities.

Fig. 1 Soil profile observation and different forms of levee deformation detected based on qc measurement

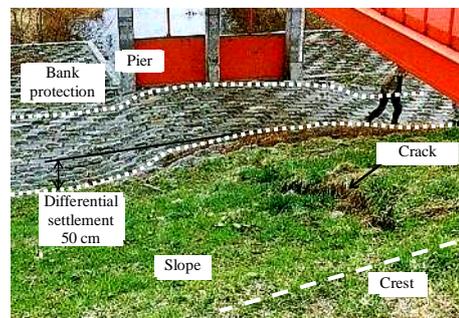
Photo 5 shows a case of uneven surface with a difference in level of 50 cm on a slope right above a box culvert as a result of differential settlement. A crack accompanied with differences in level and openings was developed at the upper part covered with lawn, the bank protection at the bottom was significantly deformed, the ground around the pier was settled, and cavities were formed underneath the bank protection.

These two cases represent a deformation type that is highly likely to increase permeability through levee surfaces and around sluices.

Photo 5 Differential settlement on slope

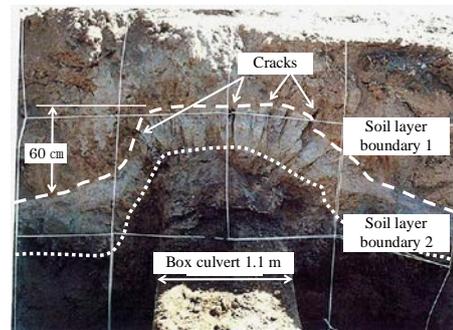
Photo 6 shows a deformed soft soil layer 21 m in thickness around a box culvert. There were a difference in level of 60 cm, cracks, and loose soil along the soil layer boundaries indicated by the broken line and the dotted line. A continuous cavity was developed under the bottom slab.

Photo 6 Soil layer deformation

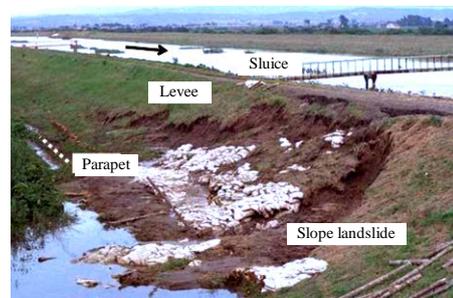
Photo 7 shows a slope landslide 50 m in width across a sluice, which was judged to be caused by leakage through the sluice since there was peat soil

below the box culvert and no overflow was seen.

These three cases indicate that cavities and other forms of levee deformation associated with differential settlement are generally seen in peaty soft ground and are likely to directly lead to levee failures in cases of flooding.

Photo 7 Slope landslide on the land side

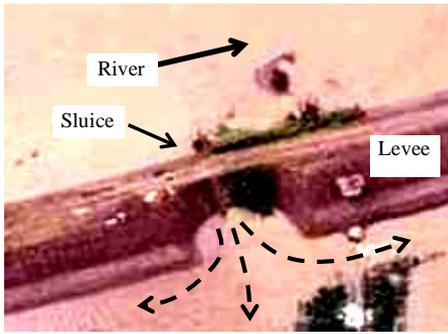
Photo 8 shows a case of piping caused by cavities developed under a sluice in a soft layer 20 m in thickness and part of the levee was washed away.

Photo 8 Leakage through under a bottom slab

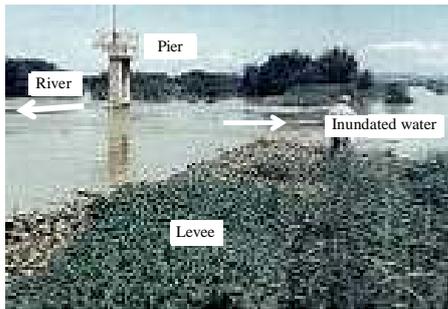
In Photo 9, a 180-m section of a levee was washed away by the overflow (5 – 10 cm) that occurred while a flood control measure against leakage through the sluice was in progress, resulting in an inundation area of 350 ha.

Photo 9 Levee failure at sluice

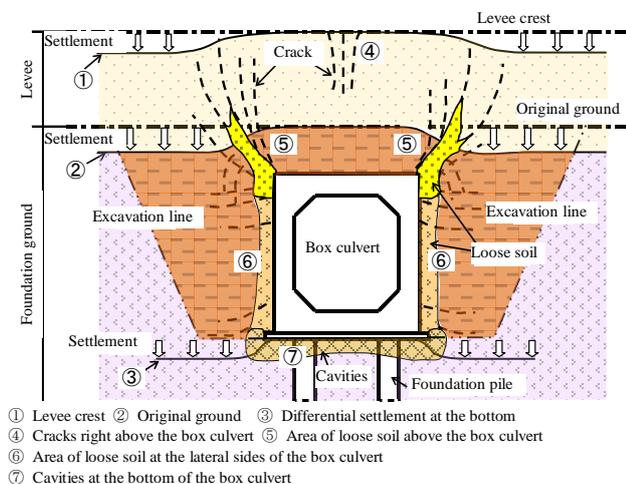
Figure 2 shows the profile of a box culvert deformation model approximately 20 years after its installment, which was revealed by an open-cut survey based on the results obtained in the preceding sections. It was found that differential settlement occurred between the levee and the box culvert, resulting in continuous differences in the level of the soil layers, loose soil, cracks and cavities developed in an area approximately 4.0 m to the right and left from the sluice and from the crest down to approximately 2.0 m below the bottom of box culvert.

Fig. 2 Box culvert cross-section deformation model
