# River Bridges with Natural Banks: A Case Study of Twenty-One River Bridges in Papua New Guinea

○Hokkaido University  
Hokkaido University

Member Gibson Ali HOLEMBA  
Member Takashi MATSUMOTO

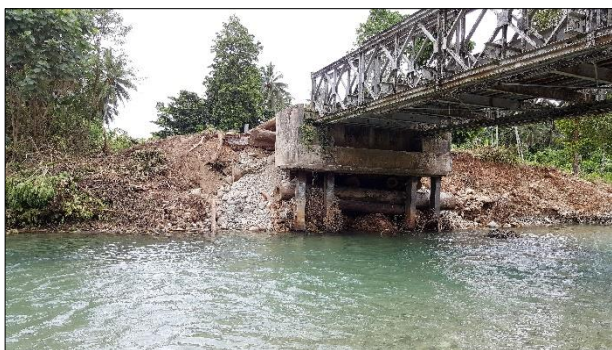
Maintenance and management of critical infrastructure such as roads and bridges that provide access to essential goods and services in a developing country like Papua New Guinea is a subject of discussion that has no end. Moreover, to add salt to the wound, the recent change in the global climatic patterns has caused more distress and disasters with high rainfall in intensity and frequency. This is causing more river floods damaging many vital bridges that link roads of high economic and social importance to the people such as shown in Figure 1 below.

**Figure 1. Riverbank Erosion induced bridge failure of Himutu Bridge, Boluminski Highway, New Ireland Province, Papua New Guinea. Photo Credit: Gibson Holemba (2016).**

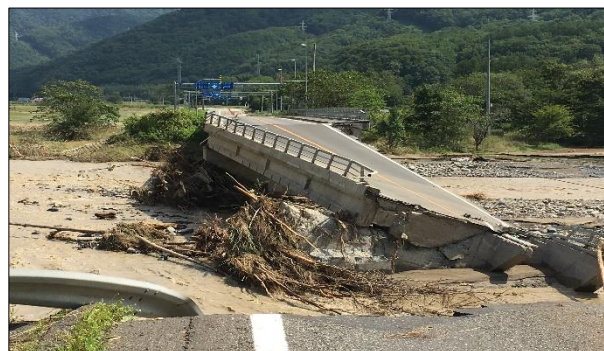
In 2016, a typhoon hit the island of Hokkaido in the Tokachi area damaging a lot of structures such as bridges, buildings and community facilities causing major havoc on the residents and businesses. In another incident, a major flood caused by torrential rain measuring up to 488mm on the 31st of August 2016, damaged the 43km road section of Nissyo Pass along the National Road 274 in sixty-six (66) different locations ranging from major to minor infrastructure damages. It was noted that ten (10) of the damaged structures were bridges, three (3) snow sheds, six (6) major road damage, and forty-seven (47) minor road damages. The major cause of the disaster was flooding carrying a high volume of flood debris, huge logs causing landslides along the natural riverbank and road embankments as shown in Figure 2 below.

**Figure 2. Riverbank Erosion induced bridge failure of a bridge along National Road 274, Nissyo Pass, Hokkaido, Japan. Photo Credit: Dr. Hiroaki Nishi, CERl (2016).**

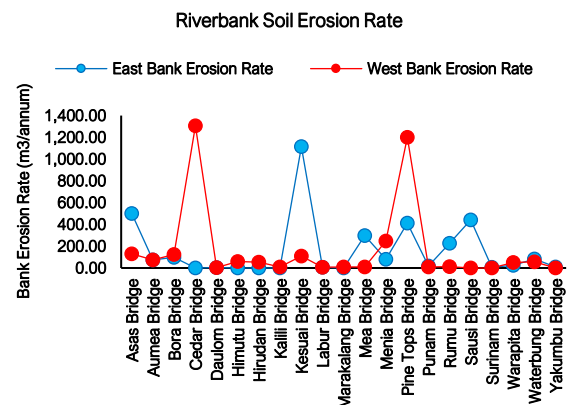
The bank erosion rate was calculated by the volume of eroded bank soil estimated from the change in channel cross-sections divided by period of two years (2017-2018) of research. The maximum bank erosion rate on the western banks was recorded for Cedar Bridge at 1306.5m<sup>3</sup>/annum and Pine Tops Bridge at 1200m<sup>3</sup>/annum. On the eastern banks, the maximum bank erosion rate was observed at Kesuai Bridge with 1113.75m<sup>3</sup>/annum. On the contrary, Sausi, Surinam and Yakumbu Bridges were observed to have zero bank erosion on the west bank whilst Cedar, Himutu, Hirudan, Kalili and Marakalang Bridges on the eastern bank had nil erosion. This phenomenon is due to meandering streams flowing at an angle less than 90-degrees as shown in Table 1 and/or from a change in flow direction during the flood, influenced by bedforms and geomorphology of the banks. Interestingly, all these rivers with high erosion rates have similar riverbed and bank soil composition and that is silty-sand and gravel and they failed by combine failure. Given in Figure 5 are the bank erosion rates for the twenty-one bridges studied.

**Figure 5. Riverbank Erosion Rate for Twenty-One Bridges**

The highest bank erosion rate was recorded for Cedar Bridge at 1306.5m³/annum with a flow velocity of 2.62m/s, at a flow angle of 45-degrees at the western bank whilst the lowest was zero for a total of eight bridges on both banks as shown in Figure 5. The average rates of erosion were 161.67m³/annum on the eastern banks and 165.33m³/s on the western banks. The median values were 24m³/annum for the eastern banks and 50m³/annum on the western banks. As a rule of thumb, if the flow angle is less than 90-degrees with respect to the longitudinal axis of the channel, the riverbank is likely to experience bank erosion.

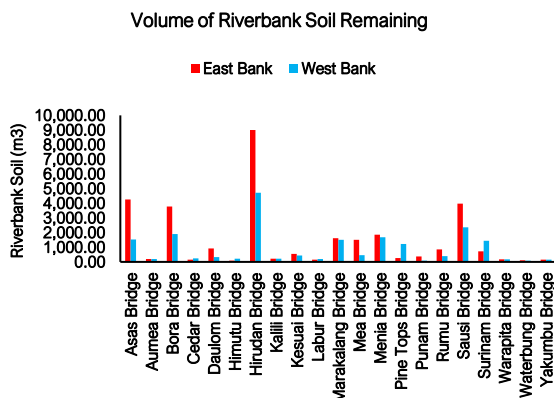
Moreover, to predict the complete erosion of the riverbank soil near the bridge abutment, the balance of remaining soil volume within the investigation limit was used. The balance volume of remaining soil was divided by the respective erosion rate of each bridge both at east and west banks and the time periods for complete erosion were estimated. These assessments were based on the riverbank soil type, submerged soil density, flow behavior of the river and the rate of erosion and given in Figure 6 below are the measure of the remaining volume of riverbank soil. Hence, it can be noted from Figure 6 that the bridge sites with a high amount of remaining riverbank soil are the sites that have lower bank erosion rates compared to those that have low bank soil remaining which are the ones experiencing high bank erosion. This type of assessment is very crucial during the feasibility study and site investigation stage of bridge design so that an appropriate bank protection structure can be selected, designed and constructed.

Figure 6. The volume of Remaining Riverbank Soil
