SEISMIC PERFORMANCE OF BRIDGE HIGHWAYS DURING THE JAN. 17, 1994 NORTHRIDGE EARTHQUAKE RELATED WITH BRIDGE RETROFITTING

SHIRO TAKADA (*)
HIDENORI MORIKAWA (**)
FREDDY R. DURAN CARDENAS (***)

INTERSECTION OF THE GOLDEN STATE FREEWAY (I-5) WITH THE ANTELOPE VALLEY FREEWAY (ROUTE 14)

4.1 Interstate 5 / Route 14 Interchange - Separation and Overhead

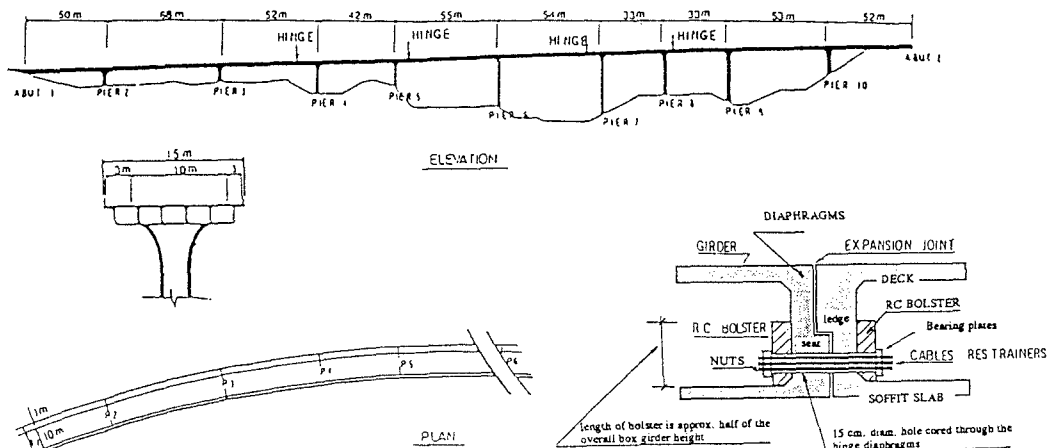
Fig. 1 Geometrical details of the Interstate-5 /Route 14 Interchange. Separation and Overhead.

- 492 m length, 15 m width and 650 m radius curved structure.
- 10 spans along five continuous segments connected by hinge restrainers, cast in place, five cell (1.7 m deep) concrete box girder. The spans were supported by 38 cm length seats at the intermediate hinges. Each of the 3 restrainers placed across the hinge joints were composed by 4 steel cables confined within a steel pipe extended across the two adjacent span segments through a concrete diaphragm wall, see Fig. 1.
- Abutments (seat type) and single columns were on spread footings or piled footings. The foundation were on loosely compacted alluvial sand with gravel. The structure had not been fully completed by the time the 1971 Sylmar Earthquake did occur. It was completed on 1972 with restrainers at hinge locations but abutments remained without restraining devices.

- The failure mechanism that seems to be occurred on this bridge may be identified by the inability of short columns to bend enough in order to absorb the larger shear forces transmitted by longer columns. On the other way, the restrainers at hinge joints could not withstand the strong undulation of the superstructure produced by the vertical motion that seemed to lift the bridge decks enough to produce the come down of them and simultaneously the swing of bridge columns, the combination of these simultaneous effects probably caused that the whole structure mushroomed and then induced the fall of the next span.

- Three spans dropped between pier 3 and the nearest abutment probably when a 13 mm thick steel plate placed at a hinge support became loose permitting that the restrainers had been pulled out by earthquake forces which exceeded their restraining capacity.
Columns seems to be punched up through the superstructure and immediately after to the next span which fell off the hinge on which sits, also a 6m height column (bent 2) nearest the abutment and pier 3 seems to be crushed by the fall of a span, # 18 reinforcing column bars sprained. Very tall flexible columns of this interchange sustained relative displacements atop them greater than 38 cm affecting directly to hinge joints.
