## Water supply pipeline damage related with geomorphology and geology in Kashiwazaki-city

Kobe University   Student member of JSCE   ○Jérôme Blard  
 Kobe University   Regular member of JSCE   Yasuko Kuwata  
 Kobe University   Fellow member of JSCE   Shiro Takada

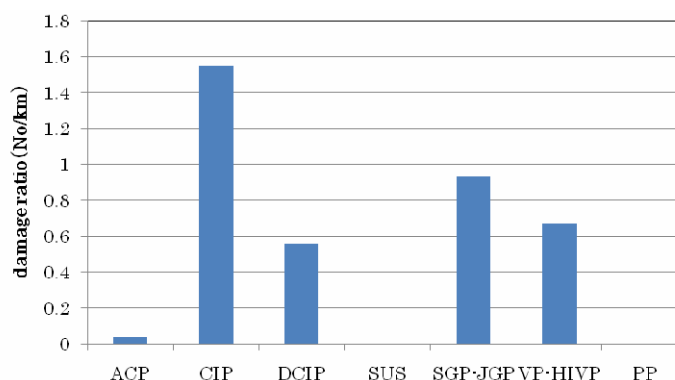
Fig.2: Damage ratio due to materials

After the earthquake, 60,000 households were concerned by water outage (40,000 in Kashiwazaki). Many different kinds of materials were used for the distribution system, as it is pointed in Fig. 1. The total length of pipe is approximately 712.3 km, with also different diameters: 31% are less than 50 mm, 45% are between 75 and 100 mm, 17% are between 200 and 350 mm, and finally 7% are more than 400 mm. 98.7% of the smallest diameters are Vinyl Pipe (VP), whereas others mainly use Ductile Cast Iron Pipe (DCIP). Fig. 2 shows the damage ratio of pipeline due to material. In the case of this city, the damage of CIP and SGP are remarkable.

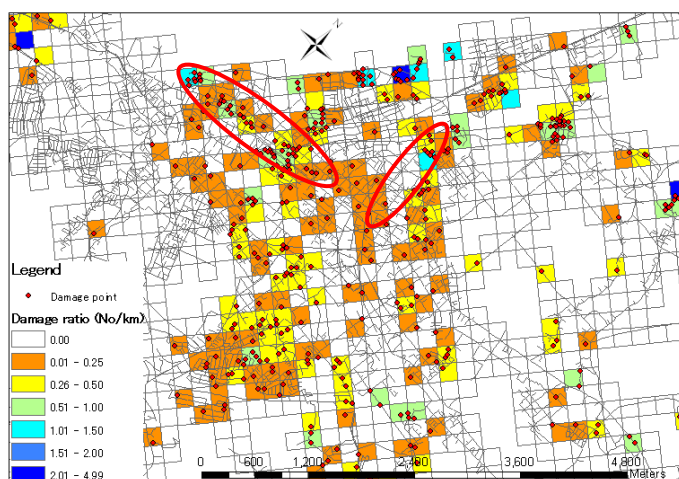
Fig.3: Map of the water supply system and result given by the damage ratio

In order to combine geology and geomorphology, pipeline information and damage location is inventoried in a Geographical Information System (GIS). 423 failure points were recorded and identified to the different pipes of the system. Figs. 3 and 4 point two main areas where the damages are concentrated. In Fig. 4, geological data are also plotted: sand dune deposits and deposits of plains are mainly represented in the soil surface of Kashiwazaki-city, and they have different properties. Both of these areas are dated from the Holocene, so it means that from a geological point of view they were formed in recent geological age. 105 of the 423 recorded failure points to the distribution pipe are located near the boundary of the two different geological areas. Considering only the built area, a big part has been damaged: 32% for the sandy soil, and 18% for the plain deposits. The ratio has been calculated in terms of mesh (200\*200 meters). In this place, the waves have been amplified due to the fact that the

plain deposits have got quite soft properties compared to the sand deposits. To understand more, a comparison with the geomorphology is made in the following part.

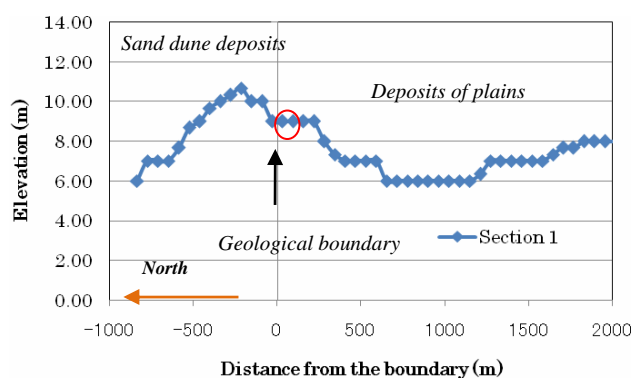
Fig.5: Topographical section, line 1

In this part, cross section lines are used to analyze and compare the previous results with the geomorphology. The section lines are represented in Fig. 4. Here, only two examples will be given (Figs. 5 and 6). Section 1 is oriented in the North-South direction, and Section 4 in the West-East section. According to the results, the boundary is located on the terrace, or just at the bottom of the slope. It is considered that shallow deposits on the stiff sand slide in the area. The same results are obtained for the other sections. This particular shape could be involved in the damages recorded here, rather than the soils properties itself.
