# Damage Approach of a RC Rigid-Frame Arch Bridge affected by Wenchuan Earthquake

Graduate School of Kyushu Institute of Technology  
Kyushu Institute of Technology  
Jiangsu Transportation Institute  
Nippon Engineering Consultants Co., Ltd.

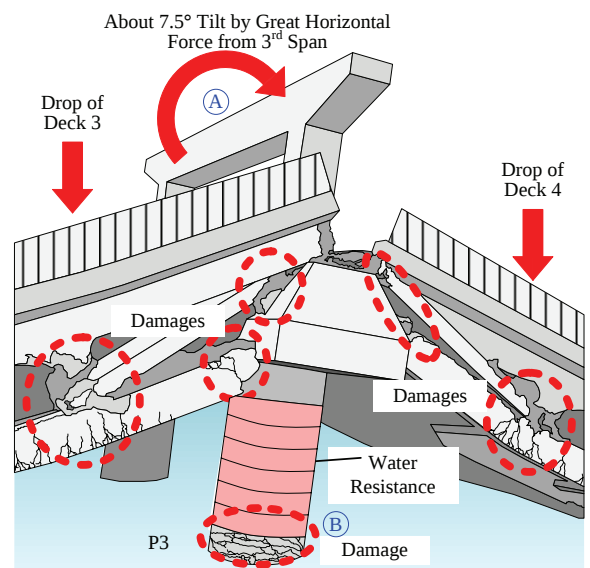
Fig.2 Failure Condition of Pier 3 (upstream)

The overall failure condition is shown in Fig.1. Noticing that extensive damage occurred to Span 3 and Span 4, they will be detailed illustrated as following. Shown in Fig.2, Pier 3 (at Point A) tilted averagely 7.5° toward Span 4 (about 8.08° at upstream side and 6.85° at downstream side, measured by the electronic total station). The piles under Pier 3 (at Point B) suffered great damage because of the tilt. Span 3 and Span 4 collapsed entirely, and the legs on them failed as well. Shown in Fig.3, for A2, a 20cm permanent displacement of the support on the top of A2 into the backsoil and shear failures on the side wall have been found, from which we inferred the girder lost the support from A2. Besides, at the joints of the girder with the arch legs, different types of failure occurred to the left and the right. On the left (see from downstream, Point A and the photo shown in Fig.3), by negative bending moment, rebars on upside of the girder resisted tension and downside concrete resisted compression. On the right (Point B), by positive moment, the girder was pulled to separate from the joint, which caused the obvious crack between the girder and the joint.

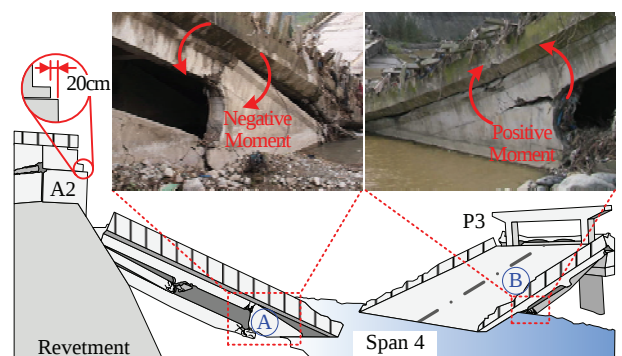
Fig.3 Failure Condition of Span 4 (upstream)

For Case 2, shown in Fig.4(b), due to the loss of support, the top of the right inclined leg (Point A) and the girder next to the right joint with the arch leg (Point C) will reach their ultimate stages, while rebars will yield at the bottom of the right inclined leg (Point B) under only dead load. Compared with Case 1, the yield of the tensile reinforcement at the middle span (Point D) occurs earlier at 0.17g. (curvature of Section D is illustrated in Fig.5) Failures at Point A, B and C will lead to the drop of girder at the right side. This may cause further failures of the right arch leg due to collision. Thus, the damage at Point A, B, C and D will cause the entire rigid-frame arch to lose its stability. These two reasons above, are likely to cause the failures shown in Fig.3 that joints of girder and arch legs suffered moment in different directions.

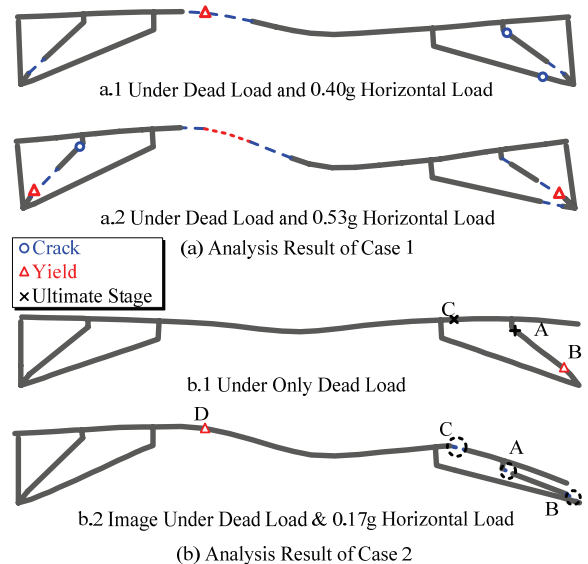
Fig.4 Analysis Result

For Case 1, shown in Fig.4(a), as the horizontal load growing up to 0.40g, the tensile reinforcement at middle span will yield due

to negative moment, and then reaches at the ultimate stage at 0.62g horizontal load. For the inclined legs, the first yield of tensile reinforcement occurs to the left bottom at 0.47g horizontal load. The same point will reach at the ultimate stage soon. Then the yield of tensile reinforcement and the ultimate stage will happen to the right bottom of the inclined leg at 0.53g. After this, considering the entire capacity may lose after serious failures occur to these three points, 0.53g is thought to be the capacity of this bridge.

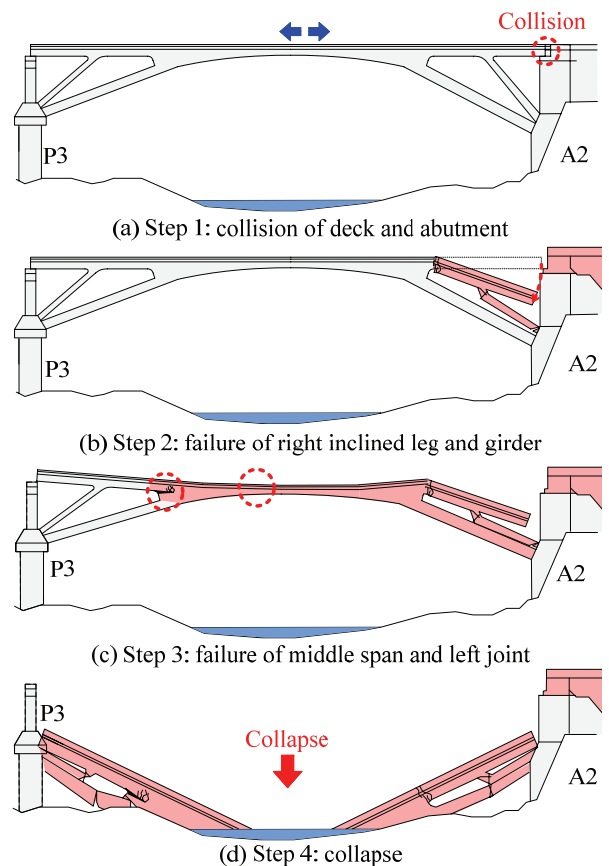
Fig.6 Failure Mechanisms of Span 4(upstream)

As step 1 shown in Fig.6(a), the decks of Span 4 moved longitudinally due to the earthquake effect, which led to the collision between the deck of Span 4 and A2. Most likely, the deck of Span 4 moved towards A2 at first and caused the parapet and the pavement on A2 slid about 20cm into the backsoil. Then, the girder moved on reversal direction also due to the earthquake. Once the displacement towards left became greater than 20cm, Span 4 lost the support from A2. Thus, based on result of Case 2, the inclined legs and the girder on the right side received greater applied load, which caused the damage occurred to them. Then, failure would happen to middle span soon (Fig.6(b)). Then, as the pier and inclined leg still supported the girder on the left but failures already occurred to the right half span, the girder was pulled to separate from the left joint with the arch leg by positive moment (Fig.6(c)). Thus, the left half also failed and the entire span collapsed into the water. Consequently, Pier 3 was pushed to tilt by the force from Span 3, which caused the enormous chain failure of Span 3.
