Investigation on the Vibration of Diagonal Members in Ikitsuki Bridge

Nagasaki University Student Member ○WANG Qu Nagasaki University Member NAKAMURA Shozo
Nagasaki University Member OKUMATSU Toshihiro Nagasaki University Member NISHIKAWA Takafumi

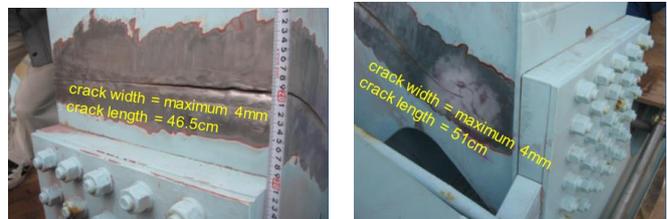
Fig.3 Photos of crack

Large crack was found in a diagonal member shown in Fig.2 near the north side of the intermediate support (P6) in December 2009. The diagonal member has a rectangular box section with the width of flange and web is 500 mm and 574 mm, respectively. The thickness of plates is 9mm. The crack on sea-side flange has the length of 465 mm and that on upper web has the length of 510 mm, as shown in Fig.3. The crack propagated along the weld toe on the outside of the flange face.

(a) Sea-side flange (b) upper web

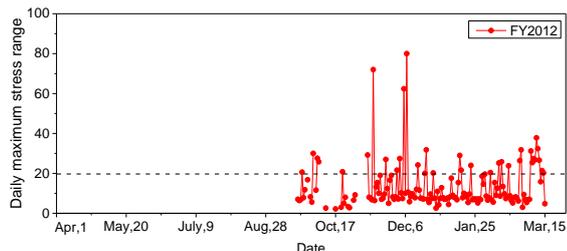
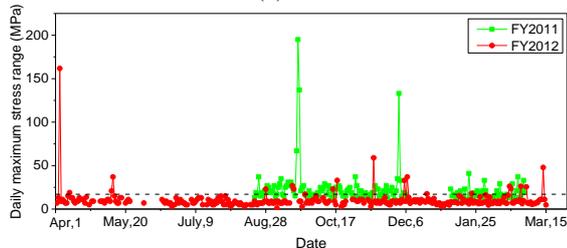
Fig.5 Daily maximum stress range (Unit: MPa)

The stress range histogram was got from the time history of strain record by the rain flow counting method. Fig.5 shows the transition of daily maximum stress range on the diagonal member of P5 and P6. Since the cut-off limit of Class E for variable amplitude stress in *Fatigue*

Design Recommendations for Steel Highway Bridges is 29 MPa, so 20 MPa is thought to be an index to judge the occurrence of vibration. Fig.6 shows the number of days when the maximum stress range is over 20MPa.

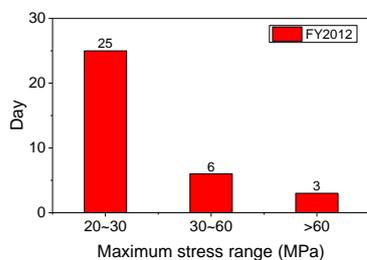
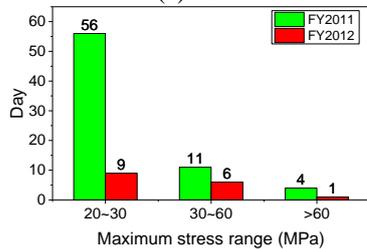
Fig.6 Number of days by daily maximum stress range

It shows the number of the day with maximum stress range between 20 MPa and 30 MPa on P5 in FY 2012, is 25 days, between 30 MPa and 60 MPa is 6 days, and over 60 MPa is 3 days. The recorded maximum stress range is 80MPa. And the number of the day with the maximum stress range between 20 MPa and 30 MPa on P6 in FY 2011 and FY 2012 is 56 days and 9 days, between 30 MPa and 60 MPa is 11 days and 6 days, and over 60 MPa is 4 days and 1 day, respectively. The recorded maximum stress range is 195MPa and 162MPa, respectively.

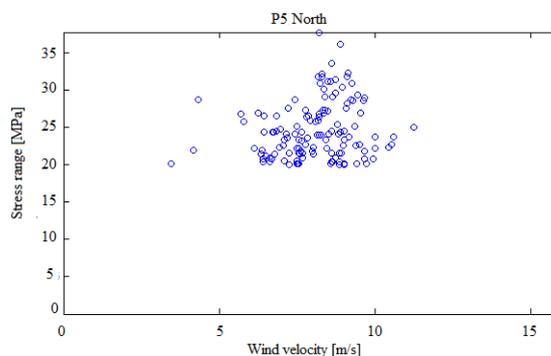
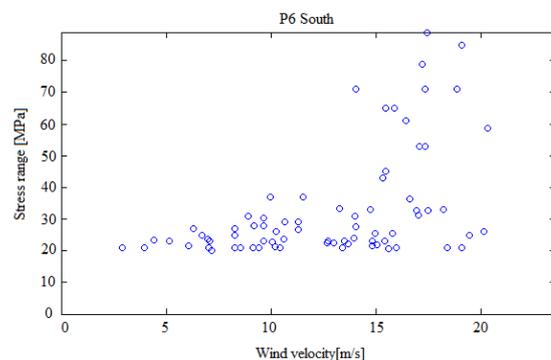
Fig.7 The relation between stress range and wind velocity

The relation between the maximum stress range and wind condition were analyzed by the vibration with the 1st natural frequency. The maximum acceleration RMS for 10 seconds was calculated by every 10 minutes, and the wind velocity and wind direction of that 10 seconds were also calculated. It is shown that most of wind velocities are between 6 m/s and 10 m/s or over 15 m/s, as shown in Fig.7, and the wind direction is almost perpendicular to the axis of the bridge.
