## Damage characteristic of the 2011 Great East Japan tsunami in Miyagi prefecture

SUPPASRI ANAWAT<sup>1</sup>, KOSHIMURA SHUNICHI<sup>1</sup>, IMAMURA FUMIHIKO<sup>1</sup>

<sup>1</sup> Disaster Control Research Center, Tohoku University, Japan

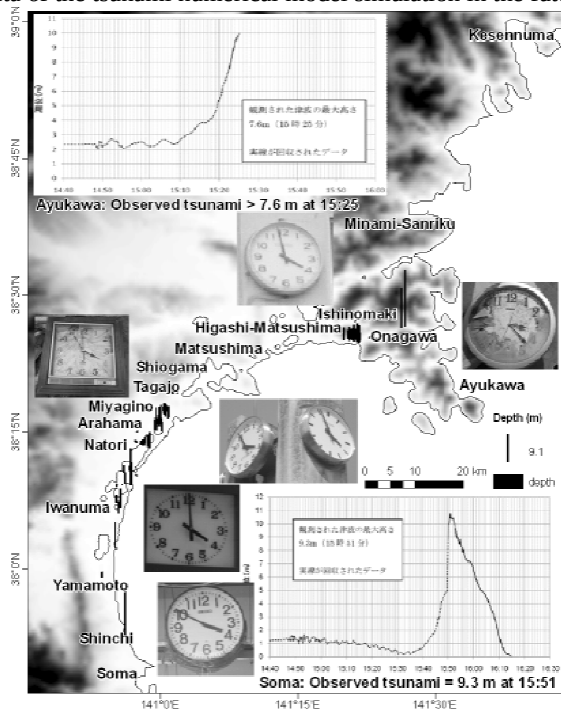
**2. Tsunami damage field survey:** A tsunami field survey was conducted to investigate the tsunami damage along the coastal areas in the Miyagi prefecture (Fig. 1). Nineteen one-day trips over four months from March to July 2011 were made to complete the general damage survey, structural damage inspection and inundation depth measurements (TTJT, 2011). The purpose of the damage survey was to investigate the impact of the tsunami on coastal structures such as breakwaters, seawalls, control forests, housing and buildings. The damage mechanism for each feature is discussed based on scientific background and compared with the findings of the survey. This investigation will be helpful for future coastal zone development. Tsunami inundation depths were measured as an important feature for developing a damage function and verification data of the tsunami numerical model simulation in the future.

Fig. 1 Measured tsunami inundation depth and arrival time of tsunami arrival from stopped clocks

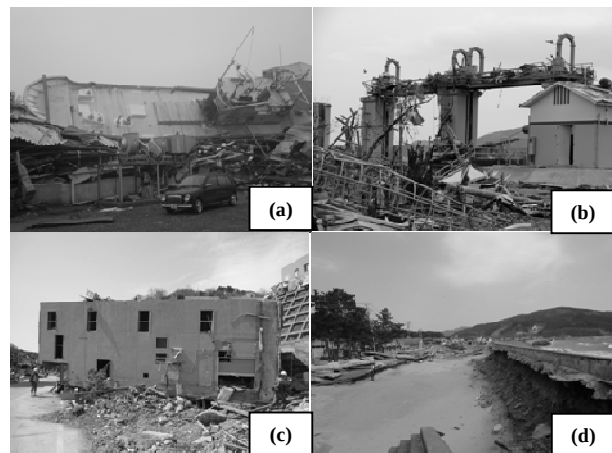
**3.1 Sanriku coast areas:** Because of the large number of fishing boats near the port, many boats were found stranded among the tsunami debris in Kesennuma city (Fig. 2a). These boats increased the impact load of the tsunami to coastal structures. Around the fishery port, damage to the oil tanks was also observed, in some cases causing fire and burning for four days. A tide station was also found damaged during the survey. Minami-Sanriku town had constructed a tsunami gate, which worked against the 1960 Chile tsunami. However, the 8 m-high tsunami gate was overtopped by 15 m height tsunami and completely destroyed (Fig. 2b). The memorial park for the historical tsunami and high-rise evacuation building is located near the tsunami gate were also destroyed. In Onagawa town, the town hospital, which is located on a hill of 15 m height, was inundated on the first floor with a maximum observed tsunami height larger than 18 m. The most remarkable feature in this area is that six reinforced concrete (RC) buildings were overturned by the tsunami (Fig. 2c). All of them were 2-4 stories high and possessed shallow or pile foundations. The populated area in Ishinomaki city located in a plain-shallow water area and not in the head-on direction of the tsunami propagation experienced a lower tsunami velocity. The city was also protected by breakwaters, seawalls and control forests. Although damage to the breakwaters was not large, the seawalls were seriously damaged by erosion on their back side (Fig. 2d). However, these structures were able to protect the forests behind them.

Fig. 2 (a) Debris impact in Kesennuma, (b) Damaged tsunami gate in Minami-Sanriku, (c) Overturned building in Onagawa and (d) Damaged seawall foundation in Ishinomaki

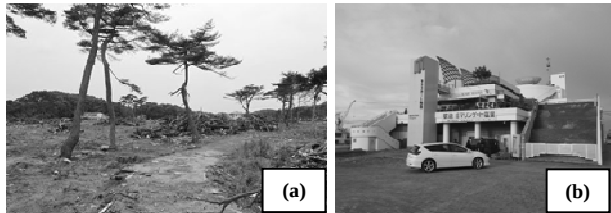
**3.2 Matsushima Bay areas:** Some locations in Higashi-Matsushima city, the tsunami overtopped and destroyed a seawall because the tsunami came from inland and attacked the backside of the seawall; during a design of the seawall, testing from this direction was not expected because tsunamis are commonly expected to arrive from the sea. The control forest was severely damaged as a large number of trees were uprooted (Fig. 3a). JR train and JR Nobiru station were also damaged. Matsushima town and Shioyama city

are located inside a bay. Approximately 260 tiny islands are located off of Matsushima town that make the town famous for one of the three best coastal views in Japan. Because of the large number of small islands and the shallow area inside the bay, Matsushima town was highly protected by this natural barrier. A low inundation depth and weak current acted resulted in flooding, causing small damage to these areas (Fig. 3b). The average inundation depth was only approximately 2 m. Unlike Matsushima town and Shiogama city, Shichigahama is located next to the Pacific coast and the town was hit by a tsunami height of nearly 10 m. The tsunami caused damage to the breakwaters, seawalls and roads as well as strong erosion.

Fig. 3 (a) Damaged control forest in Higashi-Matsushima and (b) Survived evacuation building in Shiogama

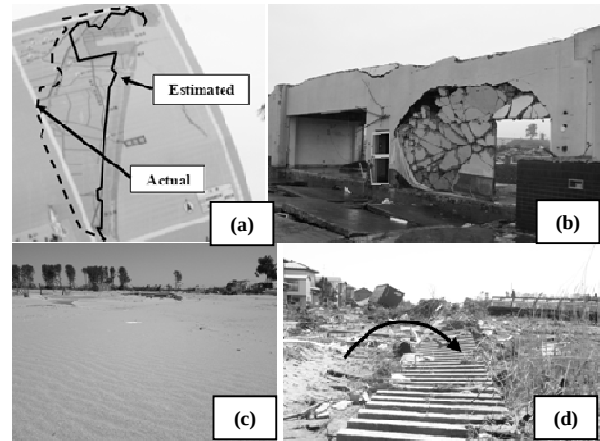
**3.3 Sendai Plain areas:** Most of the residential areas in Tagajo city are located behind the factory areas of Sendai port and the inundation depths in these areas were not as high. Therefore, a small number of washed-away houses were found. Many factories were damaged by the tsunami. The elevated park located at the center also survived the tsunami. Sand deposits were also found in a river near the JR Tagajo station. The land near a manhole receded by 40 cm. Most houses were washed away in Arahama village. The plain area underwent the maximum inundation distance of 5 km. In fact, the tsunami was accidentally blocked by the highway linking the Tohoku areas to Tokyo. Without this highway, the tsunami might have inundated further inland and caused more impact. The only high-rise building for vertical evacuation to survive the tsunami was the Arahama primary school, which was inundated up to the second floor. Tsunami hazard map (Fig. 4a) information based on the simulation of the Miyagi oki earthquake (M7.5-8.0) and tsunami estimated only 500 m inundation. Tsunami overturned most trees in Yuriage village. Some people evacuated to a shrine on an elevated hill and lost their lives because the tsunami also overtopped the shrine. Fish market was completely destroyed. Damage to an RC wall on the right side represents a common punching failure of an RC structure (Fig. 4b), whereas the non-RC wall on the left side was easier to damage and allowed water to pass through while maintaining the main structure. The Sendai airport stopped its service due to damage on the first floor caused by the 3.5 m of tsunami. Near hot spa in Watari town, the tsunami carried a large amount of sand, which was deposited around the hotel area (Fig. 4c). Fishery boats acted as debris impact and destroyed many houses, similar to events that occurred in Kesennuma city. In Yamamoto town, railway's sleepers made of wood were more heavily damaged (Fig. 4d) and overturned by the force of the tsunami while wooden sleepers with additional concrete sleepers in Higashi-Matsushima survived even the tsunami was higher. In the southern part of the town, most of the houses were washed away.

Fig. 4 (a) Tsunami hazard map in Arahama village, (b) Damaged RC wall in Yuriage village, (c) Large sand deposit in Watari town and (d) Damaged wooden railways in Yamamoto town
