III-1 Geology and other common factors favoring roadside slope failures in Nepal

○ N. P. Bhandary (正) Faculty of Engineering, Ehime University
R. Yatabe (正) Faculty of Engineering, Ehime University
J. Takahashi (非) Faculty of Education, Ehime University

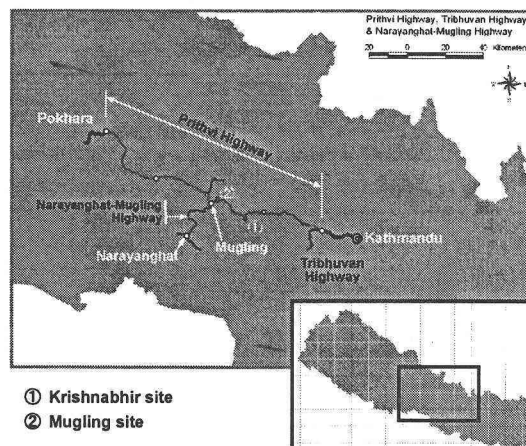
Figure 2: Location of typical roadside slope failures and the highways.

revealed that there are more than 20 noticeable unprotected or poorly protected landslide sites along the Prithvi Highway. A similar survey was conducted along the Narayanghat-Mugling Highway in November 2003, which revealed that no proper measures have been taken to protect the highway from landslide disasters, and that the most of the recent failures that turned into debris and mud flows were triggered by pore-water pressure generation in the decomposed debris mass near the failure source. The observational survey was mainly focused at five failure sites, of which two sites namely Krishnabhir, a debris fall/slide and Mugling site, a creeping landslide on the Prithvi Highway (Figure 2) are introduced in the following sub-headings.

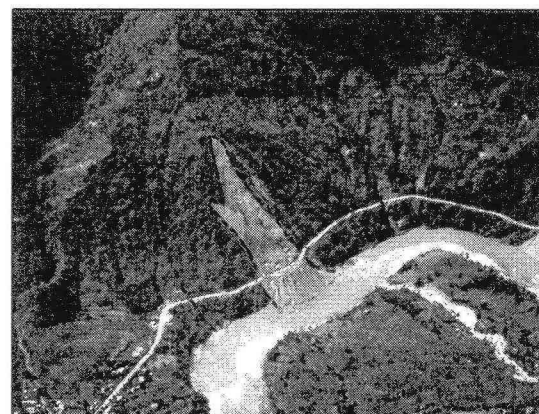
Krishnabhir site (measuring 400m long and 150m wide near the road) is located at 84km west of Kathmandu alongside the Prithvi Highway. It showed traces of failure somewhere in 1999, which was triggered by a gully erosion of the colluvial deposit on the top of the slope. With the beginning of monsoon of 2000, a massive failure of weathered rock mass in the slope took place resulting in the deposition of the slid mass on the highway and blocked the traffic for two weeks. Reoccurrence took place in the year 2001, and slowly turned into a stabilized deposition of slid mass in the year 2002.

According to Humagain (2001), the major rock types in the Krishnabhir area are phyllite, quartzite, schist, and slate with some calcareous bands. Intercalation of the quartzite and calcareous band in phyllite may be considered to have given rise to instability of the slope. In addition, presence of talc and graphite along the foliation planes seems to have further decreased the shear strength of the rock mass.

The observation of the topography and the exposed rocks reveals that the inherent geological factor involved in the failure site is development of fractures on the slope rock mass due to imperceptible movement of a huge mass that might have failed in a long past (as indicated in Figure 3). A speculation can be made of movement of an old mass in creeping manner causing upper part of the fractured mass to take a form of debris fall. Although borehole investigations need to support this speculation, the depth of mass movement, based on the size of the failure, can be estimated at 30 to 40 meters, and the depth of the debris fall on the top is 8 to 10 meters. Figure 4 explains the speculation made.

Figure 3: Oblique aerial picture of Krishnabhir Landslide and assumed block of massive failure

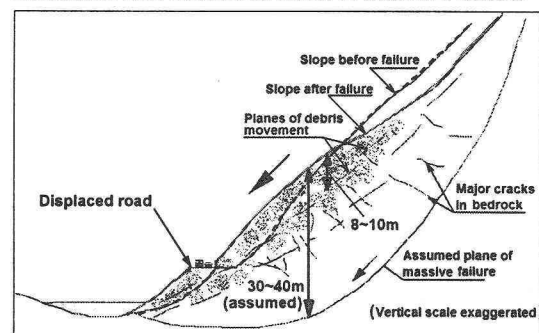
Figure 4: Speculated model of mechanism of Krishnabhir Landslide

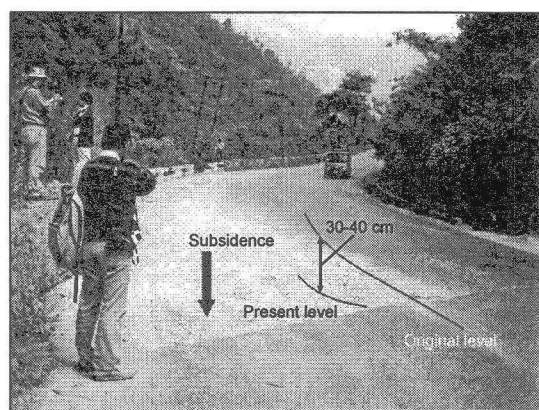
About 106 km west of Kathmandu, this landslide site is situated on side of the Prithvi Highway near Mugling. The only traces of the landslide movement at this site are subsidence of about 150m length of the road (Figure 5) and visible scarps near the crown. Seeing the amount of subsidence that has been taking place for more than five years, this failure can be categorized as creeping movement of a mass that might have failed a long time ago. A maximum of about 1.5m subsidence can be seen near the midpoint and 30-50cm depressions can be seen near the edges. The gabion retaining walls along the road edge constructed by the Department of Roads for protecting the road from failure show that this area was recognized as a landslide site at least five years ago (estimated). Observation of the topography as sagging of the slope surface shows that this landslide site is an old deposit of previous failure and subsequent subsurface weathering of rock minerals through the existing plane of failure might be considered to have triggered the creeping landslide, which remains comparatively active during monsoon periods. Based on the subsided length of the road, the depth of the landslide can be estimated at 15-20m.

Figure 5: Creeping landslide near Mugling and the road subsidence
