## Slope movement monitoring using LPWA network and slope stability analysis through its observation

Ehime University

○A. Hafidz, A. Putra, H. Yasuhara, N. Kinoshita

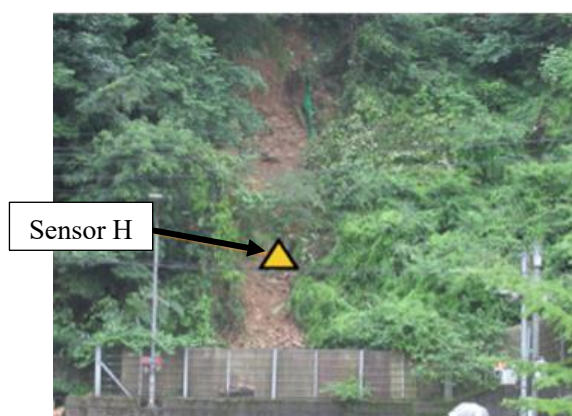
A site investigation was conducted to check the real condition in sensor H at the Tateyama site where slope failure occurred at this location. The shape of the corrupted area was made by using a topographic map, rangefinder, and tape measurement.

Slope movement monitoring system at the Tateyama site was installed on March 1<sup>st</sup>, 2018. During collecting data on the slope movement, a torrential rainfall occurred in Shikoku Island in July 2018. Due to this rainfall, slope failure happened in sensor H location on July 7<sup>th</sup>, 2018. The slope failure was found at the height of 23 m from the bottom part of the slope. The shape is a circular failure. The failure area is around 107 m<sup>2</sup> with a depth of failure ranging from 1 to 2 m (**Figure 2**). Slope stability analysis was conducted using the Bishop method. The result shows a safety factor of less than 1.25. Therefore, the failure may have occurred because slope failure may happen when the safety factor less than 1.25 (Bowles, 1979).

**Figure 2:** Slope failure in sensor H, Tateyama site

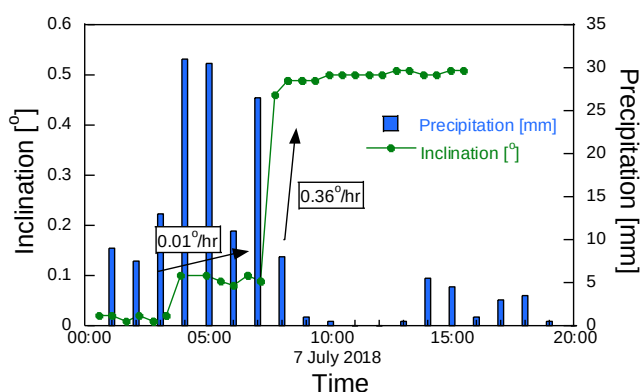
This slope movement monitoring system can show an increment in inclination during the failure. Inclination in sensor H increased rapidly from 0.02° to 0.46° in 4.5 hours. This movement happened due to torrential rainfall on July 7<sup>th</sup>, 2018. Tilting rate from 3:14 AM to 6:34 AM is 0.01°/h. If the tilting rate is more than 0.01°/h, the slope may be failed. Therefore, a precaution can be issued at a tilting rate of 0.01°/h for safety reasons (Uchimura *et al.*, 2015). The tilting rate from 7:08 AM to 8:14 AM is 0.36°/h, and the tiltmeter stops sending data at 3:27 PM. It indicate that the failure has occurred at the timing. If 0.1°/h were observed, slope failure may occur within 10 hours. Shorter duration remained before failure when a higher tilting rate was observed (Uchimura *et al.*, 2015).

**Figure 3:** Inclination and rainfall in sensor H, Tateyama site
