Damage Analysis of Xiaoyudong Bridge Affected by Wenchuan Earthquake, China

Zhongqi SHI¹, Kenji KOSA², Jiandong ZHANG³, Hideki SHIMIZU⁴ and Yuji SAKAMOTO⁵

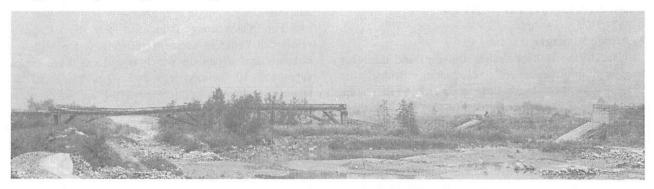
Photo.1 Overall Photograph of Xiaoyudong Bridge

According to the field survey, shown in Photo.1 and

Fig.1, Deck 1 moved about 75cm downwards at mid-span while Deck 2 moved about 10cm upwards in the middle and almost fell down from Pier 1. Besides, Pier 3 tilted extensively toward A2, and Deck 3 and Deck 4 collapsed entirely. Furthermore, shear failure happened to the arch legs and inclined legs at A1, and the deck collided into the A1 approximately 90cm. As well, a permanent displacement about 20cm in the backsoil side due to the collision of Deck 4 and A2 was found for the pavement. Thus, extensive shear cracks were developed in the side walls resulting from this. In addition, a great amount of visible cracks were observed at the joints between legs and pile caps, and between legs and girders.

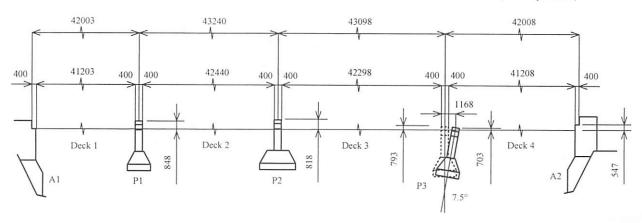
Fig.5 Settlements of Piers & Abutments and Lengths of Spans (unit: mm)

Based on the survey by total station, the settlements of piers and abutments have been determined as illustrated in Fig.5. Compared with the left abutment A1, three piers and A2 moves upwards about 838mm, 818mm, 748mm and 547mm respectively, which means that all the three piers have noticeable upwards vertical displacements.

The Pier 3, as shown in Photo.2, titled averagely 7.5° more or less towards A2 (about 8.08° at the upstream side and 6.85° at the downstream side of the bridge). In order to judge the changes of span lengths, backwards rotation has been applied to Pier 3 by using the average angle, as illustrated in Fig.5.

After the backwards rotation of Pier 3, the length of every span from Deck 1 to Deck 4 becomes 41.203m, 42.440m, 42.298m and 41.208m respectively, as shown in Fig.5. According to the field survey, because the space between decks is relatively very small (not greater than 5cm), here set the length of each support equals 400mm, 1/2 of the width of the beam upon the pier. Thus, add by two lengths of support, the length of each deck becomes 42.003m, 43.240m, 43.098m and 42.008m respectively. Comparison of these lengths by total station with the lengths by measuring tape mentioned in 2.1 has been conducted to judge the horizontal displacements of piers and abutments. Here, the length of span by total station stands for the available value of the deck length between two supports after the earthquake, while the span by measuring tape refers to the actual length of decks before the earthquake. As a consequence, it is obvious to us that

Deck 2 and Deck 3 has an approximate displacement of 9cm (the difference between the span length by measuring tape of 43.15m and that by total station of 43.24m) and 5cm for each (about 0.16% and 0.12% changes), which is relatively small and thus can be ignored. On the other hand, Deck 1 and Deck4 have similar assignable displacement of 34cm (about 0.81% change), which suggests that earthquake enormously influence these two spans.

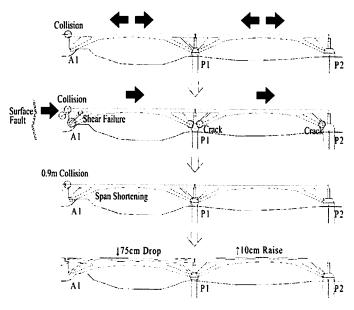
Fig.7 Possible Mechanism of Failure of Span 1&2

Based on the field damage survey, the author considers the possible mechanism of failure as illustrated in Fig.7 for the 1st and 2nd spans, and in Fig.8 for 3rd and 4th spans. They will be explained for each two spans as following.

At first, when the earthquake occurred, movement of Deck 1 and Deck 2 in the longitudinal direction due to the huge force of earthquake caused the collisions of A1 and Deck1. The surface fault might cause A1 moved towards the decks, which also contributed to the collision and the consequent shortening of Span 1. Thus, extensive shear cracks were developed in the side wall at left abutment A1. After the cracks occurred to the arch legs and inclined legs, and the shear failure happened to the legs at A1, Deck 1 dropt about 75cm while the Deck 2 raised about 10cm.

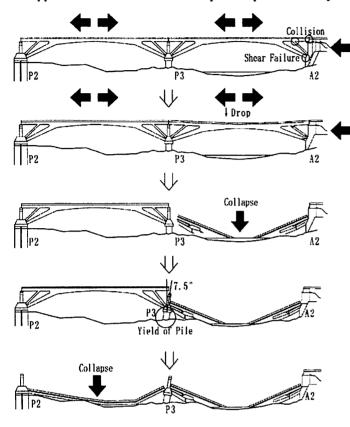
Fig.8 Possible Mechanism of Failure of Span 3&4

longitudinal as well due to the earthquake effect. This led to the collision of Deck 4 and A2, and the movement of A2 towards decks. Consequently, at right abutment A2, huge shear crack about 0.2m permanent displacement in the backsoil occurred. Then, Deck4 dislodged from A2 support due to excessive response placement by

earthquake force in the opposite direction. Insufficient seat length of about 0.3m at A2 is another remarkable reason of the drop of Deck4. Once Deck 4 collapsed, the equilibrium of lateral forces between Deck 3 and Deck 4 was lost. Therefore, this enormous lateral force of Deck 3 made the piles under Pier 3 yield and pushed Pier 3 tilted extensively toward A2. The Deck 3 itself fell down as a result of the tilt of Pier 3. In turn, the tilt of Pier 3 resulted in Deck 3 being dislodged from its reliance on Pier 2 and Pier 3. As a consequence, there should have been a lost of balance at Pier 2. However, probably thank to relatively more piles and lager cross section of pile cap, the Pier 2 had got a much better resistance of tilt. Thus there were only some small cracks on the piles of Pier 2, while Deck 2 did not fall down due to the lost of balance.

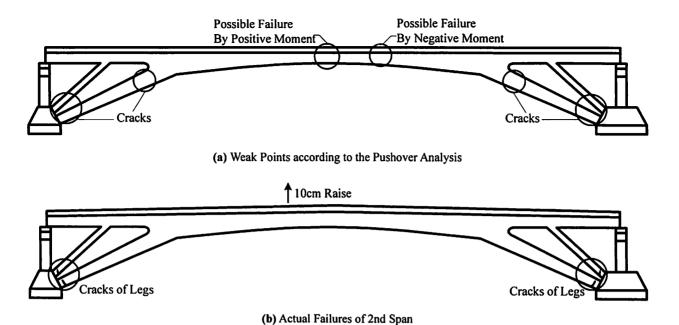
Fig.15 Comparison between the Actual Failures and Results of Analysis

Compared the results from pushover analysis with the actual failure condition of the 2nd span from field survey, we can see that the failures occurred to most of the weak points base on the analysis. According to the analysis, the middle might move upwards by about 40cm at most until 1.0g horizontal load, which can explain the 10cm raise in the middle span. Besides, cracks have been found at the joints of legs and pile caps as the result from the analysis.
