Damage Analysis of Utatsu Bridge Affected by Tsunami due to Great Eastern Japan Earthquake

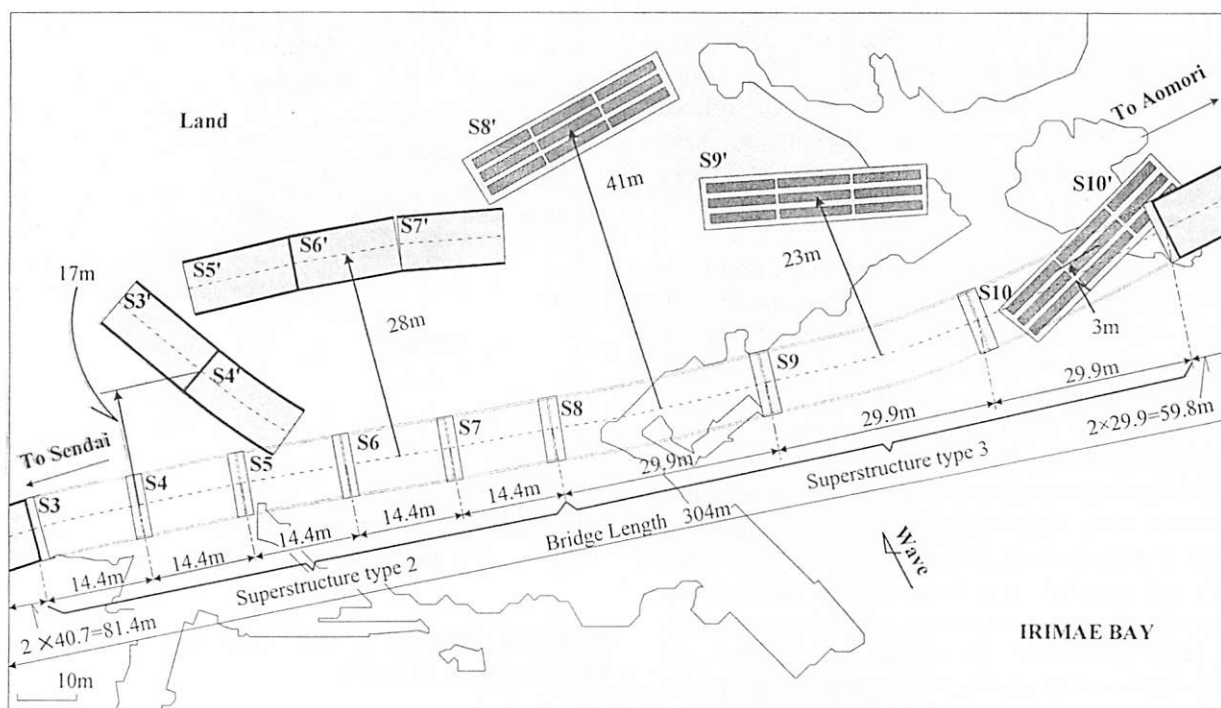
Fig.3 Outflow Condition of Utatsu Bridge

Based on the detailed survey, superstructures S3~S10 moved off from their supports under the wave-induced lateral load while the superstructures of span1, span 2, span 11 and span 12 did not flow out. The displacements of S3~S10 have been illustrated in Fig.3. The directions of displacements are transverse to the bridge axis. The characteristic of outflow condition is that the central spans such as S5~S7 and S8 experienced long displacements (28m and 41m). On the contrary, the side spans such as S1, S2, S11 and S12 did not flow out.

It was also observed that S3~S4 and S5~S7 flowed out with no separation. Due to a great wave-induced uplift force, S8~S10 were inverted when they moved off.

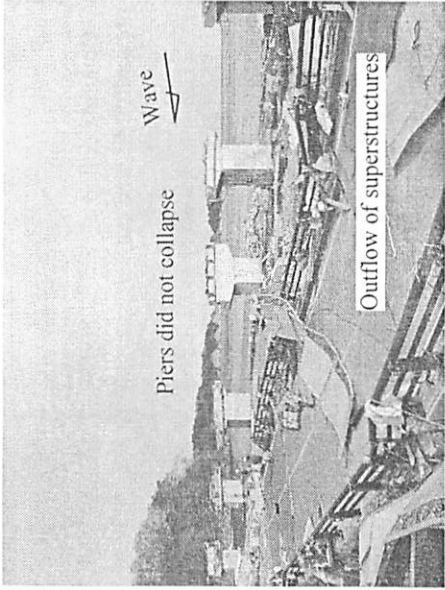
Fig.4 Damage of Piers

However, contrary to the damage of superstructures, during the tsunami attack, all piers of Utatsu Bridge withstand the wave action and did not collapse. The main damage of the piers is that the concrete surfaces of beams dropped due to a collision with girders and most

of bridge collapse preventions were crushed or flowed out, refer to Fig.4.

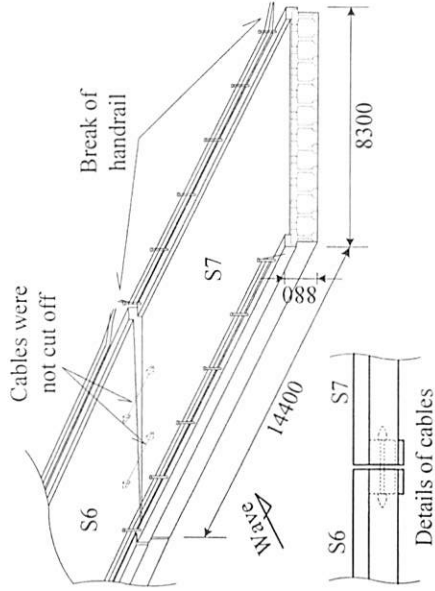
Fig.5 Detailed Damage of S6, S7

The damage of S3~S7 is one of the typical ones, which flowed out connecting with each other, and the damage of S6~S7 was selected as an example to state in the following content. Under the wave action, S6 and S7

experienced a displacement of 28m together thus it is proper to regard them as a whole. When the bridge was retrofitted, 2 cables, which were used to prevent the relative movement in axis direction of superstructures, were installed between S6 and S7. The details of the cables are plotted in Fig.5. These cables played an important role to keep S6 and S7 flowing out together. Besides that, the damage of handrail between S6 and S7

was observed as well.

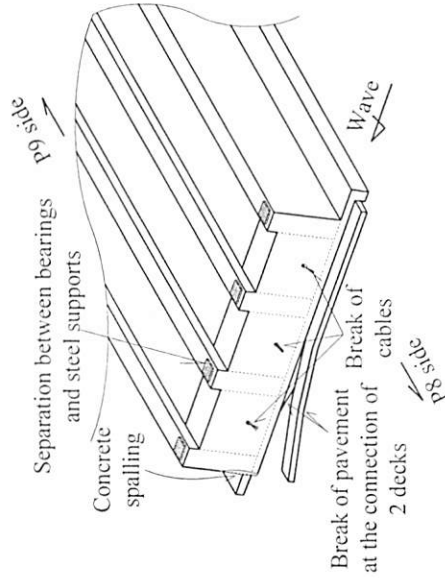
Fig.6 Detailed Damage of S9

S9 is one of the inverted superstructures, the damage of which is shown in Fig.6. S9 experienced a displacement of 23m and was inverted by the wave-induced uplift. At the end surface of P8 side, different from the damage of S6 and S7, all of the cables which connected S8 and S9 were broken by the force between superstructures and the fracture traces could be found. Moreover, at the supporting area of girders, the remains of bearing plates were noted. In light of this, it is obvious that during the tsunami attack the bearings fractured. Besides that, at the connection of the 2 decks, the debris of pavement connection was observed.

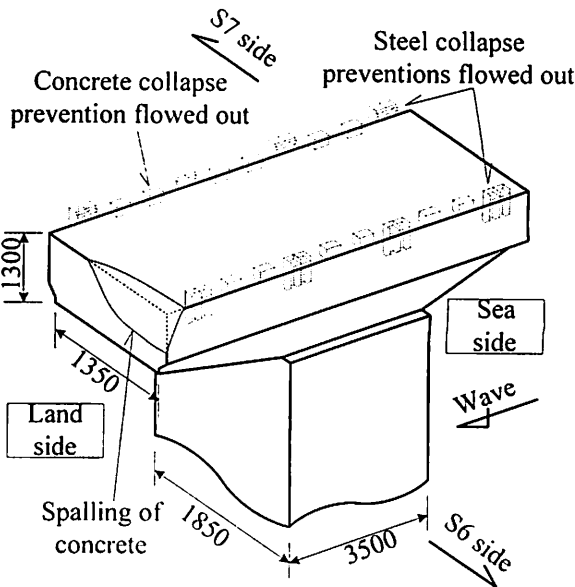
Fig.8 Detailed Damage of P6

The detailed damage of P6 is shown in Fig.8. When S6 and S7 were separated from P6, they imposed a horizontal collision on the concrete collapse preventions. Therefore, on the supporting plate of P6, 12 concrete collapse preventions were crushed. And for the same reason, the 8 steel collapse preventions, anchored on the sides of the beam, flowed out as well. Apart from the

damage of the collapse preventions, the concrete surface of the beam which was located at the land side was also crushed.

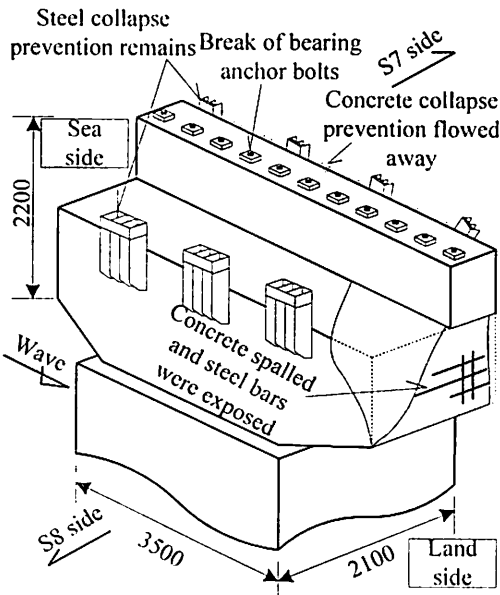
Fig.9 Detailed Damage of P7

Fig.9 illustrates the detailed damage of P7 which supported 2 types of superstructures: S7 and S8. At S7 side, the installing details of superstructure collapse preventions were same as P6. Although the 6 concrete collapse preventions were crushed, the 4 steel ones were left. However, due to the girder-induced impact, the steel ones tilted. At S8 side, different from P6, only 3 larger steel collapse preventions were anchored and they did not flow out. The damage condition of steel collapse preventions demonstrates that when the superstructures, located on P7, displaced they were elevated by a wave-induced uplift. Because of this, the superstructures flowed from the top of the steel collapse preventions and did not impose a sufficient impact to make them separate from supports. Besides that, at the land side, the concrete surface of the beam was crushed and some steel bars could be observed.

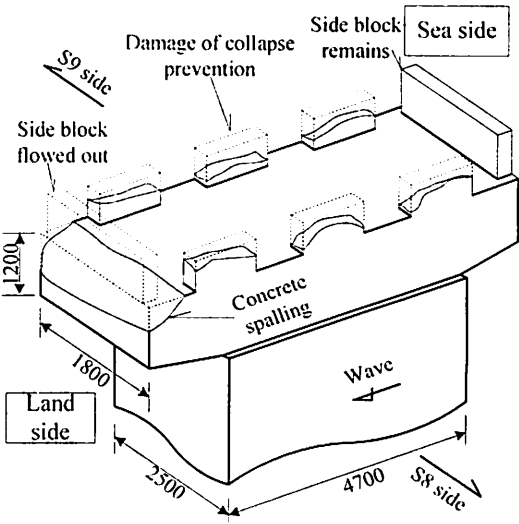
Fig.10 Detailed Damage of P8

The damage of P8 is plotted in Fig.10. On the top of beam, 6 concrete collapse preventions and 2 side concrete blocks had been set up. For the same force situation as the preventions of P6, the 6 concrete collapse preventions and one side block, which was at the land side, were crushed. Besides that, it was found that while the side block flowed out, a damage of the concrete surface, which under the side block, occurred.
