Effect by Failure of Foundation on Deformation Behavior of a RC Rigid-Frame Arch Bridge Damaged in Wenchuan Earthquake

Zhongqi SHI¹, Kenji KOSA², Jiandong ZHANG³, Tatsuo SASAKI⁴

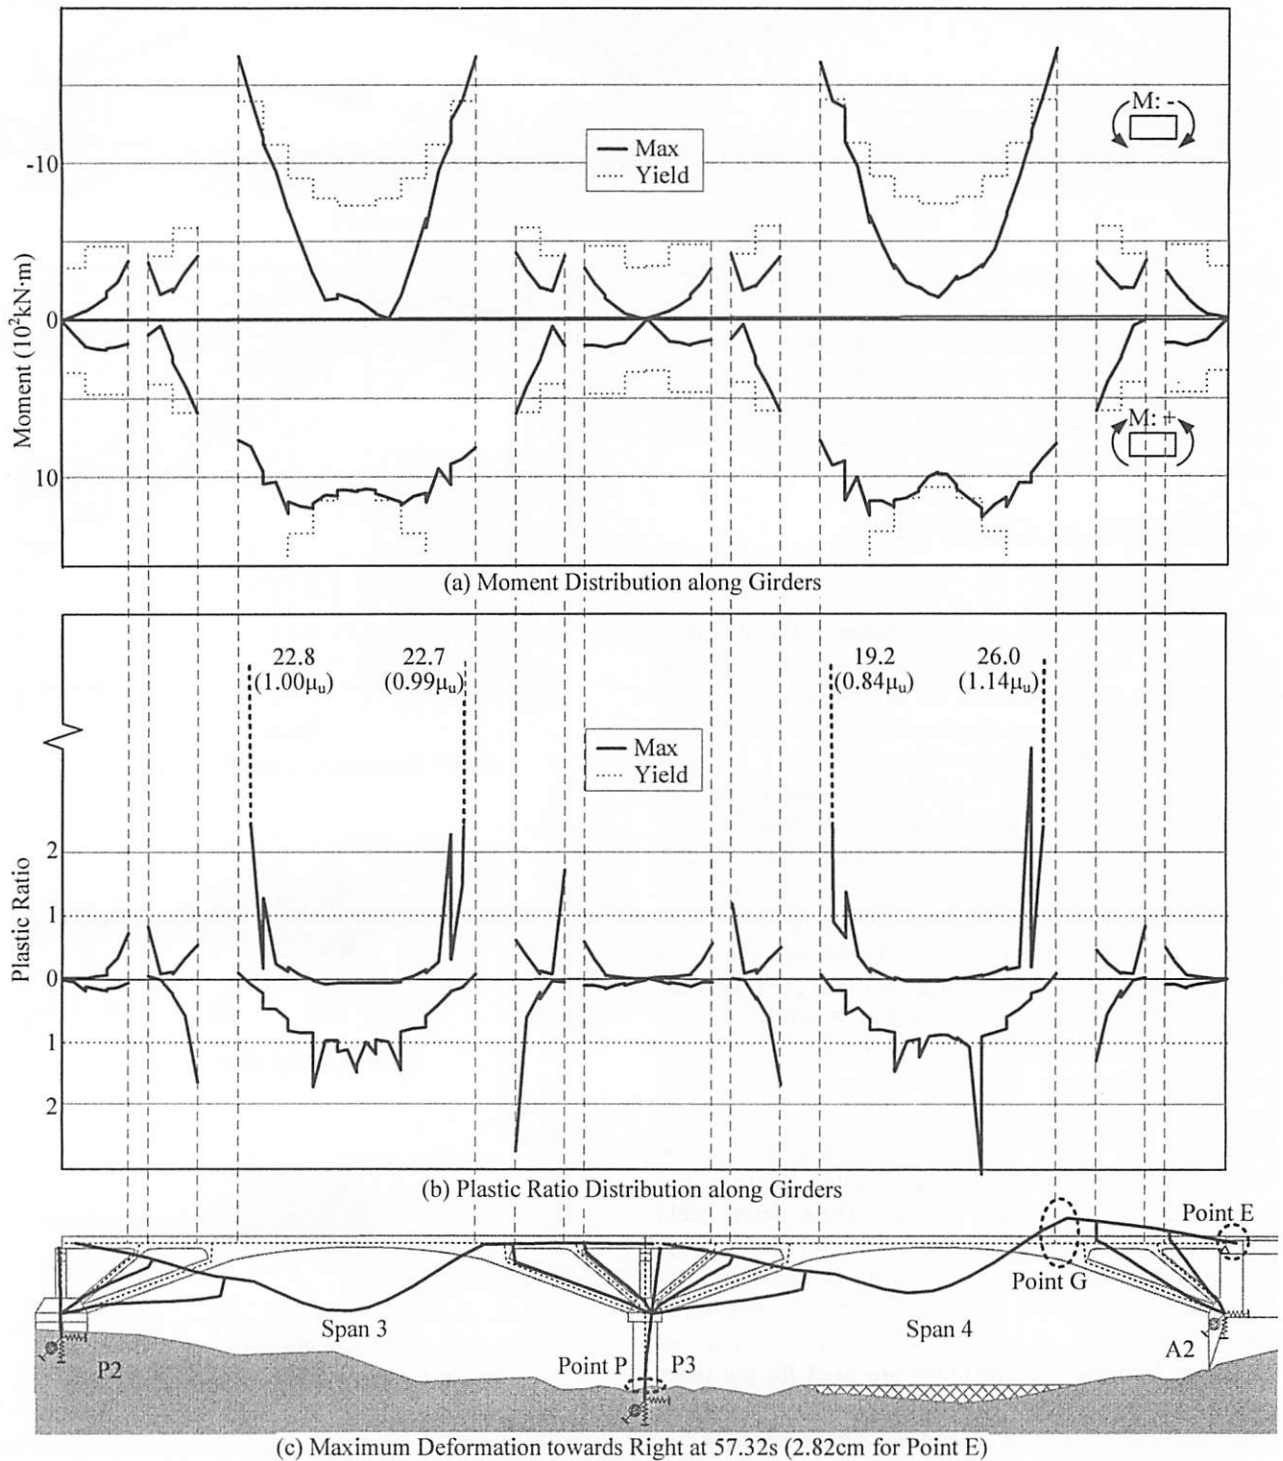
Fig. 9 Maximum Flexural Response & Maximum Deformation

As the peak response moment distribution along the girder shown in Fig. 9 (a), we can see that all elements of girder suffer changeable moment in both positive and negative direction. It should be noticed that the joint of girder with arch legs (for example the right joint on Span 4: Point G) are the most crucial point along girder, whose response moment exceeds the yield moment (defined by the yield of tensile reinforcement) and even the ultimate moment (defined by the compressive concrete reaches the ultimate strain $\epsilon_{cu}=0.0035$).

By Eq. 1, we got following phenomena: (1) all 4 joints with arch legs on Span 3 & 4 suffer most serious damage, whose maximum plastic ratios reach from 19.2 to 26.0 (Point G reached at 1.14 times of ultimate plastic ratio μ_u); (2) although other points, for instance the outside point of joints with arch legs and middle of both spans, receive relatively noticeable response as well, over yield stage, the absolute value of the maximum plastic ratio does not exceed 3.0 (smaller than $2\delta_y$ in experimental tests), therefore the failures at these points are limited.

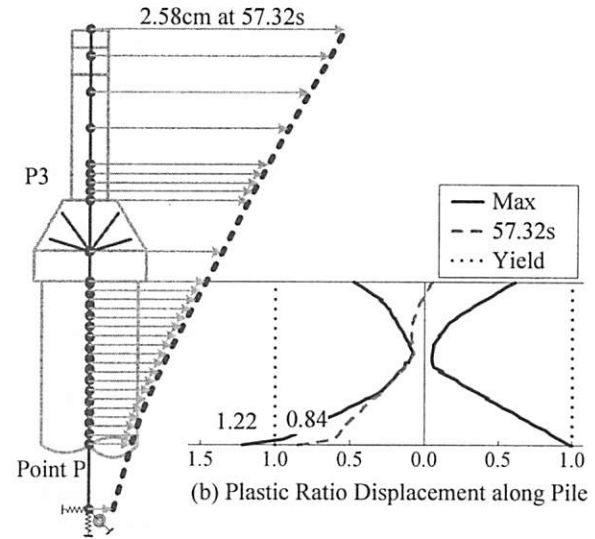
Fig. 11 Response of P3 at 57.32s

On the other hand, the pile beneath P3 is also damaged noticeably. The deformation at 57.32s (the time point when girder of Span 4 moves towards right most) of P3 is illustrated in Fig. 11 (a), while the plastic ratio distributions at maximum and at 57.32s are shown in (b) together. It becomes obvious to us that significant slope change occurs around Point P seen from Fig. 11 (a), this contributes the most to the tilt of P3 and 2.58cm on the top at 57.32s. The phenomenon is considered to be caused by relatively great response curvature (as plastic ratio being 0.82 at 57.32s) around Point P.

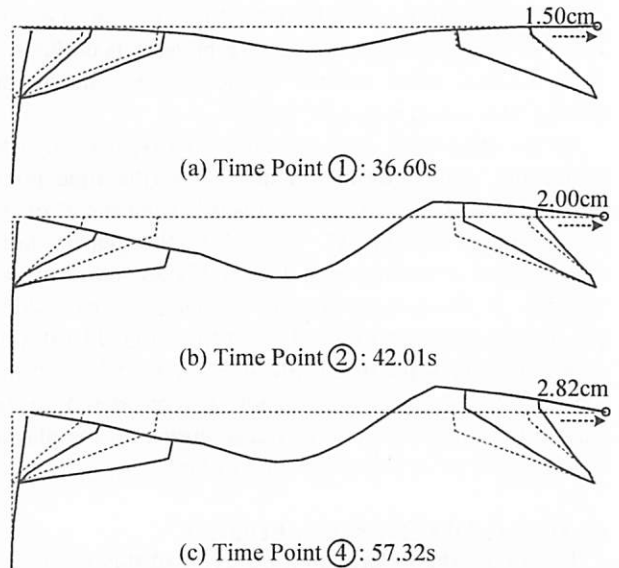
Fig. 14 Deformation Development of Span 4 (x50)

Furthermore, the development of deformations for Span 4 for three representative time points ①, ② and ④ is illustrated in Fig. 14, for verifying the reason of different displacement with similarly noticeable flexural response. For the deformation at 36.60s shown in (a), P3 tilts and top of P3 moves towards right notably while the girder does not deform notably. Thus, the horizontal

displacement of Point E (1.50cm) is limited by the small deformation of girder. For the deformation at 42.01s shown in (b), the tilt of P3 is not great while the deformation of girder is significant. The displacement (2.00cm) is consequently not great as well. However, for deformation at 57.32s shown in (c), P3 and the girder of Span 4 vibrate harmoniously. Point P and G receive great flexural response, with the plastic ratio being 0.84 and 26.0 respectively, and both P3 and girder deform greatly from original position. Thus, the maximum horizontal displacement is got as 2.82cm at 57.32s.

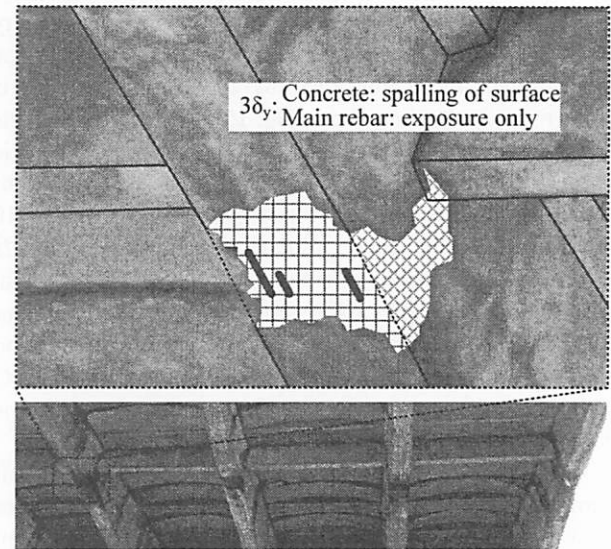
Fig. 15 Actual Damage of Point f of Span 2

An example for the damage judgment at joints on girder with arch legs (Point f) of Span 2 is shown in Fig. 15. From this figure we can see that spalling of surface concrete occurred to the bottom, while the main rebar was exposed but no buckling was discovered. Thus, $3\delta_y$ can be defined.

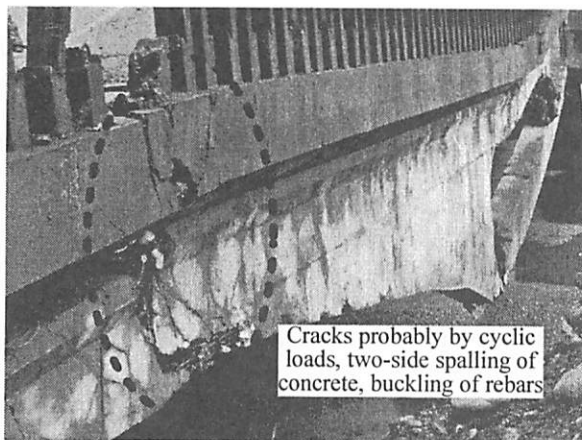
Fig. 17 Point f of Span 3

In the middle span of girder, near the joints with arch legs), actual damage is shown in Fig. 17 for Pont f of Span 3. We can see cyclic load-induced cracks, spalling of concrete at both bottom and top, and buckling of

rebars. Thus, $5\delta_y$ is judged for the actual damage. Furthermore, this $5\delta_y$ damage is probably developed from the $3\delta_y$ damage of Point f of Span 2 explained in Fig. 15, rather than totally damage by collapse, since the cyclic load-induced cracks. And shown in Fig. 9, $26.0\Phi_y$ or $1.14\Phi_u$ of Point G in analysis is got, which coincide with actual damage well. On the top of all legs (Point c, d, g and h, example is shown in Fig. 18 for Point h of Span 3), neither pull-out rebar nor tensile crack of concrete was observed for upper surface, while all rebars were

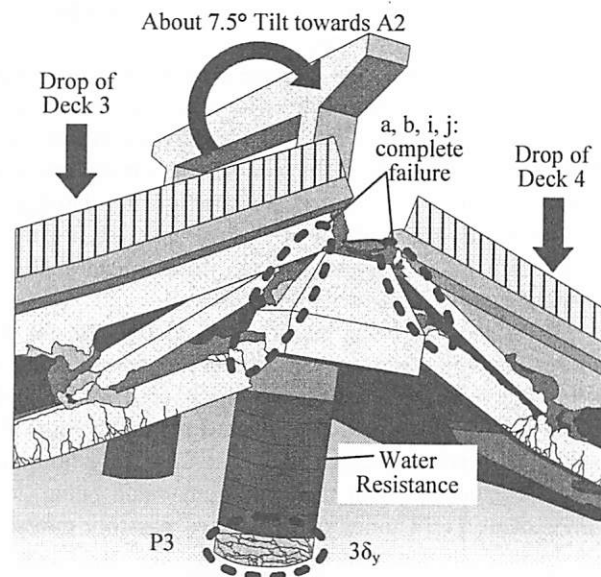
Fig. 19 Actual Damage of P3

pulled out and great tensile cracks occurred to concrete for lower surface. This indicates the damage is probably induced by collapse, rather than before it. At bottoms (Point a, b, i and j, Fig. 19) are damage completely. Thus, actual damage condition is not compared with analytical result for both tops and bottoms of all legs of Span 3 & 4. For P3, to the maximum, 2.58cm horizontal displacement on top and $1.22\Phi_y$ for pile in analysis is observed (about $1\delta_y$, illustrated formerly in Fig. 11), which is less severe than the residual 7.5° tilt towards A2 side and great amount of wide cracks in the actual damage by field survey (about $3\delta_y$, shown in Fig. 19).

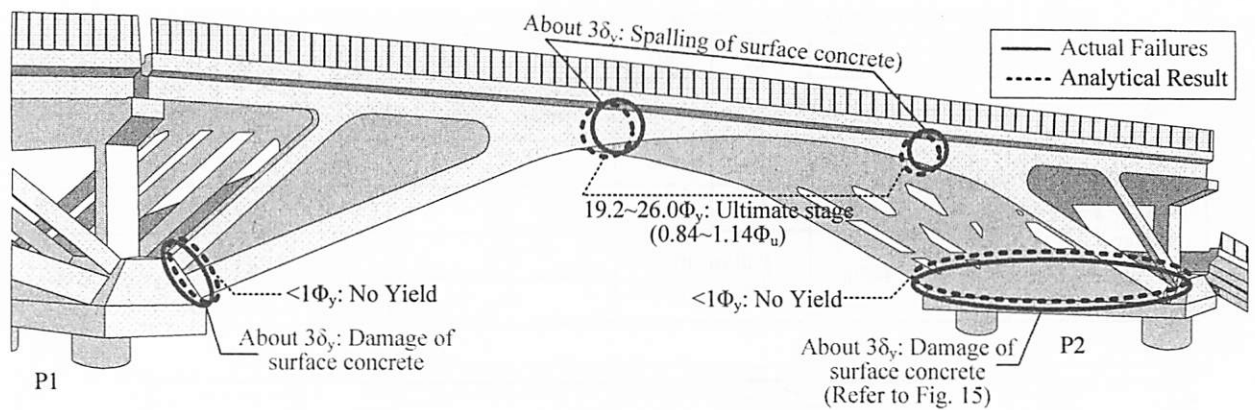
Fig. 20 Actual Damage Condition of Span 2 and Comparison with Analytical Result (view from upstream)

For Span 2, as being summarized in Fig. 20, for the girder, spalling of surface concrete at the lower surface at the joints with arch legs were discovered in the field survey. Thus, about $3\delta_y$ is evaluated for them. From the analytical result explained above in Chapter 4, ultimate stage is exceeded with the maximum value being 26.0 times of Φ_y (1.14 times of Φ_u). Thus, possibly movable P3 in analysis leads more severe damage than that in actual at these joints. On the other hand, for bottoms of both arch legs and inclined legs on both sides, $3\delta_y$ is estimated. However, analytical result shows relatively slight damage for these points without any yield observed. This contrast suggests, by the dynamic analysis using Bajiao wave, the response of legs is underestimated, comparing with the actual damage condition.
