Damage Distribution in the 2013 Awaji Island Earthquake and Ground Motion Characteristics in Sumoto plain

Twayana Ratna Prasad¹ · Shinichiro Mori² · Yoshiya Hata³ · Masayuki Yamada⁴

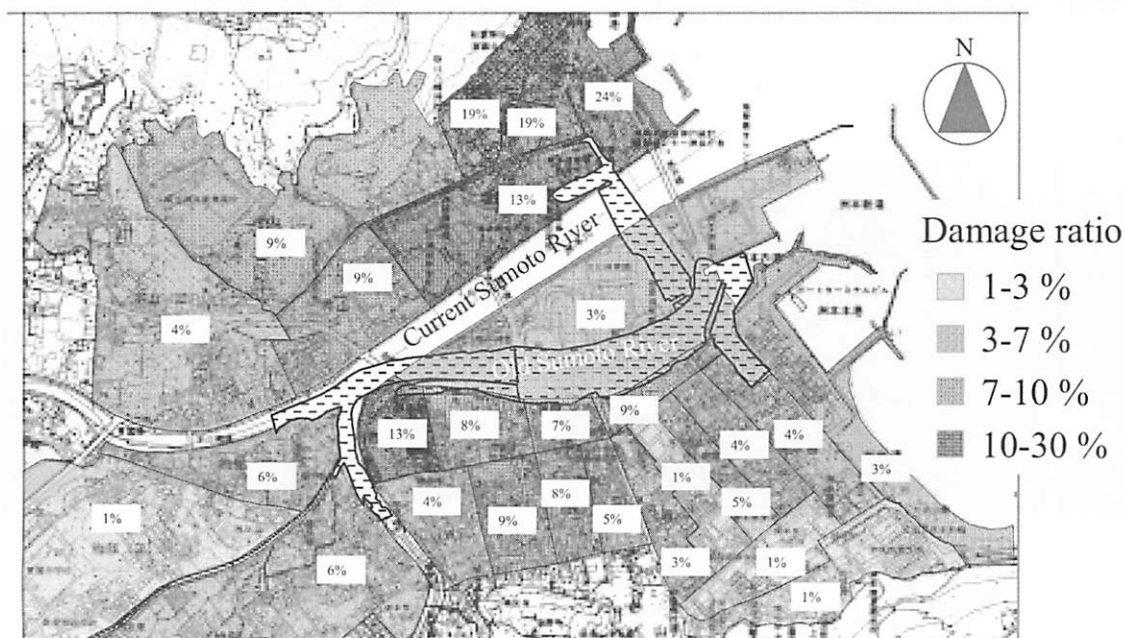
Fig.1 Damage distribution of wooden houses damaged by 2013 Awaji Island Earthquake in Sumoto City.

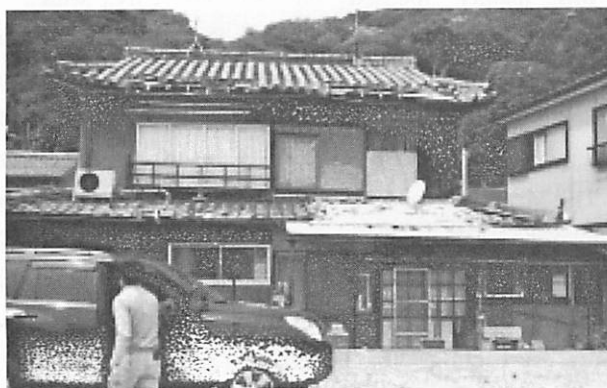
Fig.2 (a) Damages to the roofs and broken tiles of a two storey wooden house at Takenokuchi 2-chome.

houses were concentrated within small area. The damages ratio of Takenokuchi town was highest among our surveyed area. The typical damages to the roofs of wooden houses in Takenokuchi 2-chome are in shown in Fig.2 (a) to Fig.2 (c). It is supposed that Dabutsugawa River used to flow around the Takenokuchi area. The soft sediment of this river might have amplified the ground motion causing concentrated damages. During our survey, some minor damages to the reinforced concrete (RC) building (Fig.2 (d)) were also observed in Takenokuchi 1-chome. A 1.4 mm width vertical cracks were noticed on the walls of two storey RC building. Sakaemachi and Monobe towns were moderately densed damaged zone where the number of damaged houses was in the range of 10-20. The old Sumoto river, till Meiji period, used to flow in between Shioya 1-chome and Sakaemachi town as indicated in Fig.1. Thus it can be assumed that Sakamachi might be the flooding area of this river during raining seasons at ancient Meiji period. Thus layer of soft sediment deposits may be thick in this town and this might be major parameter for more damages in this zone. However, the damage ratio at Shioya was low (only 3%)

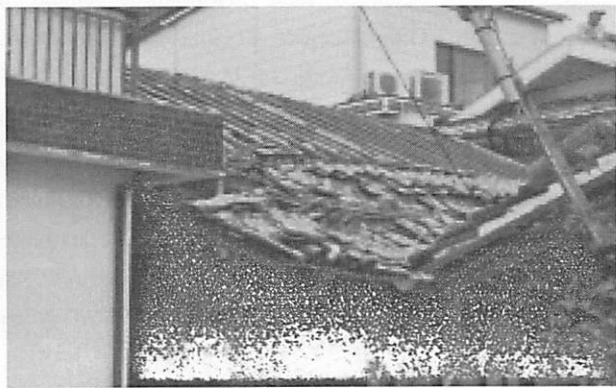
tremor of earthquake, many one storey and two storey old wooden houses were suffered from roof damages. The roof tiles were broken and even fell down to the ground. However, no structural damages to the timber beams and columns were noticed. Moreover, it is interesting to state that no breakage of window glass was observed even in the house with damaged roof. The distribution of damaged houses in the Sumoto city is shown in Fig.1. This map was prepared based on the damaged ratio of wooden houses in specific site. Damage ratio is the ratio of number of total damaged houses to the total number of houses in specific site. In this case, damage ratio was calculated for every town (known as chome in Japan) and damaged towns were divided into four zones. Damage ratio 1-3 %, 3-7 %, 7-10 % and 10-30% were termed as highly sparsely damaged zone, sparsely damaged zone, moderately densed damaged zone and densely damaged zone respectively. At Takenokuchi town, locating at left bank side of current Sumoto River, the roofs of wooden houses were heavily damaged and number of damaged

Fig.2 (b) Sliding of roof tiles of one storey wooden house with no breakage of window glasses.

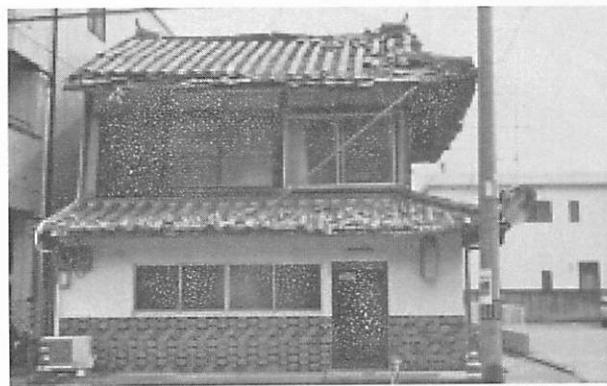
Fig.2 (c) Large deformation of the roofs and second storey frame of a two storey wooden house at Takenokuchi 2-chome.

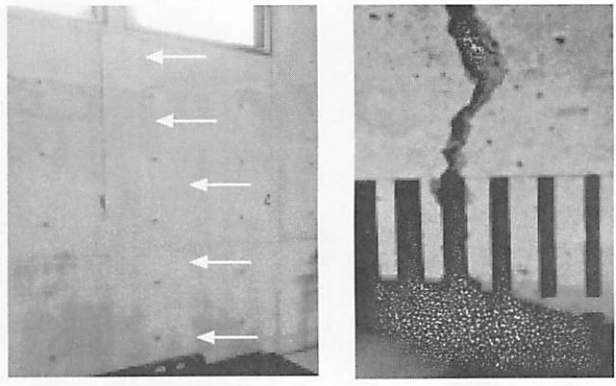
Fig.2 (d) vertical cracks (1.4 mm width) on the walls of reinforced concrete building at Takenokuchi 1-chome.

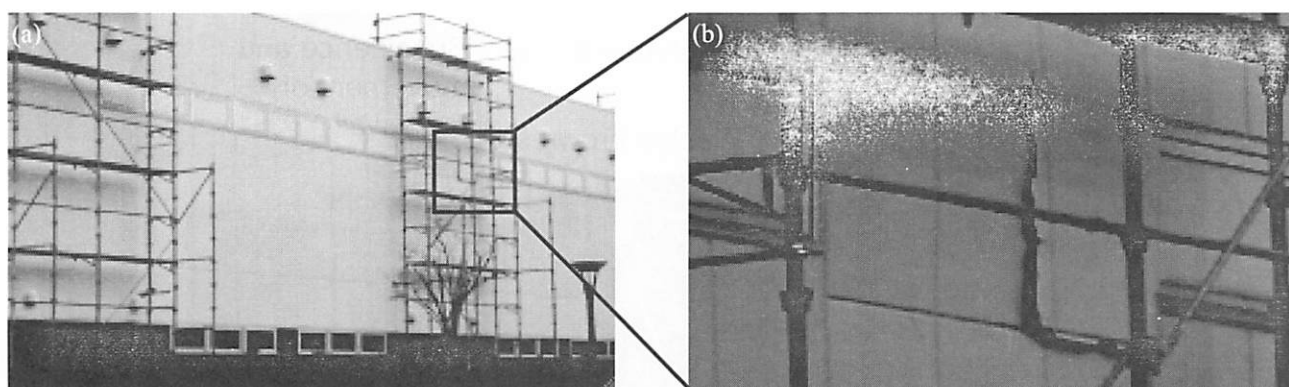
Fig.3 Slight damages to the exterior wall of a shopping center at Shioya 1-chome; (a)View of damaged exterior wall made of ALC panel (autoclaved lightweight aerated concrete panel); (b) Out-of plane deformation of ALC panel.

although this area is reclaimed area. In this town, wooden houses were less and newly constructed reinforced concrete building were made earthquake resistance which resulted in less damages. A shopping center constructed over the reclaimed land on the old Sumoto River was slightly damaged as shown in Fig.3. The exterior wall made of ALC panels (autoclaved lightweight aerated concrete panel) deformed out-of plane due to earthquake motion. Similary, the damage ratio at Honmachi town, consisting of 8 sub- towns (chome), was 5 % in average however inside this town, the ratio varies from 1 % to 9 % depending upon its sub-town (chome). The damage ratio of Honmachi 3-chome was least where only two wooden houses were damaged while this ratio was around 9 % in Honmachi 7-chome and 8-chome. In these sub-towns, the damages houses were concentrated. The first gate of Sumoto Hachiman Shrine was damaged due to sliding and rocking of upper horizontal members supported by two columns during main shock as shown in Fig.4. Some houses in Honmachi 1-chome were also suffered from roof damage even though these houses were survived in 1995 Hyogoken-Nambu earthquake. In

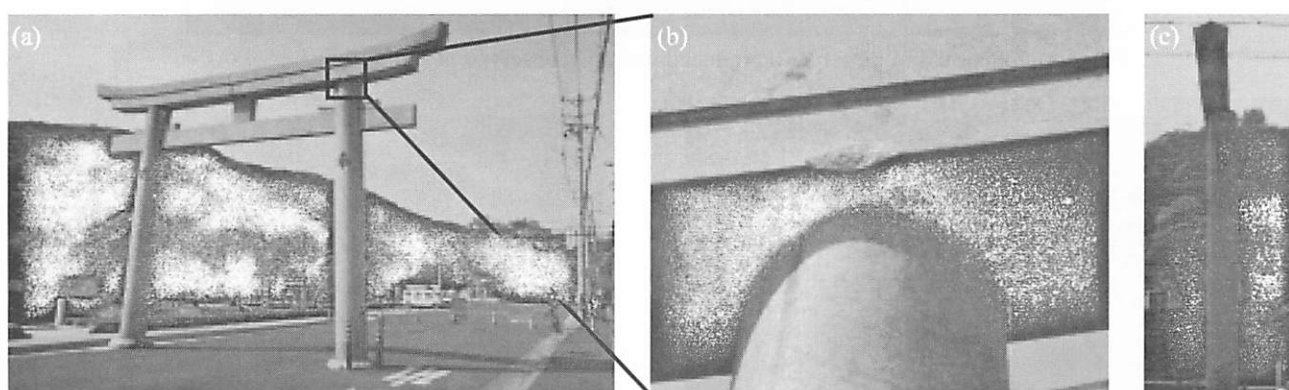
Fig.4 Earthquake damages to the first gate of Sumoto Hachiman Shrine; (a) Front view of gate; (b)Focused damaged; (c) Side view of gate showing sliding of horizontal member.

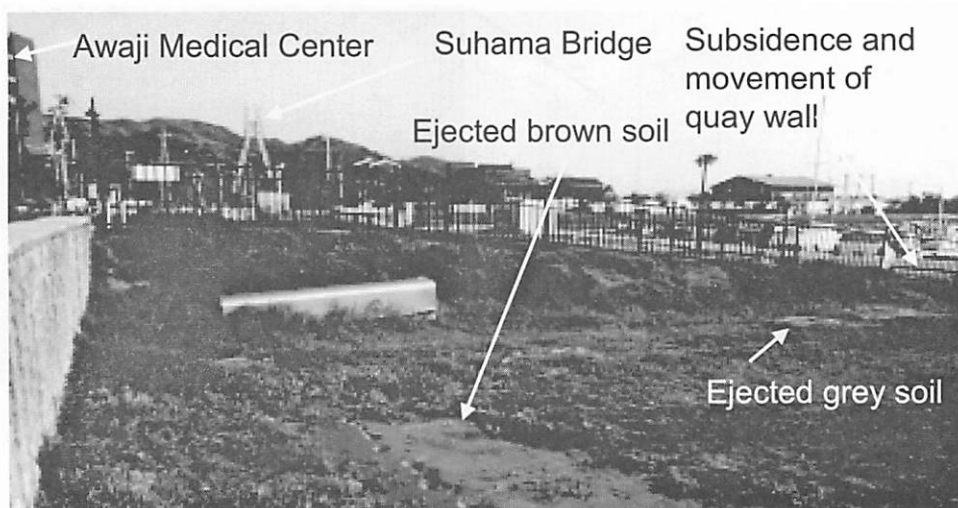
Fig.5 liquefaction and liquefaction induced damages observed at Sumoto Fishery Port.

damage of earthquake in the reclaimed areas when the intensity of earthquake exceed 5. Some areas around Sumoto Fishery Port near to the Awaji Medical Center were liquefied as indicated in Fig.5. Brown and grey soils were ejected due to liquefaction. The liquefied soil eruption created fissures in the ground parallel to the quay wall line (Fig.6). About 13 cm subsidence of ground behind the quay wall (Fig.7) was observed due to liquefied soil eruption. Cracks due to differential

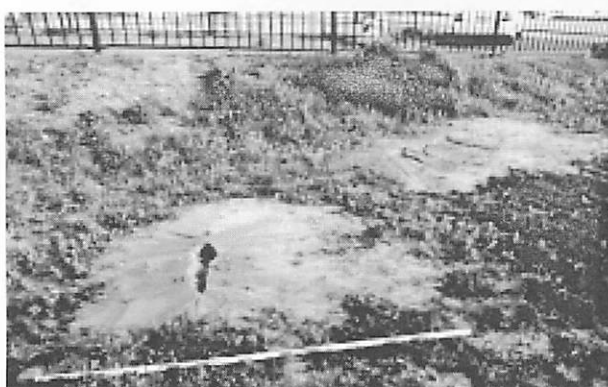
Fig.6 Liquefied grey soil creating fissures parallel to the quay wall

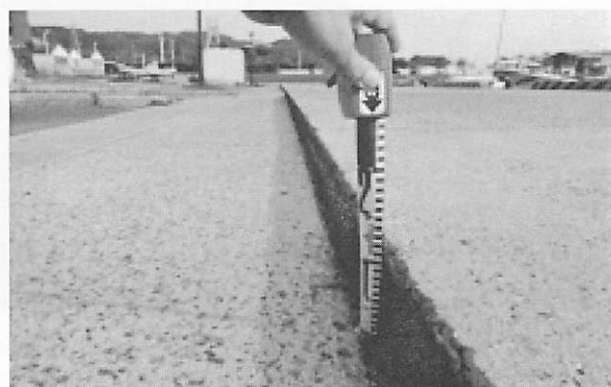
Fig.7 Subsidence of ground behind the quay wall and movement of quay wall toward sea.

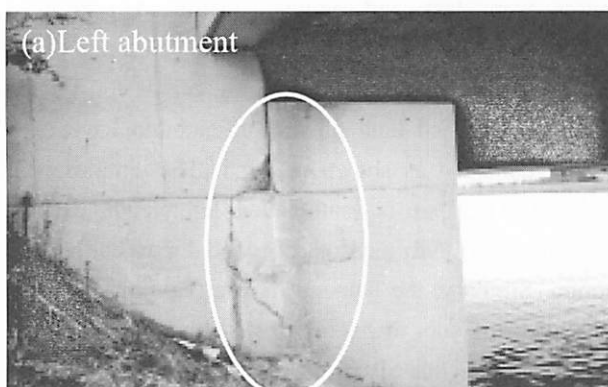
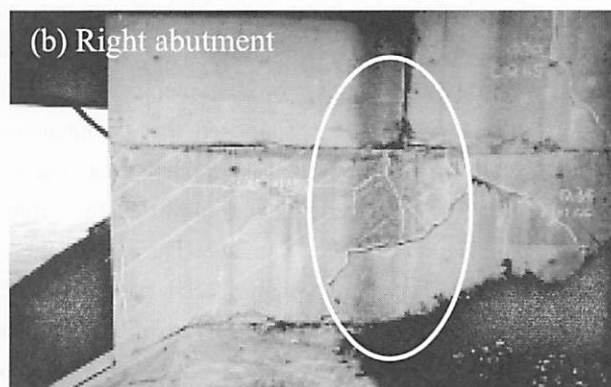
Fig.8 Earthquake damages to the abutments of Suhama Bridge; (a) Cracks on the left abutment; (b) Cracks on the right abutment.

All the infrastrucutres especially bridges located in this city performed well during this earthquake. However the damages to the abutments of Suhama bridge, a 149 m long two span cable-stayed bridge, was quite noticeable. Shear cracks on both abutments (left and right) of this bridge were observed (Fig.8). The cracks were concentrated on abutments and no major cracks and damages were observed in the bridge girder. The coupled interaction between bridge girder, stopper and abutment due to earthquake motion could be possible cause of shear cracks in the abutments. The failure mechanisms of this bridge was discussed by Mori et.al.³⁾
