DAMAGE CHARACTERISTIC OF BRIDGES DUE TO 2013 BOHOL EARTHQUAKE

Jun-ichi Hoshikuma¹ · Toshiaki Mabuchi²

1. INTRODUCTION

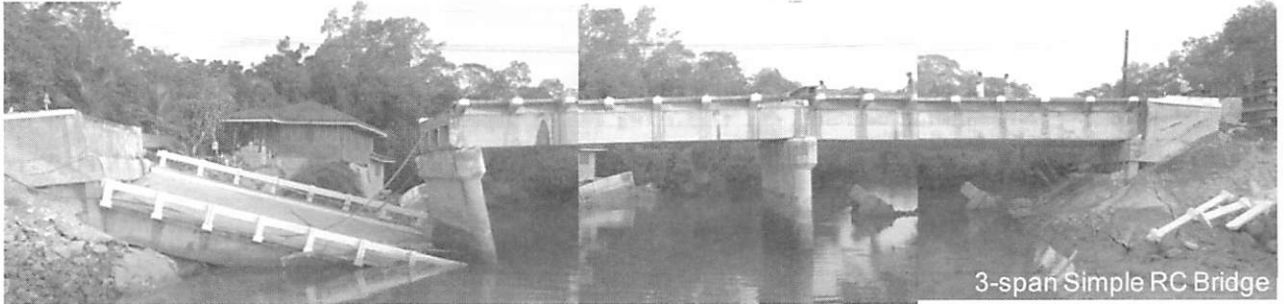
longitudinal direction, which caused excessive inclination of substructure and finally resulted in unseating of superstructure in multi-span simple-supported bridges. One of the typical examples of the damage is Moalong Bridge as shown in **Photo 1**. Moalong Bridge constructed in 1982 is a 3-spans simple-supported bridge with 42.6m of total length, and it seems to be built on the soft soil condition. As seen in the northeast-side pier wall in **Photo 1(a)**, the bottom of pier wall significantly moved to the side of bridge center, which caused heavy inclination of pier wall. Since larger displacement than the seat width (estimated at around 500mm) developed at the pier top due to the lateral movement and inclination of the pier wall as shown in **photo 1(b)**, the Northeast-side span was unseated. It can also be observed that the southwest-side pier wall moved to the bridge center as shown in **Photo 1(c)**. However the displacement developed at the pier top did not

(a) Panoramic View of Moalong Bridge

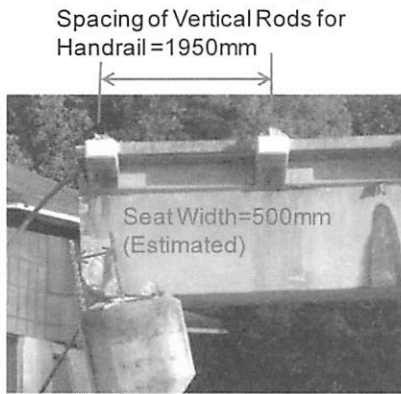
(b) Top of Northeast Pier Wall

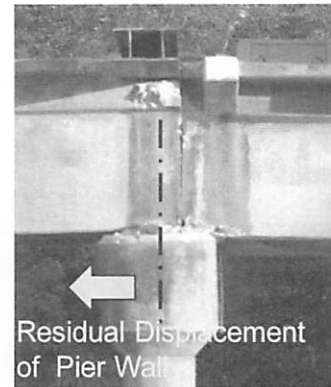
exceed the seat width, which avoided unseating the southwest-side span.

(c) Top of Southwest Pier Wall

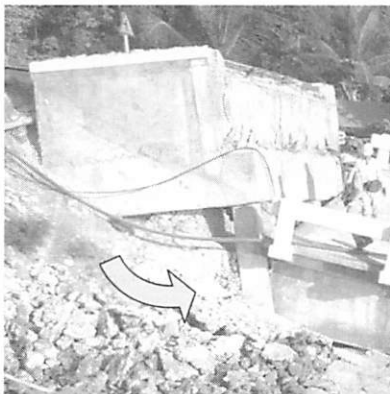
A northeast abutment was also severely damaged. The abutment body was built on the embankment protected with the riprap and the single-aligned 400mm square piles supported the abutment body as shown in **Photo 1(d)**. This structural type of abutment is very typical in Philippines. The embankment significantly settled due to the earthquake as shown in **Photo 2** and moved ahead with cracking the riprap, which induced shear force and moment to the piles. However, since there was very few amount of transverse steel (6mm diameter bar with spacing of 200mm) in the section of the piles, vulnerable shear failure was developed at the pile top as shown in **Photo 1(e)**. Many clear traces of collision between parapet and girder were also observed as seen in **Photo 1(f)**.

Based on above observations for Moalong Bridge, significant lack of lateral strength of piles of both pier and abutment is one of the most important factors of the damage.

(d) Residual Inclination of Northeast Abutment

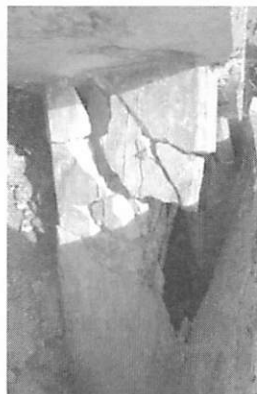
(e) Shear Failure of Pile Head

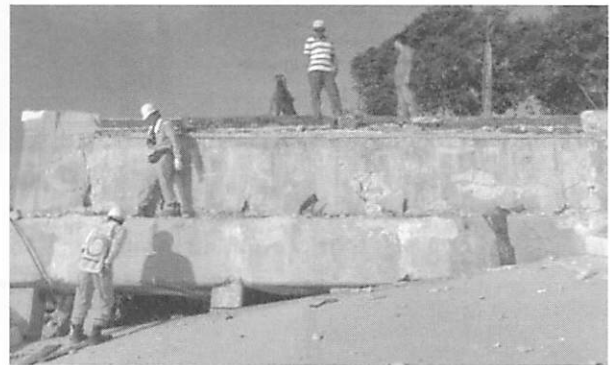
(f) Traces of Collision between Parapet and Girders

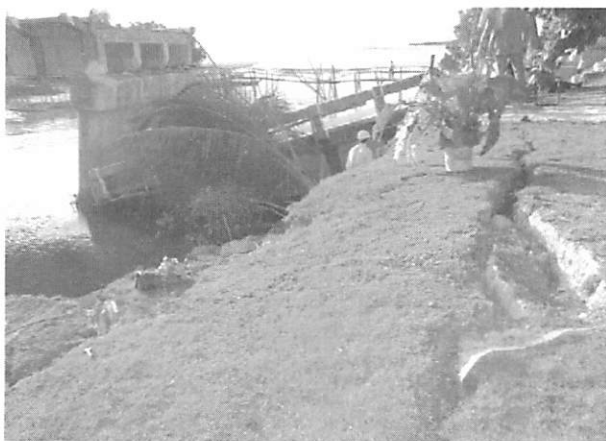
Photo 2 Big crack of embankment heading for northeast abutment

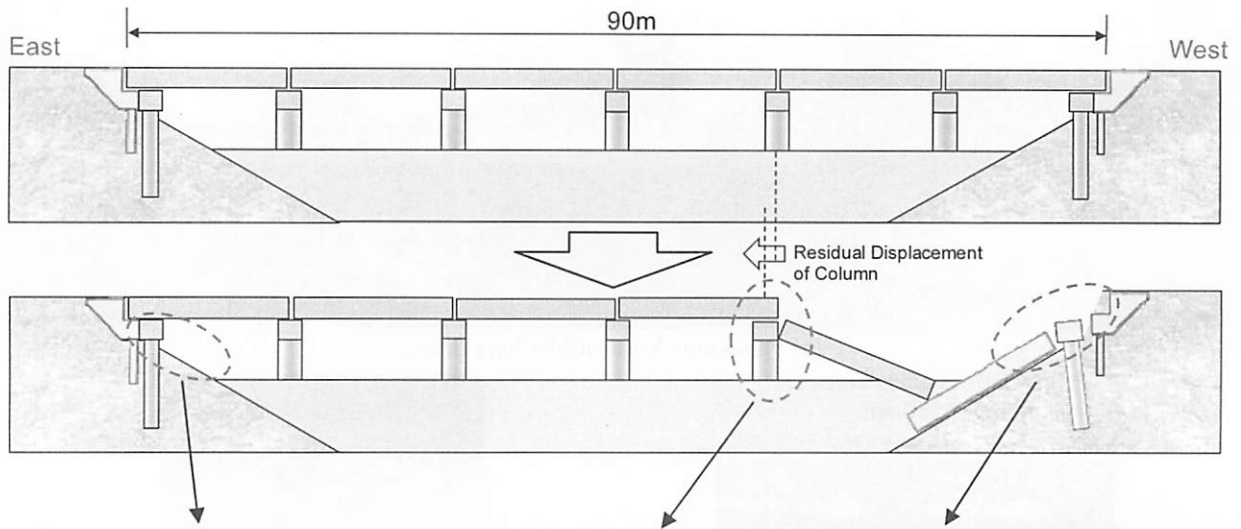
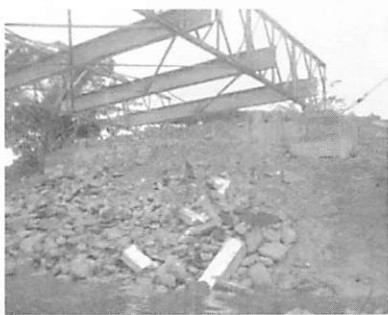
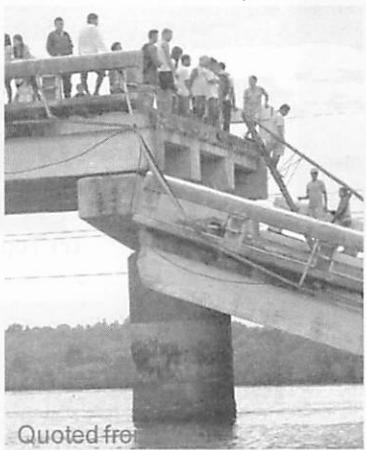
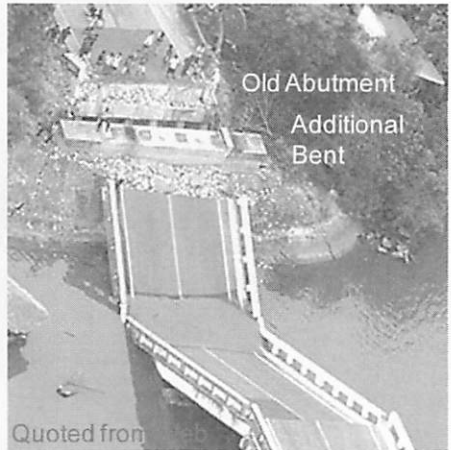
Fig.3 Schematic View of Damage to Abatan Bridge

Abatan Bridge crossing Abatan River is a 6-spans simple-supported bridge with 90m of total length, and the ground condition around the bridge seems to be soft. Abatan Bridge was constructed in 1981, and additional two-pile bents were constructed at the front of existing abutments as illustrated in **Fig. 3**. Although design philosophy of additional bents is unclear, these

additional bents might be set in the past for rehabilitation of the existing abutments with settlement and tilting. Some shear keys are equipped on the cap beam of the additional bents as shown in **Photo 3**. The west additional bent moved ahead (to east) with significant tilting due to the earthquake as shown in **Fig. 3**. Furthermore, a west bridge column was collapsed and an adjacent column might be displaced to east. Although precise measurement of column position and investigation for piles of the columns should be performed for the solution of the unseating mechanism, the lateral spreading may cause significant residual displacement of the bent and the columns with failure of

Superstructures had already been demolished and a temporary bridge was constructed when authors visited.

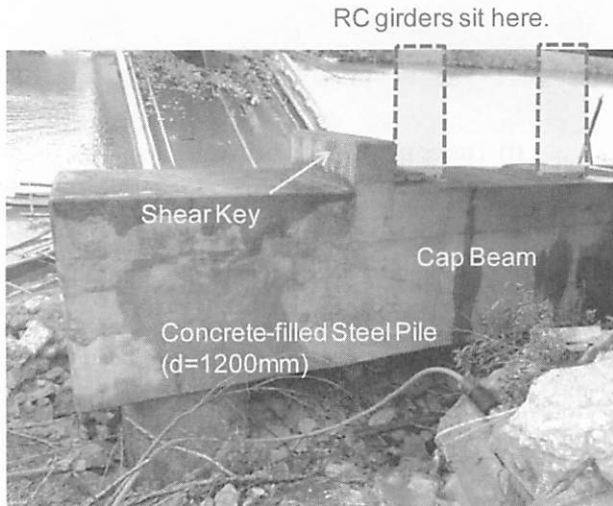
Photo 3 Additional Bent and Shear Key

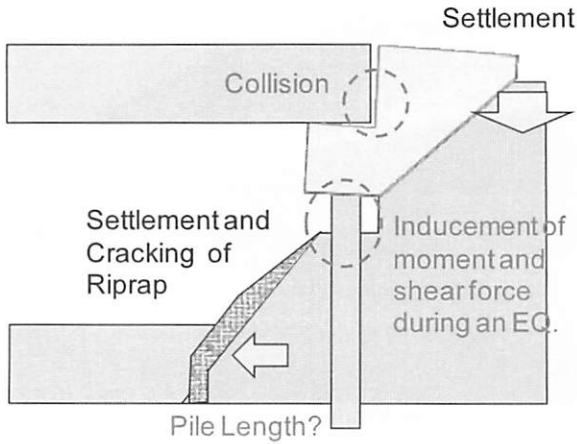
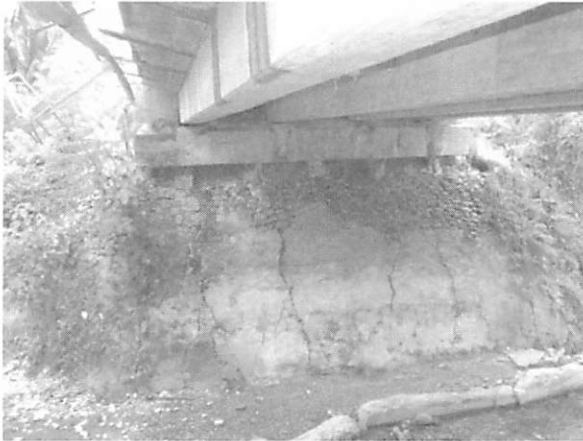
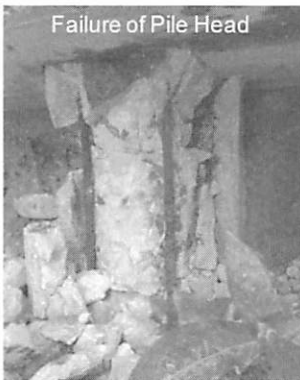
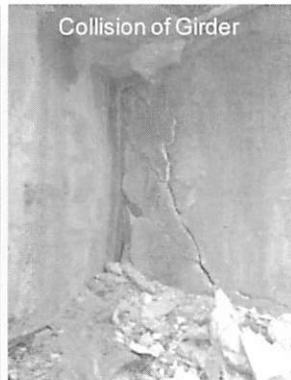
Photo 4 Damage Observation of Tultugan Br.

riprap and the single-aligned 400mm square piles supported the abutment body as employed in Moalong Bridge. Damage examples of this type of abutment were also observed in other bridges. **Photo 4** shows the damage observed in Tultugan Bridge which is a single-span simple-supported bridge constructed in 1968. Approach embankment significantly settled with cracking the riprap, however movement of abutment was restrained by collision with girder, which induced shear force and moment to piles. Since there were no transverse steel in piles of Tultugan Bridge, the pile head exhibited severe failure. However, since Tultugan Bridge is a single-span bridge and all of girder ends are supported by the abutments, the bridge has not resulted in the state of unseating of girder.

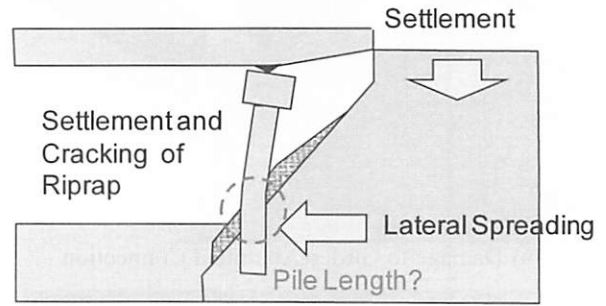
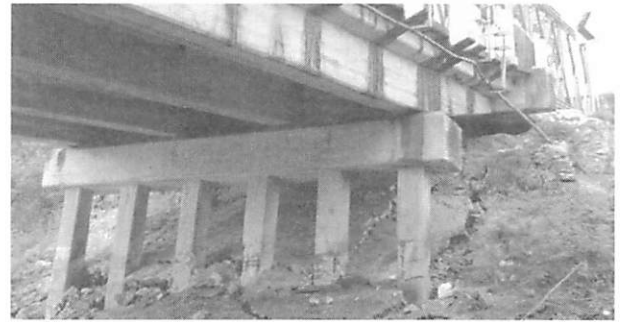
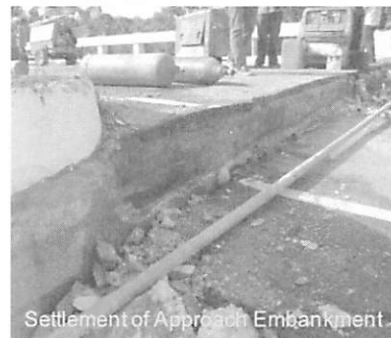
Photo 5 Damage Observation of Tagbuane Br.

Photo 5 shows the other example, namely Tagbuane Bridge which exhibited an excessive tilting of a column bent. Tagbuane Bridge is a 3-span cantilever bridge constructed in 1954. The lateral spreading displaced the

column base and the damage was developed to the columns. Since the excessive tilting of the column bent makes the bridge unstable for the live load, this damage mode significantly affected the serviceability of the bridge after an earthquake.

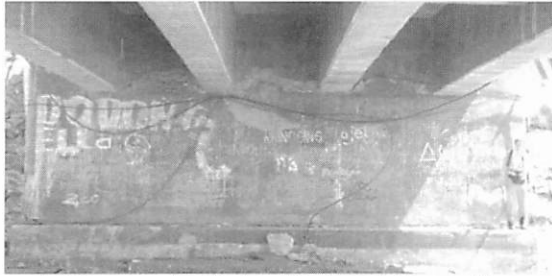
the damage was developed at the section of the girder-abutment connection, where cover concrete spalled off as shown in **Photo 6(b)**. Based on residual deformation of exposed reinforcement bars, the abutment wall moved ahead and the front face of the abutment wall at the section of the connection with girders was subjected to compression due to bending moment. Residual gap was found at the front face of the abutment-footing connection as shown in **Photo 6(c)**, which also indicated that the footing moved ahead.

(a) Damage to Girder-Abutment Connection

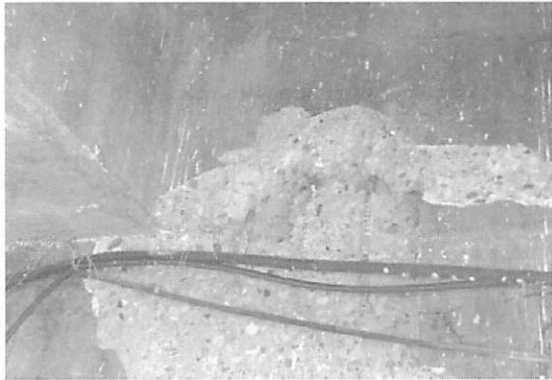
(b) Buckling of Exposed Reinforcing Bars

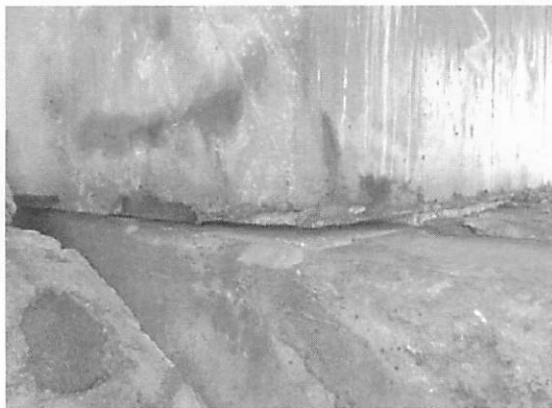
(c) Gap at Abutment-Footing Connection
