# Recent Landslides / Research

## Landslide Causes a Building Collapse in Malaysia

T. NONAKA

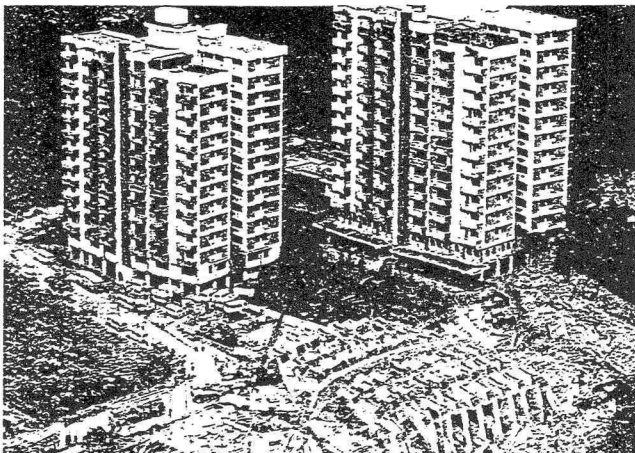
Fig. 2 Air photo of the Highland Towers condominium complex including the collapsed building (Courtesy of *New Straight Times*, 13 December 1993).

A 12-story reinforced-concrete building collapsed due to a landslide in Malaysia, killing at least 50 persons. Failure occurred on Saturday, 11 December 1993, at 13.35-13.40 hrs. The site was located in Talman Hillview, Ulu Klang (or spelled Hulu Kelang) in the suburbs of Kuala Lumpur, as shown in Fig. 1. The collapsed building was Block 1 (or called Block A) of the Highland Towers condominium complex, which also contains Blocks 2 and 3 of the same building. The Block 1 building was constructed on a hillside in 1979 as the first structure in the complex. Fig. 2 shows the entire complex after collapse. Fig. 3 shows the plan of the complex.

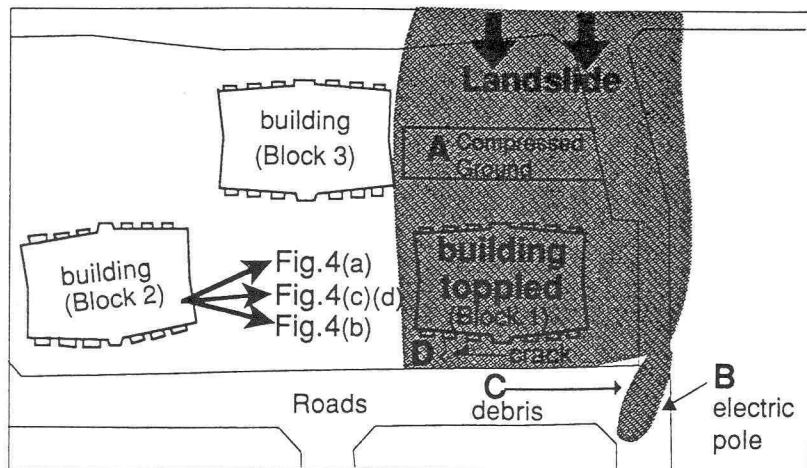
Fig. 3 Plan of the site and the locations of ground deformations prior to building collapse.

season; heavy rainfall had occurred in the preceding night. The landslide movement was in the direction indicated by the red arrows in Fig. 3. The hilltop is situated at the top of the figure. A retaining wall was situated above and to the right of the collapsed building. In between, and just below the upper retaining wall, were a parking garage and badminton courts.

(b) shows a tilted electric light pole (B), spreading debris (C) from the failed retaining wall at the back, and a crack on the foreground (D). From another photo taken between (a) and (b), it was clear that this crack was extending; it could be along the landslide boundary. The locations of (A), (B), (C) and (D) are plotted in Fig. 3. Figs. 4 (c) and (d) show the toppling process of the building.

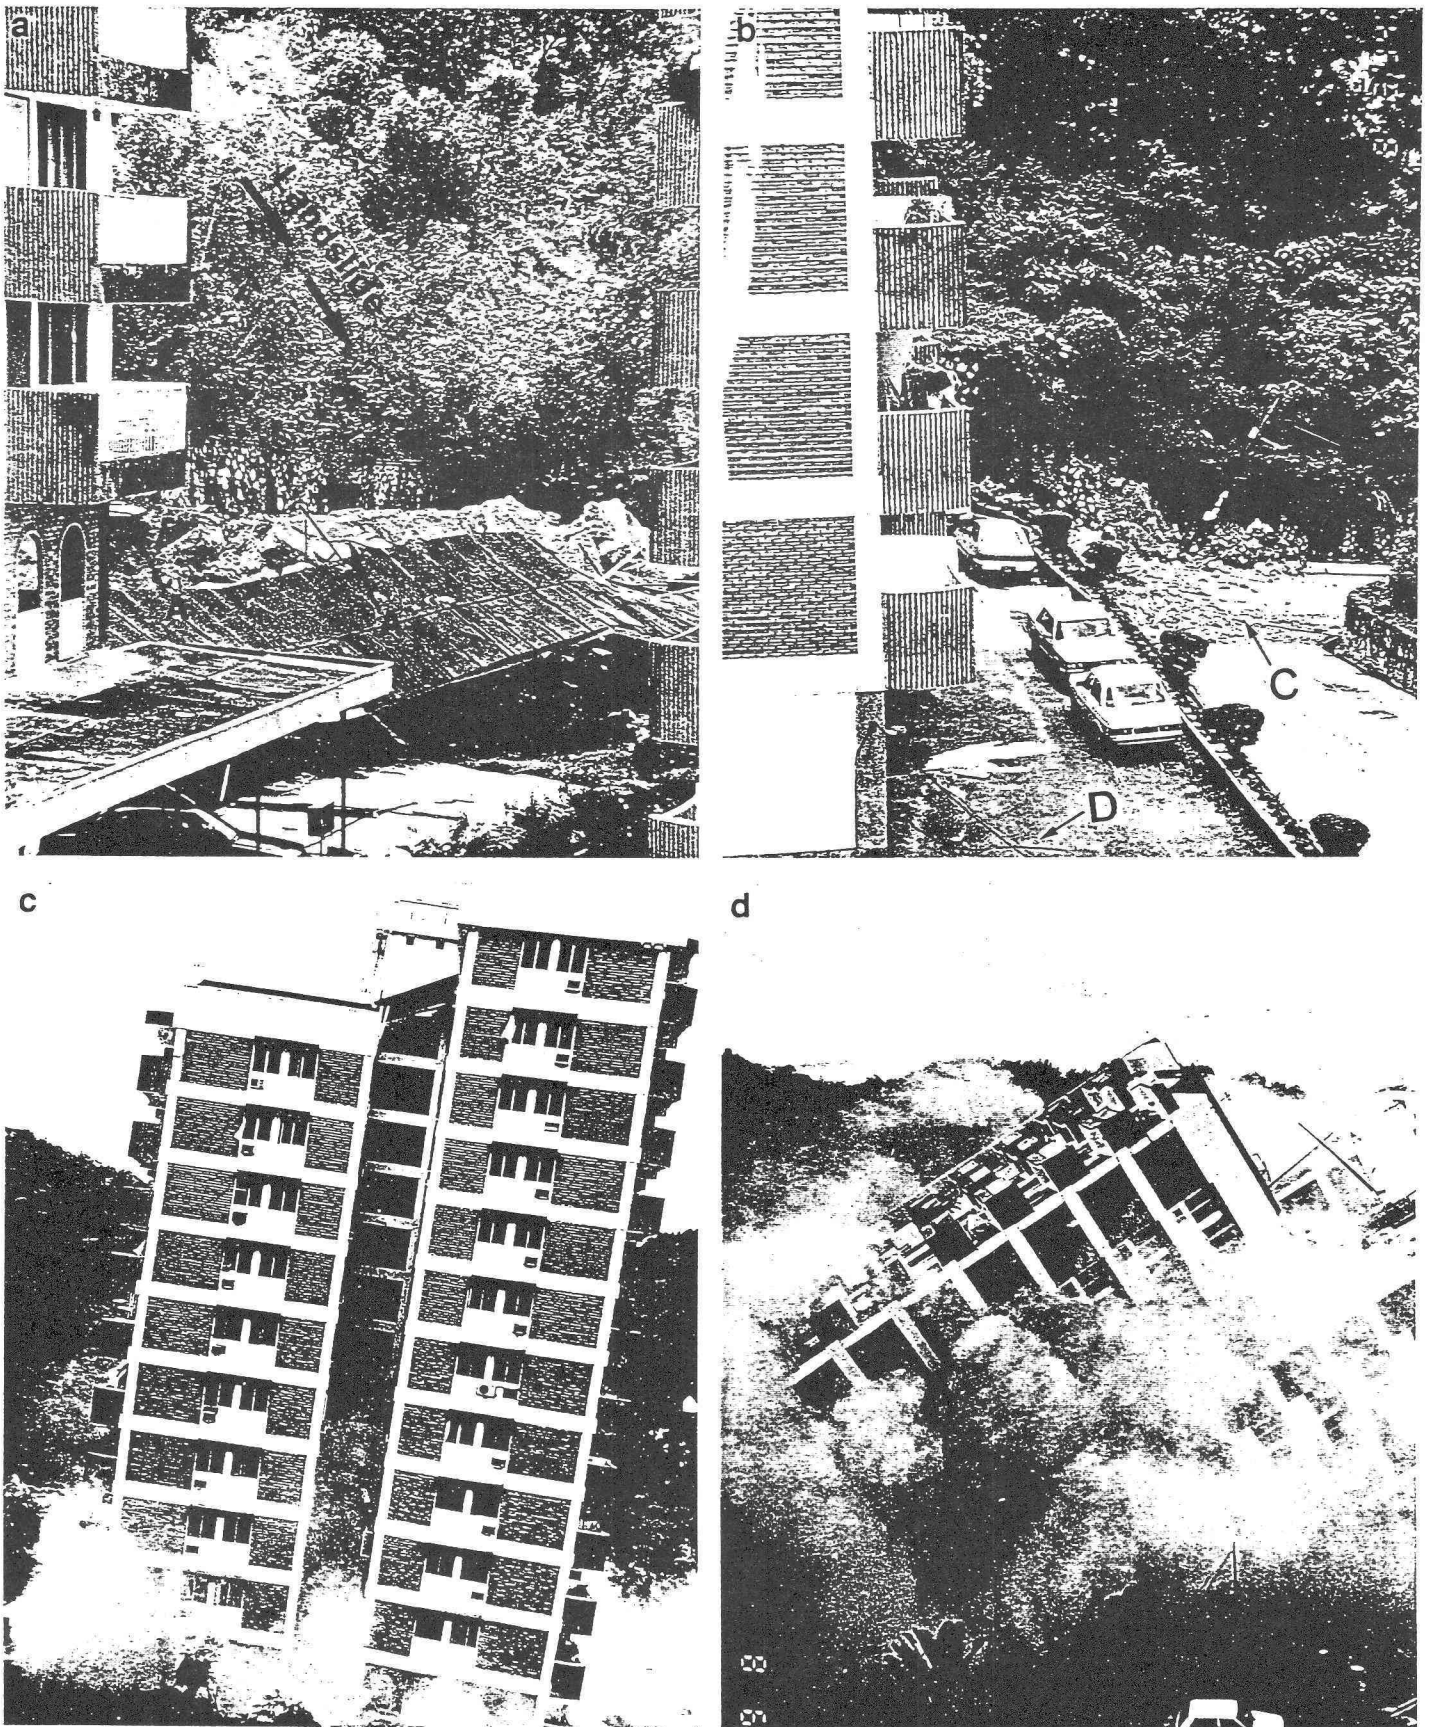
Fig. 4 Process of toppling of the building.

Photos (a), (b), (c) and (d) in Fig. 4 were taken in this order by a nearby resident, Bruce Mitchell, who said: "I heard the crack of the retaining wall giving way. The whole block started to move. The building first slid forward in a vertical position for about ten feet, making little noise. When it started to topple, it went over very quickly. Then there was an explosion of glass and of air" (cited from *Asiaweek*, 22-29 December 1993).

These photographs supposedly were taken from a midheight story of Block 2 in the directions indicated by arrows in Fig. 3. In Fig. 4, the building of Block 1 is seen on the right in (a) and to the left in (b), and toppling clockwise in (c) and (d). Also in Fig. 4 (a), fractured asphalt pavement (marked as "A") on top of earth blocks is visible between the retaining wall and the roof of the parking garage. This suggests that the ground between the retaining wall and the building failed and was upheaved by compressive stress applied by landslide movement. Fig. 4

Apart from possible defects in the structure, it is certain that the building collapse was initiated by a landslide, which took place as a result of loss in stability of slope. Heavy

rainfalls must have increased water content, and hence fluidity of clayey sands lying on the granitic bed rock. The process of excavation and embankment prior to building construction may have participated in the loss of stability.
