# LAS COLINAS LANDSLIDE CAUSED BY THE JANUARY 13, 2001 EARTHQUAKE OCCURRED OFF THE COAST OF EL SALVADOR

*Key Words : El Salvador earthquake, landslide, pumice*

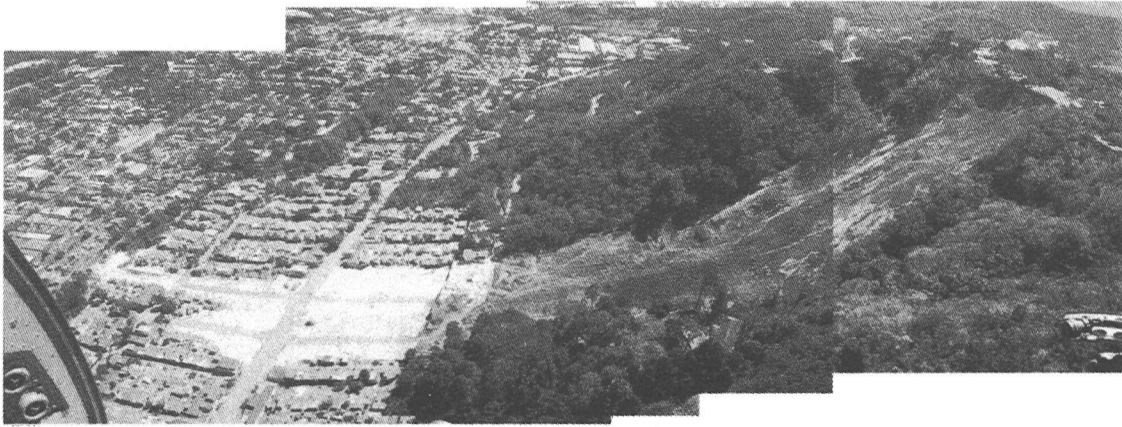
A mountain ridge rises south behind the city, and the slope failure took place in its northern side (Figure 1). Just behind the top scar is a flat area slightly

**Figure 1** A bird's eyes view of the Las Colinas landslide from a helicopter

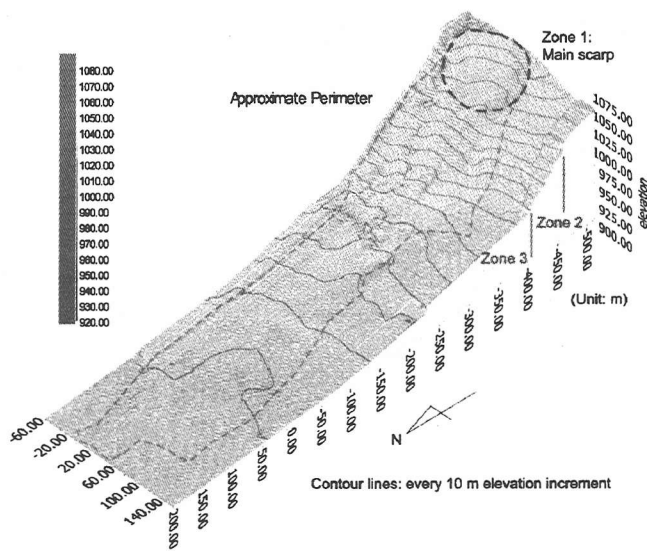
The Las Colinas sliding surface was surveyed with a laser based theodolite (Laser Ace 300), connected to a portable computer. The theodolite has a built-in digital compass, and with its laser beam, it calculates the azimuth, dip angle, and horizontal distance to a point. The exposed failure surface can be roughly divided into three zones (Figure 2). The uppermost zone (Zone 1) is a hollow of about 100m in diameter, which was caved in some 20-30 m from the original ground surface. South beyond the hollow, there appears a steepest slope (Zone 2), which becomes gradually gentle as it comes close to the toe. In Zone 3, the slid soil mass and flushed houses had been removed already, and the cleared area was totally white with disinfectant (see Figure 1).

**Figure 2** Exposed slip surface surveyed by using a laser based theodolite

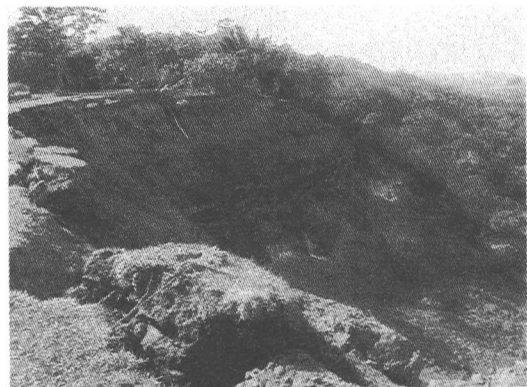
Figures 3a and 3b show the same soil layers appearing on the west half of the scar photographed on January 14 and February 4, respectively. Differently colored stripes appearing on the scar show a stratified soil profile with the top lapilli tuff layer (dark bluish gray) of about 2.0 m thickness overlying a pair of two differently colored (white and ocher) pumice layers of about 11.9m thickness. Dark colors of the top lapilli tuff layer indicates that the soil is moistened, and this pair of photos shows that the dark colored stripes were steadily thinning, in other words, exposed soils were drying. This fact may evidence that the intact soils along the slip surface were wet before the event.

**Figure 3a** West scar, January 14

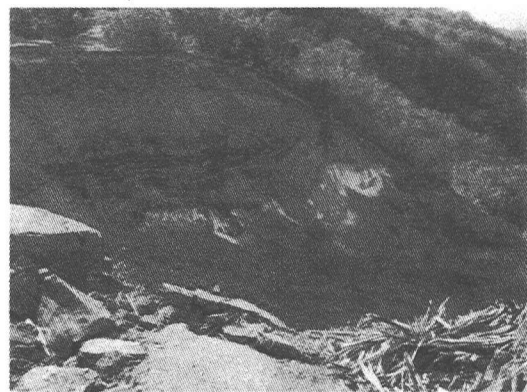
**Figure 3b** West scar, February 4

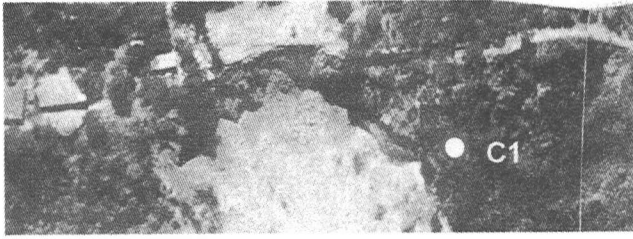
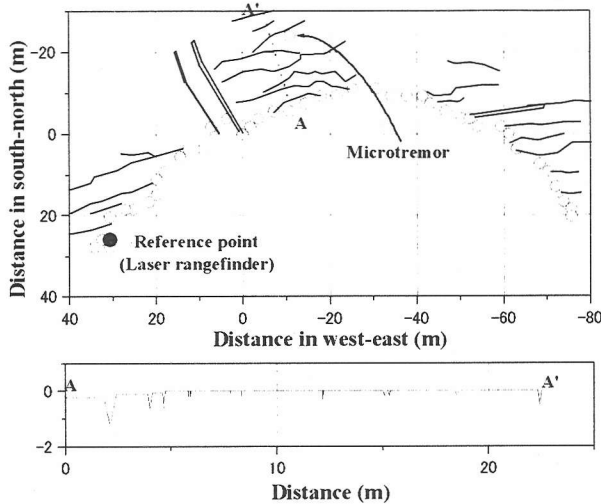
Figure 4. Perimeter of scar, Las Colinas Landslide

Total 43 points were marked along the perimeter of the scar using a GPS receiver (**Figure 4**). Behind the scar, there were extensive cracks running in almost west-east (**middle in Figure 4**). Crack openings (12 visible cracks, **bottom of Figure 4**) were measured along Line A-A'. Total 1.25 m's opening was reached over the 22 m's distance of Line A-A'. Namely, about 5% average strain was induced within the soil behind the scar. Extensive cracks were found along the ridge crest even in areas that did not slide; the cracks are certainly the threat of further slides.

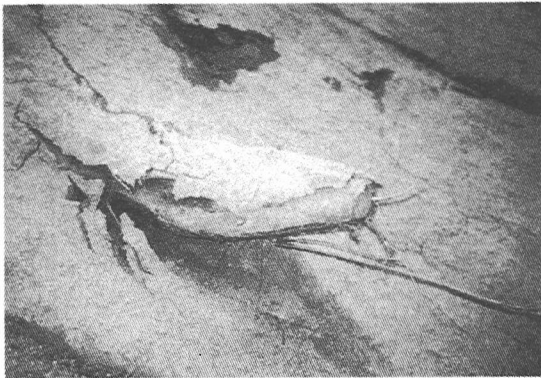
Figure 5 Thin mud film

As shown in **Figure 5**, the steepest slope in zone 2 was covered thin with a film of mud including porous fragments of pumice; the film is noticeably stiff after totally dried up. The film covered trees, bamboo and other plants mowed down on the slope. This fact suggests that the original slope in zone 2 was not scraped off, and is consistent with the result from the 3D survey of the slope configuration. This fact also suggests that the bottom surface of the slid soil mass was wet, and may have been liquefied (Sassa, 2000), possibly related to some weak tephra layers spreading over less permeable paleosols.

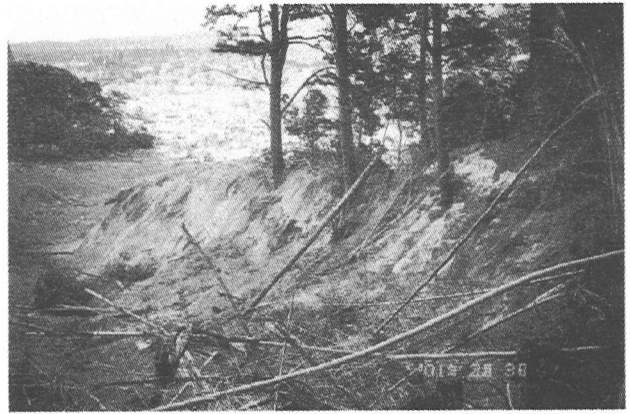
Figure 6 Trace of mud flow

The slid soil mass seems to have surged across a small ravine coming down from east mountainside, and splashed up a small bank. Some splashes were remaining 6-8 m high on some tree trunks on this bank (**Figure 6**).

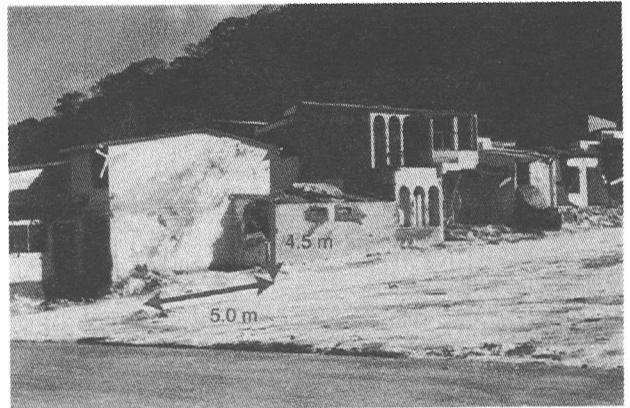
Figure 7 House wall spotting with splashes

There were many splashes of mud remaining on house walls, trees and etc. In general, the splashes seem to be higher at around the toe of the slope than those in the middle or close to the distal end of the soil deposition zone. The highest splash of about 8 m was found on a trunk near the toe. There was water stopped on a pavement. **Figure 7** shows the walls of a dwelling on the eastside perimeter of the slid soil mass, the wall spotting in parabola with mud splashes. The parabola with its peak of about 4.5m high drops downward, and reaches the ground after about a 5m horizontal run. This fact suggests that the time  $t$  needed for the splashes to reach the ground from their peak height  $\Delta h$  ( $= 4.5 \text{ m}$ ) was about 1s ( $\Delta h = g \cdot t^2 / 2$ ), and during this time, the splashes ran about the 5m horizontal distance (5 m/s). The main stream of the soil mass flow might have faster than this speed even after running through dwellings standing close together.

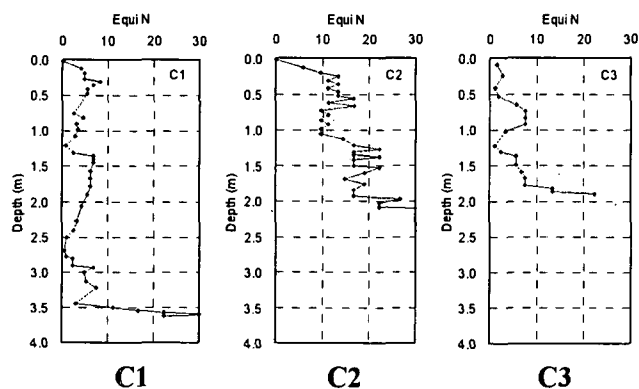
Figure 8 Equivalent Ns-values for three sites

Variations with depth of the equivalent Ns-values at the three points are shown in Figure 8. As contrasted with other points, all equivalent Ns-values at Point C1 are considerably low as a whole. Among them, extremely low values reaching zero were found at about 1.2m and 2.5m depths. These two small Ns

values suggest the presence of two weak layers, which can be the pumice and/or fragmental volcanic products judging from their depths.

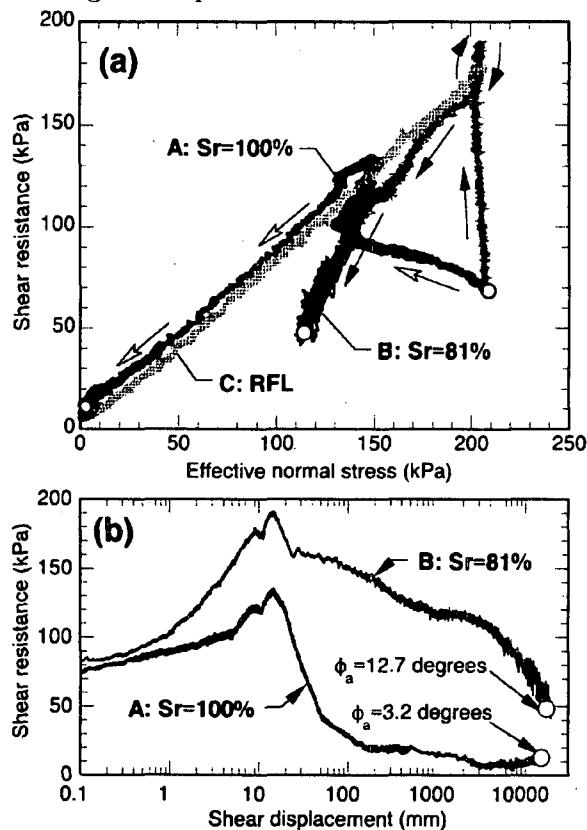
Figure 9 Ring shear test results

Figure 9a shows the effective stress paths for the performed two tests (A and B). As soon as the shearing of the sample started in TEST A ( $S_r=100\%$ ), there appeared an excessive pore pressure buildup, which was then followed by dilation of the pumice. When the residual failure line RFL, which was obtained from a drained speed control test, TESTC, was reached, a sudden decrease of apparent friction angle along the RFL was observed. The drop of the shear resistance is also plotted in Figure 9b with respect to the increasing shear displacement. When the twisted pumice sample had slipped 20m distance, the apparent friction angle of about 3.2 degrees was reached, the fact suggesting that a sliding-surface liquefaction occurred in the saturated soil sample (Sassa, 1996). The average apparent friction angle mobilized in place, however, was seemingly about 13 degrees, much higher than 3.2 degrees reached in TEST A.

For this reason, TEST B was carried out for a smaller value of  $S_r$  ( $S_r=81\%$ ). In this test, the stress path went almost straight up until the RFL was reached (Figure 9a), and then the apparent friction angle dropped down to 12.7 degrees, which is closer to the angle roughly evaluated over the entire travel distance. The path deviated from the RFL presumably because the sensor did not keep a good track of pore pressure of the unsaturated pumice sample.
