# SURFACE RUPTURE OF THE NORMAL SEISMIC FAULTS AND SLOPE FAILURES APPEARED IN APRIL 11<sup>th</sup>, 2011 FUKUSHIMA-PREFECTURE HAMADOORI EARTHQUAKE

Zaheer Abbas KAZMI<sup>1</sup>, Kazuo KONAGAI<sup>2</sup>, Hiroyuki KYOKAWA<sup>3</sup> and Cigdem TETIK<sup>4</sup>

On April 11<sup>th</sup>, 2011, Iwaki region of Fukushima prefecture was jolted by Fukushima-Prefecture Hamadoori Earthquake. Surface ruptures were observed along causative Idosawa and Yunotake normal faults. In addition to numerous small slope failures, a coherent landslide and building structures of Tabito Junior High School, bisected by Idosawa Fault, were found along the causative faults. A precise digital elevation model of the coherent landslide was obtained through the ground and air-born LiDAR surveys. The measurements of perimeters of the gymnasium building and the swimming pool of Tabito Junior High School have shown that ground undergoes a slow and steady/continual deformation.

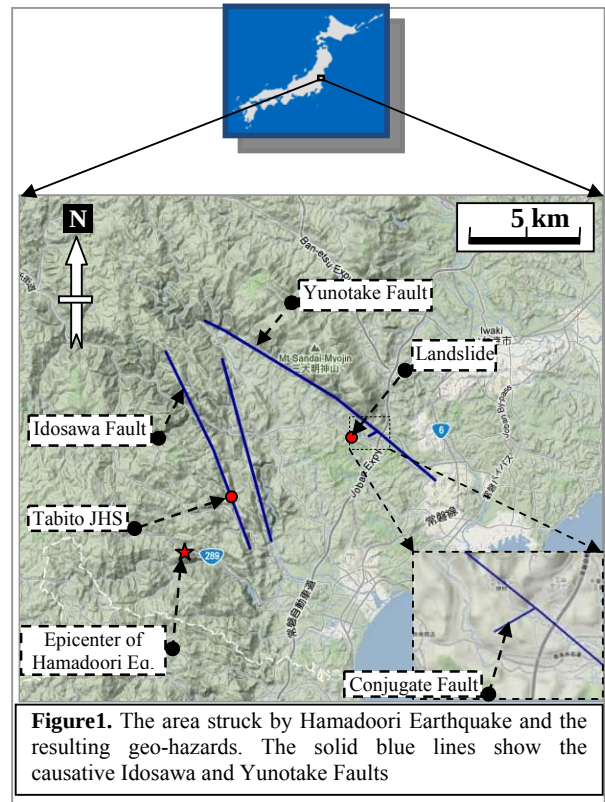
The focal mechanism of this earthquake was a normal-fault type with the tensional axis oriented in west-southwest to east-northeast direction and was a shallow crustal earthquake. This area had been seismically inactive until the Great East Japan Earthquake, but frequent seismic events of the normal fault type have been reported since then. In the Hamadoori Earthquake, surface fault ruptures appeared along the recognized traces of Idosawa and Yunotake Faults (Figure 1)

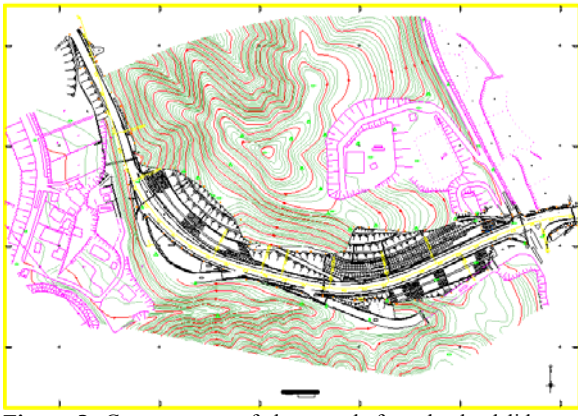
The landslide, mentioned above, was one of the most catastrophic failures caused by this earthquake. The soil mass moved coherently down the slope, burying the road which was constructed by cutting the toe of natural slope (Figure 2 and 3). One person, whose vehicle happened to pass by, was found dead in the landslide mass.

**Figure 2.** Contour map of the area before the landslide was triggered. (Figure provided by Fukushima Prefecture).

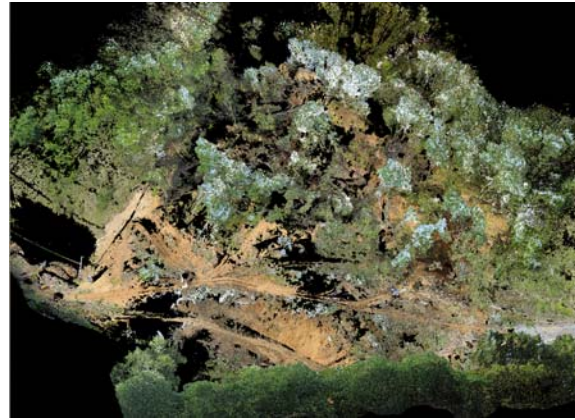
Knowing the importance of that road, a new/temporary road was planned to be constructed over the landslide mass. It was, therefore, important to monitor the gradual movement of the landslide mass, given the current landform configuration as reference. Large scale tension cracks were observed along the top of the landslide mass which indicated a possibility that the landslide mass would move especially during the rainy season. For this, the authors conducted a LiDAR survey on May 18<sup>th</sup> to obtain a precise digital elevation model (DEM hereafter). The obtained DEM (Figure 4) covered only an upper middle to toe parts of the landslide mass because we had a narrow view of the landslide mass through thick vegetation covering it. Later on it turned out that one more image from an air-born LiDAR was obtained by Aero Asahi Co. for the upper half of the landslide mass, and the image was combined with what obtained from our field survey (Figure 5).

**Figure 4.** Landform of the lower half of the landslide mass obtained by ground LiDAR survey

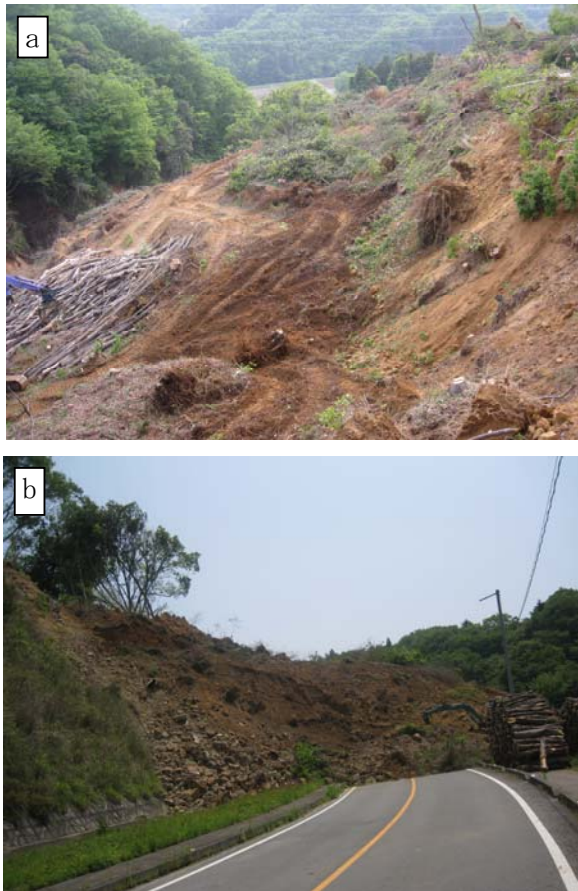
**Figure 3.** A view of the landslide from a) right and b) left ( $37^{\circ}00'00.3''$ ,  $140^{\circ}47'14.5''$ ).

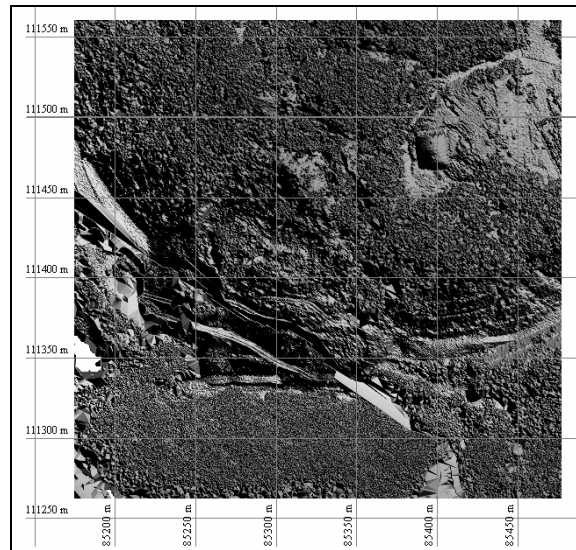
**Figure 5.** Precise Digital Elevation Model (DEM) of the whole landslide area obtained by combining the ground and air-born LiDAR survey data

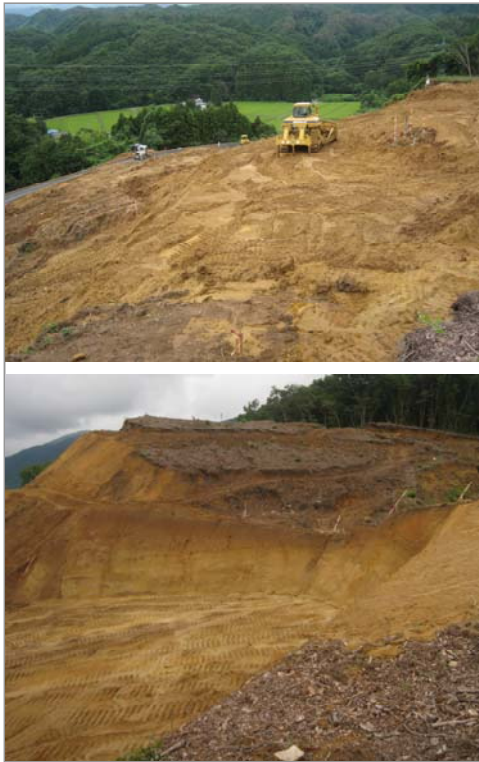
After the authors' LIDAR survey, the landscape was dramatically changed for the construction of temporary road (Figure 6). Earth cut and fill operations were done in such a way that the road would be constructed directly on the landslide mass without deeply cutting it, thus the greater toe part of the landslide mass would remain as it is for better stabilization of the soil mass.

**Figure 6.** The landslide mass is re-profiled to an apparent stable configuration for the purpose of road construction. Huge tension cracks (lower photo) are present along the top, showing the deep seated slip planes.

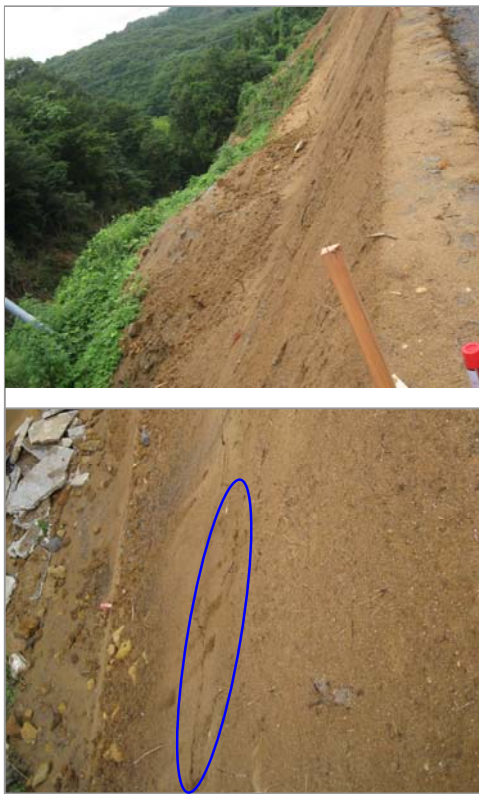
However a careful and continuous eye is to be kept on it because of the disturbed landslide mass as well as the fill for the temporary road is not completely consolidated (Figure 7) and there surely exists a deep-seated slip surface.

**Figure 7.** Embankment of the road constructed on the landslide mass (upper photo). Small scale cracks were observed near the base of embankment even during construction (lower photo).

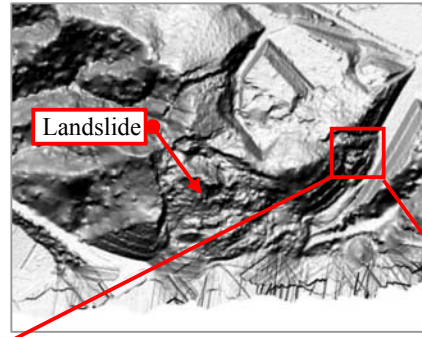
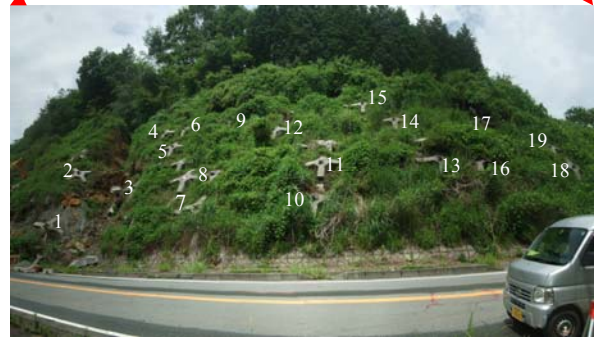
A natural slope immediately right to the current landslide reportedly started to move slowly immediately after the road was constructed across this area. Therefore the slope was intensively tied back with pre-stressed anchors.

During the above mentioned earthquake, this slope was also disturbed significantly, being dragged by the adjacent major landslide mass. During the last survey on June 23, the positions of ground anchors were also measured to monitor gradual slippage of this slope (Figure 8).

**Figure 8.** A disturbed natural slope adjacent to landslide mass. The numbers for the ground anchors were marked for the reference to be used in future.

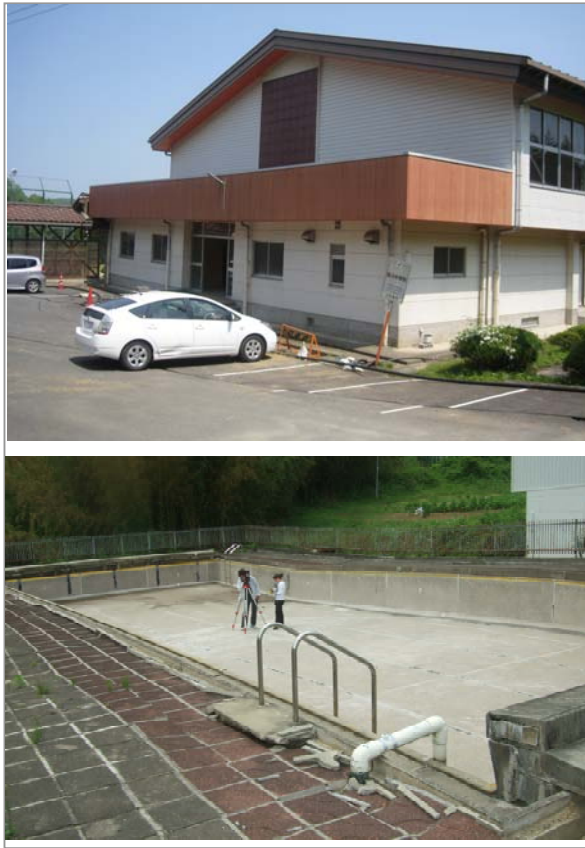
On the southern extension of Idosawa Fault, there is Tabito Junior High School whose gymnasium building and swimming pool, immediately next to each other, were resting on a fill exactly above Idosawa Fault. As shown in figure 9, the structures were deformed and tilted to unserviceable condition and large scale open cracks were observed along their peripheries.

**Figure 9.** Idosawa Fault passing exactly under the gymnasium building (upper photo) and swimming pool (lower photo) of Tabito Junior High School, tilting and deforming the structures ( $36^{\circ}57'52.2''$ ,  $140^{\circ}42'10.0''$ )

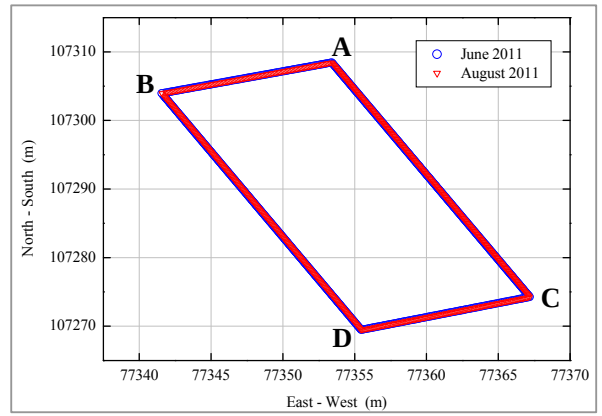
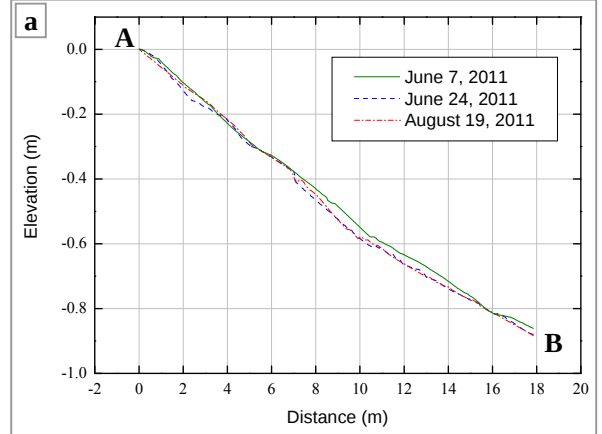
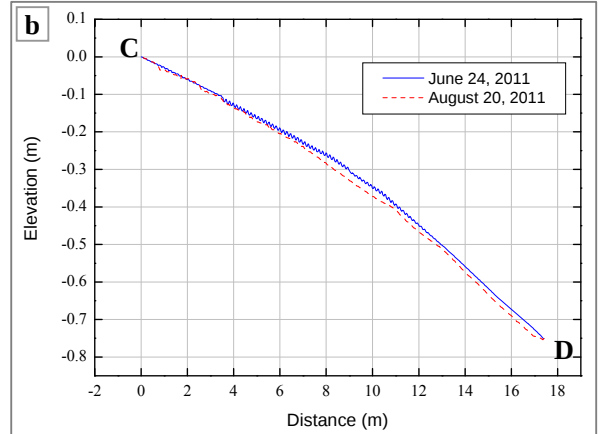
Perimeters of both the structures were laser scanned on June 7<sup>th</sup>, 24<sup>th</sup> and August 20<sup>th</sup> to observe the continual ground deformation. Swimming pool was small and visible enough to be scanned from a single scanner position while for the gymnasium building, four scanner positions were required to scan the complete periphery. Although a single reference point (top of an antenna) was also measured from all the positions, the resolution of the tilt-meter was not so accurate in shooting the reference point at large dip angles to figure out the deformations all along the periphery of the gymnasium building. Therefore, the front and rear faces (AB and CD in figure 11, respectively) of the gymnasium building, perpendicular to the fault line, are considered only. Assuming that the hanging wall has not moved, elevations of all other points are determined setting the hanging wall elevation as a reference. On June 7<sup>th</sup>, only front face of the gymnasium building was measured. While comparing it with that measured on June 24<sup>th</sup>, it is found that the footwall side has sunk down by about 3~4cm (Figure 10a).

Similarly, comparing the measurements of June 24<sup>th</sup> and August 20<sup>th</sup>, the front face does not show any change but the rear face shows that foot wall area has deformed by 2~3cm (Figure 10a and b). This suggests that ground had been undergoing a continuous/continual deformation; as one of teachers at this junior high school noticed that some cracks were getting wider slowly but steadily.

**Figure 10.** Continual deformation of the ground supporting gymnasium building of Tabito Junior High School from June 2011 to August 2011 a) face AB b) face CD

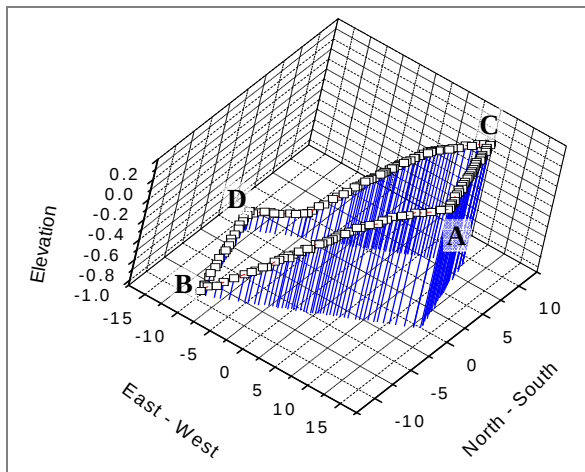
The swimming pool was deformed considerably by the fault dislocation (Figure 11). Following the same way as for the gymnasium building, change in elevation of the faces perpendicular to the fault line was determined. It is quite clear from figure 12 that the footwall side sunk down by almost the same amount as it was observed for gymnasium building.

**Figure 11.** The swimming pool of Tabito Junior High School deformed by fault dislocation (measured on June 24th, 2011)

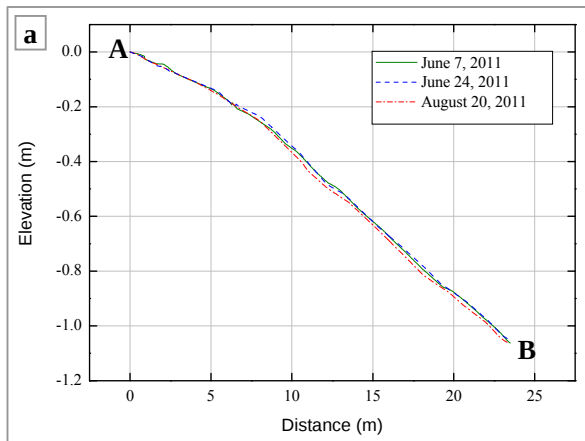
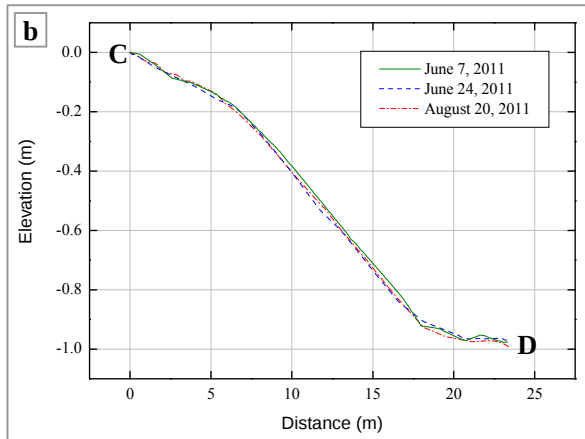
**Figure 12.** Continual deformation of the ground supporting swimming pool of the Tabito Junior High School a) AB face marked in figure 11 b) CD face marked in figure 11

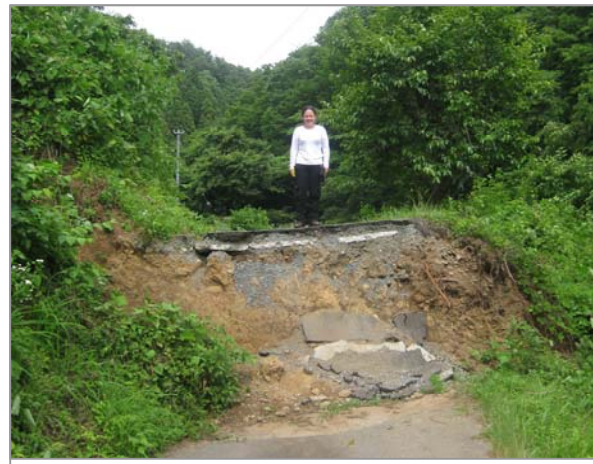
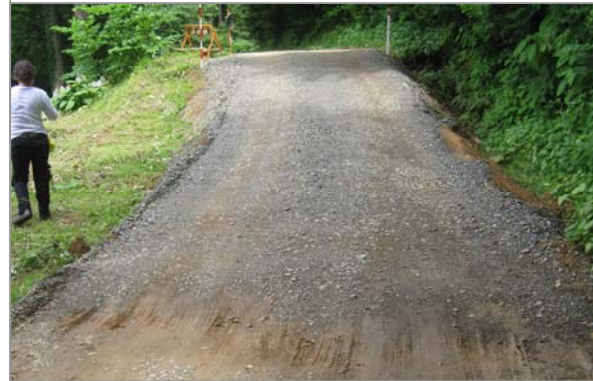
Though major hazards were found only along Yunotake Fault, Idosawa Fault was considered to be the most responsible for the April 11<sup>th</sup> Hamadoori Earthquake. Actually fault dislocations were in general larger along Idosawa Fault than those along Yunotake Fault (Figure 13)

**Figure 13.** Fault dislocations along Idosawa Fault. The road meandering around the mountain was bisected at a number of locations ( $36^{\circ}59'41.5''$ ,  $140^{\circ}41'12.8''$  (upper photo)  $36^{\circ}58'44.4''$ ,  $140^{\circ}41'42.4''$  (lower photo)).
