# ROAD BRIDGES IN MINAMI-SANRIKU WASHED AWAY IN THE MARCH 11<sup>th</sup> 2011 GREAT EAST JAPAN EARTHQUAKE AND TSUNAMI

Mary Roxanne I. AGLIPAY<sup>1</sup>, Kazuo KONAGAI<sup>2</sup>, Hiroyuki KYOKAWA<sup>3</sup> and Sharma KESHAB<sup>1</sup>

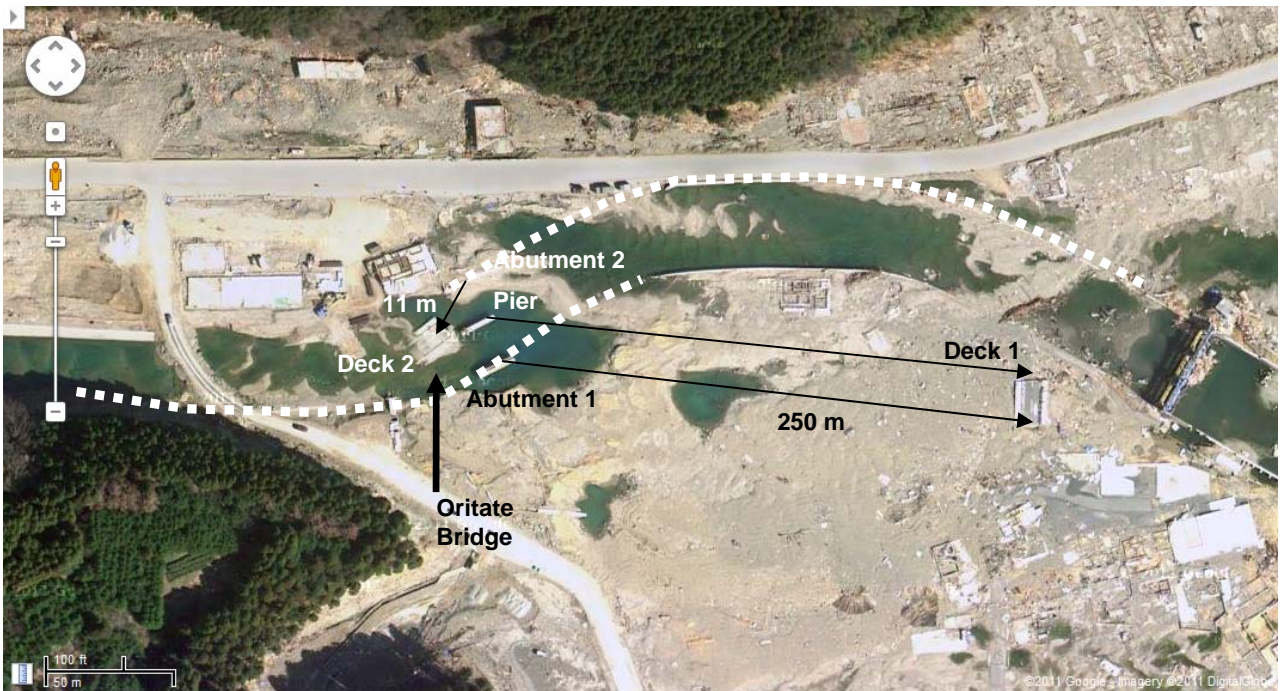
Figure 2 Oritate Bridge and tsunami engulfed Oritate area (imagery from Google map)

locations (see the pier and abutments in Figure 2, Location of pier: 38.647021, 141.437044). Deck No. 1 was seen approximately 250m east downstream of abutment 1 whose backfill had been scoured, while Deck No. 2 was seen approximately 11m west upstream of the abutment 2 (Figure 2).

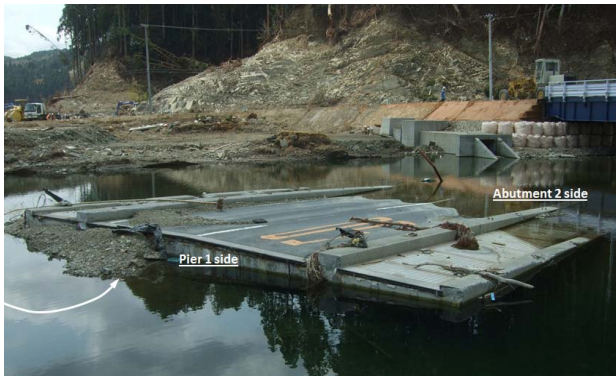
**Figure 4** Displaced Deck 2 of Oritate Bridge  
(Date & location: May 4<sup>th</sup>, 2011, 38.647134, 141.436868)

A possible scenario for the damage to the bridge is that when tsunami inundated the area, the strong wave was on the abutment 2 side as manifested by the gentle downward-curving river banks in northern part of the bridge. This centrifugal force had caused super-elevation of the water surface, and Deck No. 2 was carried approximately 11m west and upstream of the abutment No. 2 and was rotated

approximately 90 degrees counterclockwise (See **Figure 4**). This caused the dowel pins at the abutment No. 2 to bend towards the west/upstream side of the bridge (See **Figure 5**) while dowel pins at pier No. 1 toward the coastline (**Figure 6**).

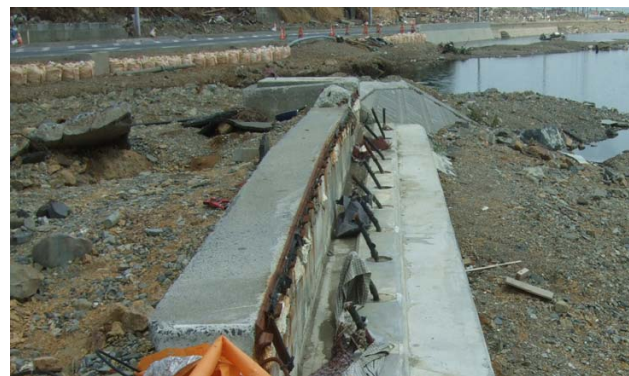
**Figure 5** Bent dowel pins at abutment 2  
(Date & location: May 4<sup>th</sup>, 2011, 38.647134, 141.436868)

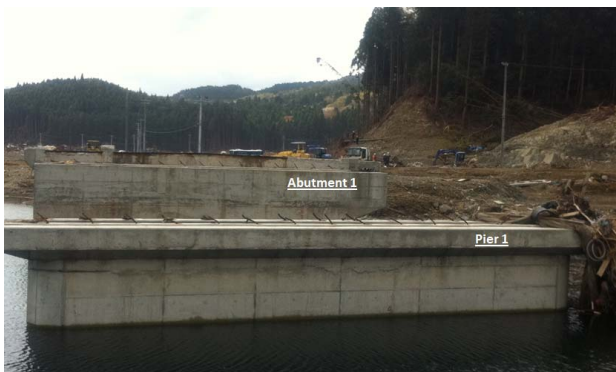
**Figure 6** Bent dowel pins at pier 1 and abutment 1  
(Date & location: May 4<sup>th</sup>, 2011, 38.647156, 141.436973)

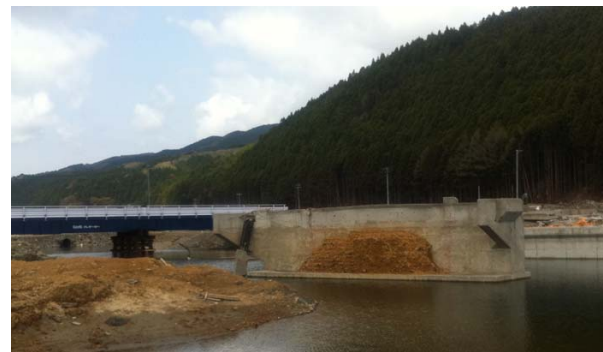
**Figure 7** Eroded backfill at abutment 1  
(Date & location: May 4<sup>th</sup>, 2011, 38.646771, 141.437469)

Not long after, the tsunami began surging back to the ocean; the flow was strong on the abutment No. 1 side, manifested by the upward-curving southern river bank. This flow, which scoured the backfill for the abutment No. 1 (See **Figure 7**), was strong enough to carry Deck No. 1 over an about 250m distance towards the coastline as manifested by the dowel pins all bent toward the coastline and heavily

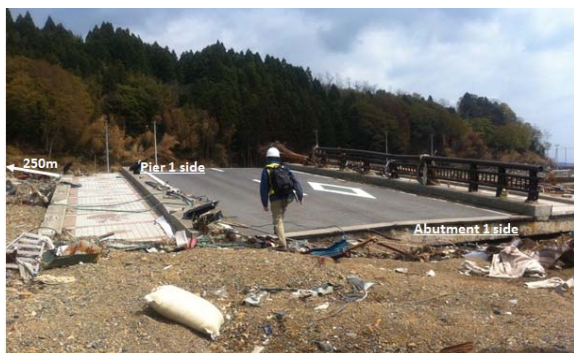
**Figure 8** Displaced Deck 1 of Oritate Bridge  
(Date & location: May 4<sup>th</sup>, 2011, 38.646589, 141.439437)

damaged pedestrian railing at the west side of the deck (See **Figures 8** and **9**).

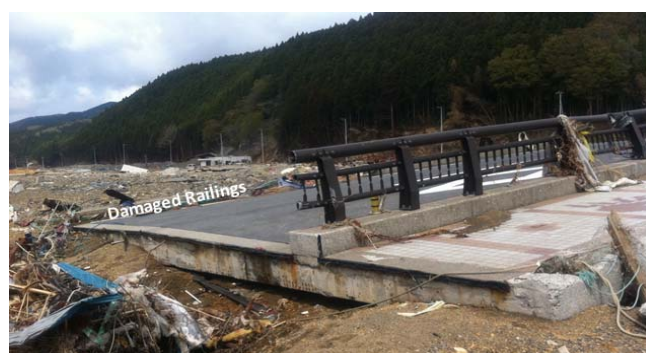
**Figure 9** Damaged railing at west side of span 1  
(Date & location: May 4<sup>th</sup>, 2011, 38.646611, 141.439671)

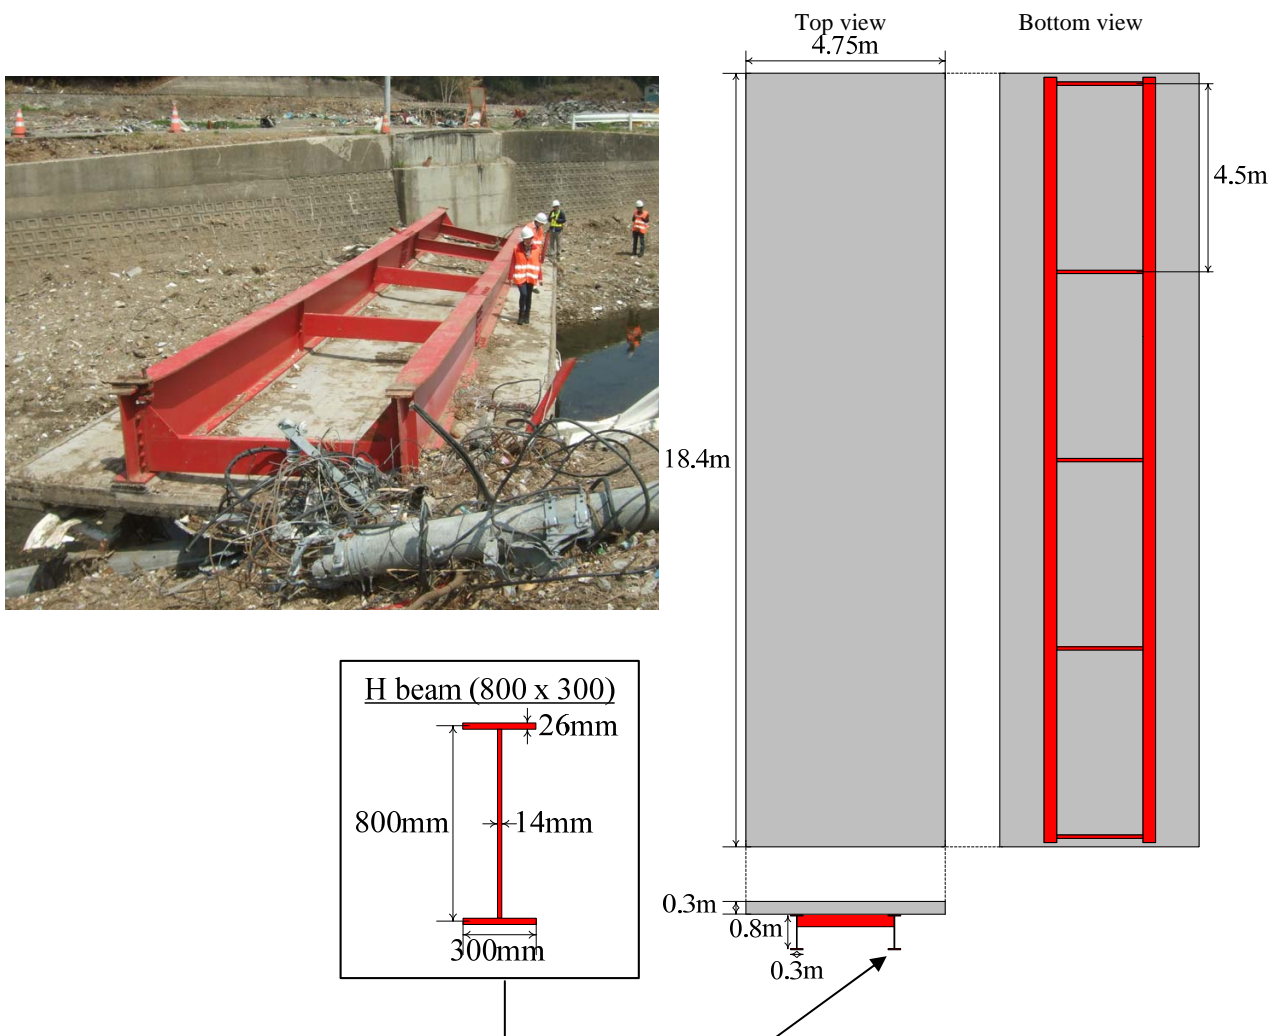
**Figure 10** Overturned Oganeyama Bridge and its configuration

Oganeyama Bridge, spanning a small stream of Oritate River at, 38.646808, 141.426649, was a single-span steel girder bridge, 18.4m long and 4.75m wide with RCC slab casted on two I-beams. The face plate of the bridge says that the construction of the bridge was completed in October, 1968, more than 40 years ago. The bridge was lying upside down and diagonally across the stream (See **Figure 10**).

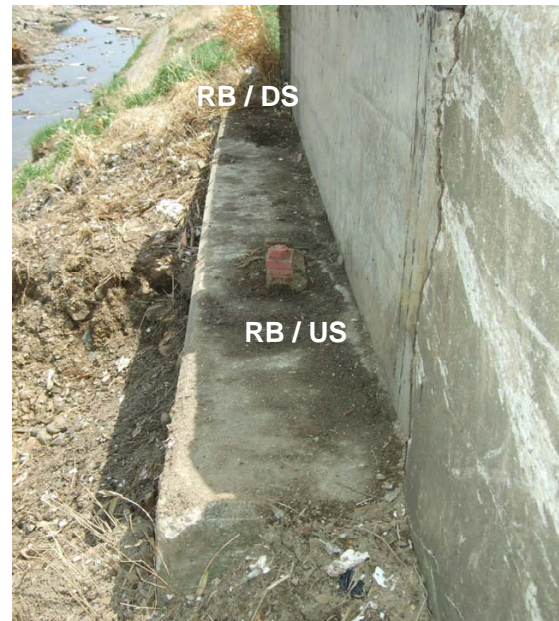
The rusty surface of the exposed bolt remaining on the lower flange of I-beam (RB/DS side) indicates that the friction between the anchor and the concrete had been loosened and deteriorated already. Therefore, it is deduced that the right end of the bridge (RB / DS) was detached first in the tsunami surge (**Figure 11**). Both the lateral drag from tsunami and buoyancy from the air instantaneously entrapped between two girders and

**Figure 11** Line bearings on the right abutment: A rusty bolt for the RB/DS bearing was remaining on the lower flange of I-beam indicating that the friction between the anchor and the concrete had been loosened already.

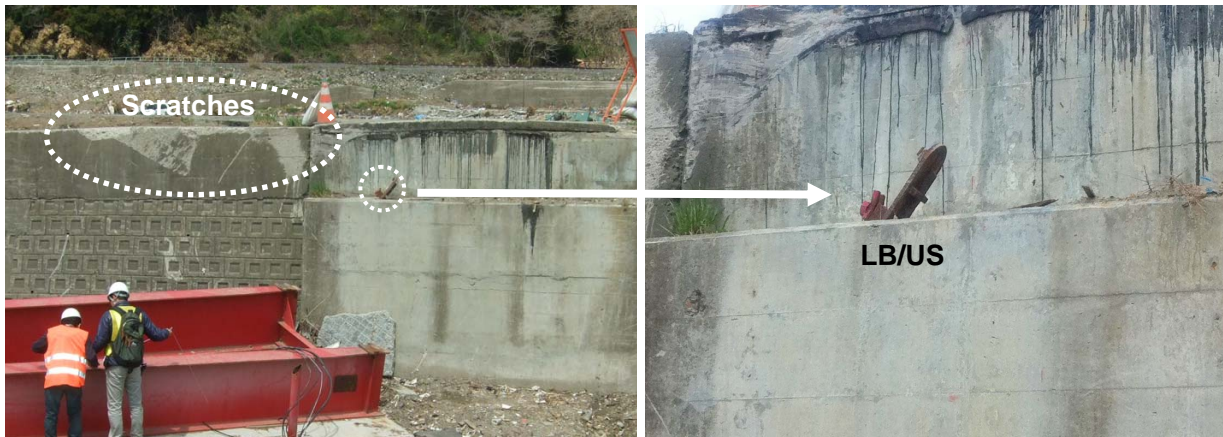
**Figure 12** Broken line bearing on the upper stream side of the left abutment (LB/US) and scratches remaining on the left river wall (Date & location: May 4<sup>th</sup>, 2011, 38.646726, 141.42659)

beneath the slab were probably large enough to break the thin pinching plate of the remaining line bearing on the upstream-right bank (RB / US) side. On the left bank (LB) side however, the bearing for the upstream side girder (LB / US) had gripped the lower flange until the right end of the bridge was carried about 15m upstream, and the entire bridge was turned over. In this movement of this bridge, the anchor bolt for LB / US bearing was pulled up and bent in an arc towards upstream, and finally the

LB / US bearing was ripped off causing the left end of the bridge to fall on the river bed leaving scratches on the left abutment (See **Figure 12**).

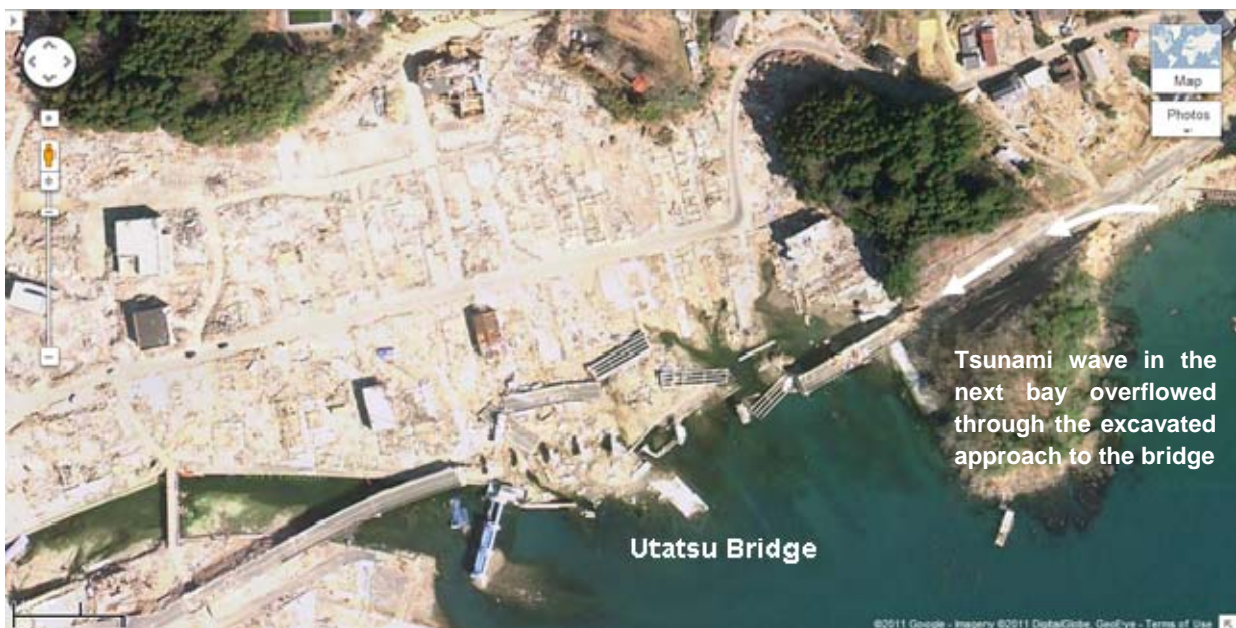
**Figure 14** Decks of Utatsu Bridge carried inland (Satellite imagery from Google Map)

decks over waters and 5 middle decks over land (**Figure 13**). The bridge was retrofitted in 2004 and 2005 in such a way that steel brackets were fixed to pier tops to be interlocked with main pre-stressed concrete beams of the bridge, thus confining the beams' transverse movements<sup>4, 5</sup>, and yet 8 decks of total 12 were found carried over several tens meters distances inland as shown in Figure 14. These steel brackets were remaining almost intact on pier tops except for the northernmost ones on the inland side (**Figure 14**). Some bridge decks were lying upside down showing all their lattices of main

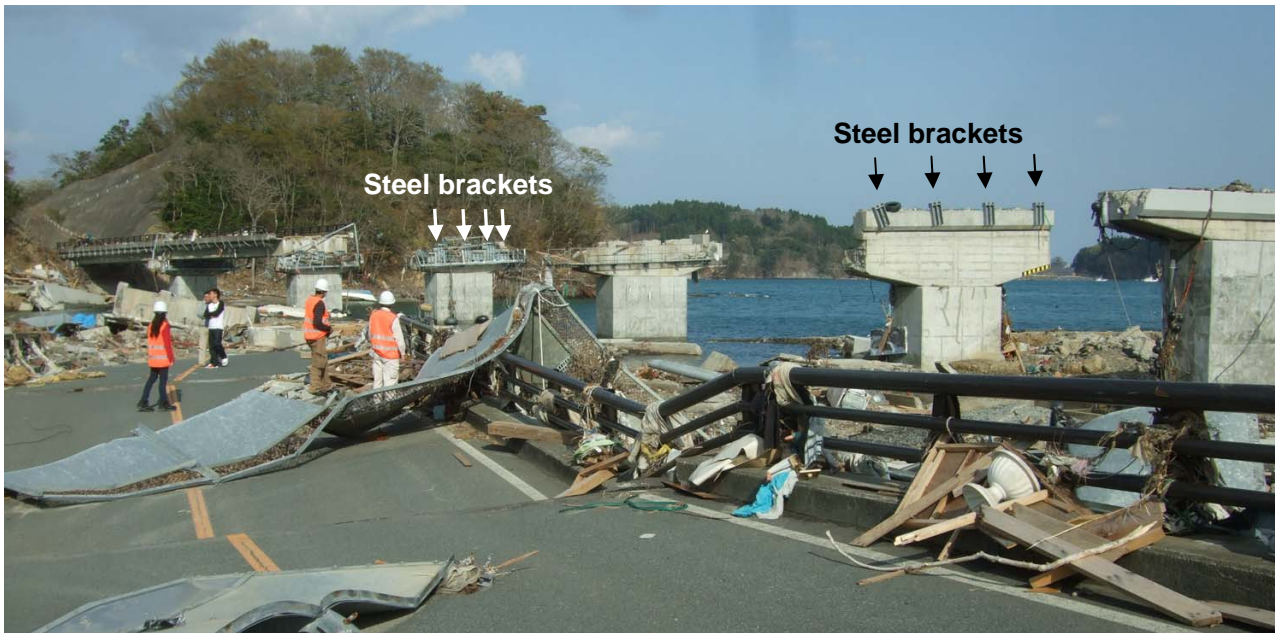
**Figure 15** Remaining piers with steel brackets (Date & location: May 4<sup>th</sup>, 2011, 38.716373, 141.522153)

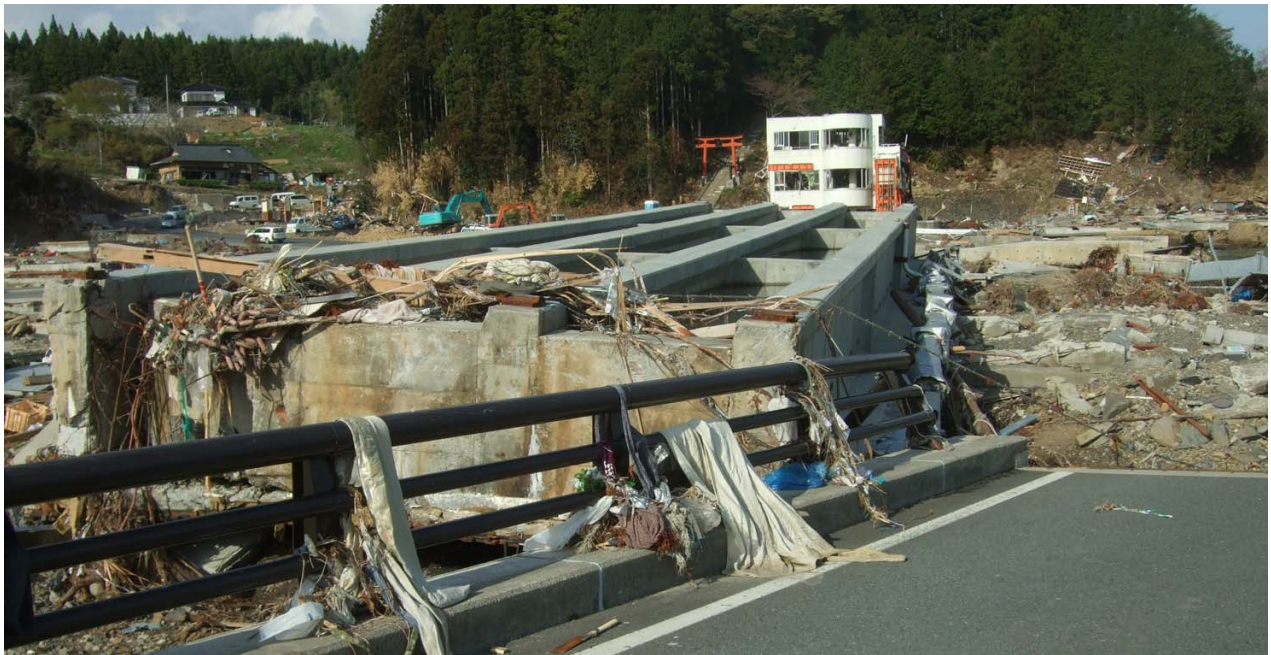
**Figure 16** Bridge deck lying upside down showing lattice work of beams  
(Date & location: May 4<sup>th</sup>, 2011, 38.716373, 141.522153)

and cross concrete beams about full of water (**Figure 15**). This fact indicated that the watertight lattices of main and cross concrete beams may have entrapped airs giving some remarkable buoyancy to bridge decks. The cross-section of the bridge deck shown in **Figure 16** indicates that the hollow volume among the lattice beams of about 223 m<sup>3</sup> is about 2.2 times as large as the entire volume of the bridge deck of 100 m<sup>3</sup>. Considering that the relative density of concrete is around 2.3, this volume of the hollow in the beam lattice may have been large enough for the weight of the deck to be almost
