Damage during the 2013 Awaji Island Earthquake in Sumoto Plain and Its Ground Motion Characteristics

Ratna TWAYANA¹, Shinichiro MORI², Yoshiya HATA³ and Masayuki YAMADA⁴

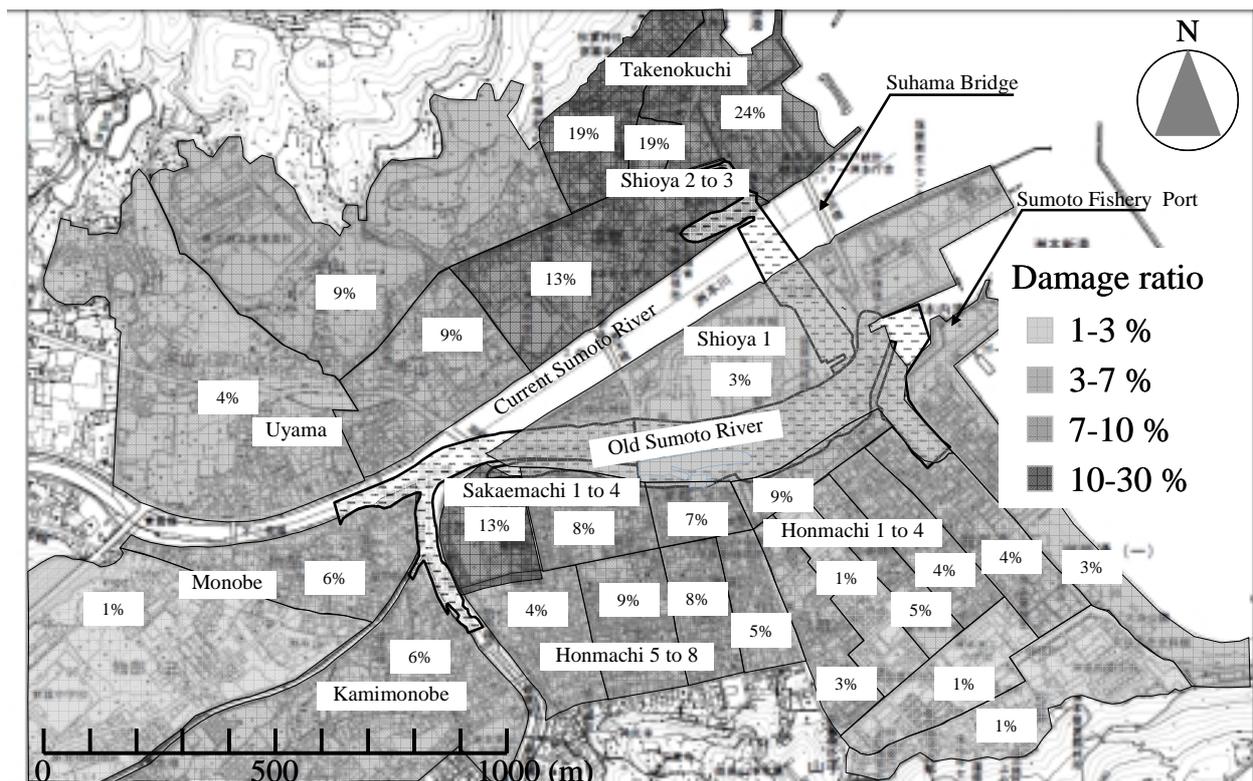
Fig.1 Damage distribution of wooden houses damaged by 2013 Awaji Island Earthquake in Sumoto City. Hatched portion indicates the flow direction of old Sumoto River until Meiji Era. The value in a box represents the damage ratio (in percentage) of damaged wooden houses at specific site.

The distribution of damaged houses in Sumoto City is shown in **Fig.1**. This map was prepared based on the damaged ratio of wooden houses at specific site. Damage ratio is the ratio of number of total number of damaged houses to the total number of houses at specific site. In this case, damage ratio was calculated for every town (known as chome in Japan) and damaged town were divided into four zones. Damage ratio with 1-3%, 3-7%, 7-10% and 10-30% were termed as highly sparsely damage zone, sparsely damage zone, moderately dense damage zone and densely damage zone respectively. At Ta-

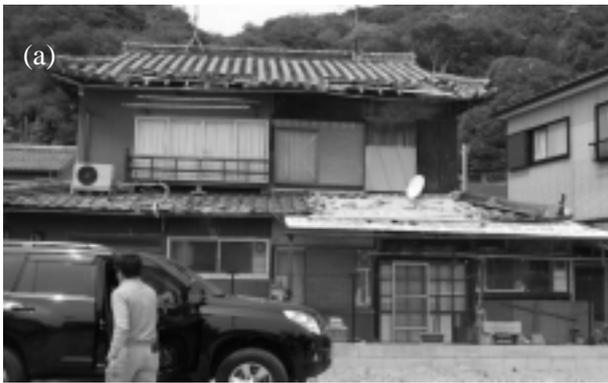
kenokuchi town, the roofs of wooden houses were heavily damaged and number of damaged houses were concentrated within small area. The damage ratio of Takenokuchi town was highest among our surveyed area. The typical damage to the roofs of wooden houses in Takenokuchi 2-chome are shown in **Fig.2(a)** to **Fig.2(c)**. It is supposed that Dabutsugawa River used to flow around the Takenokuchi area. The soft sediment of this river might have amplified the ground motion causing concentrated damages. During our survey, some minor damage to reinforced concrete (RC) building (**Fig.2 (d)**) were also observed in Takenokuchi 1-chome. A 1.4 mm width vertical cracks were noticed on the wall of two story RC building. Sakaemachi and Monobe towns were moderately dense damage zone where the number of damaged houses was in the range of 10-20. The old Sumoto River, till Meiji period, used to flow in between Shioya 1-chome and Sakaemachi town as indicated in Fig.1. Thus it can be assumed that Sakaemachi town might be the flooding area of this river during raining seasons at ancient Meiji period. Thus layer of soft sediment deposits may be thick in this town and this might be major parameter for more damage in this zone. However, the damage ratio at Shioya 1-chome was low (only 3%) although

Fig.2 (a) Damage to the roofs and broken tiles of two story wooden house at Takenokuchi 2-chome.

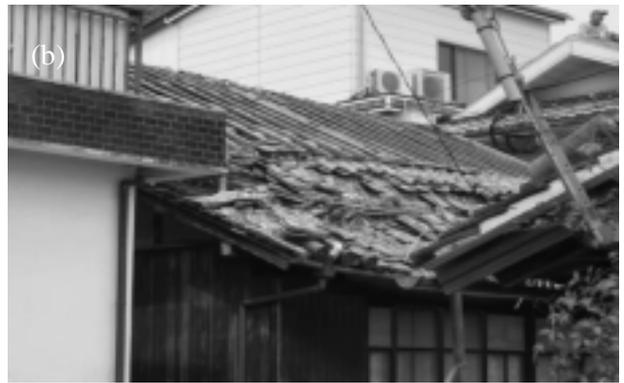
Fig.2 (b) Sliding of roof tiles of one story wooden house with no breakage of window glass.

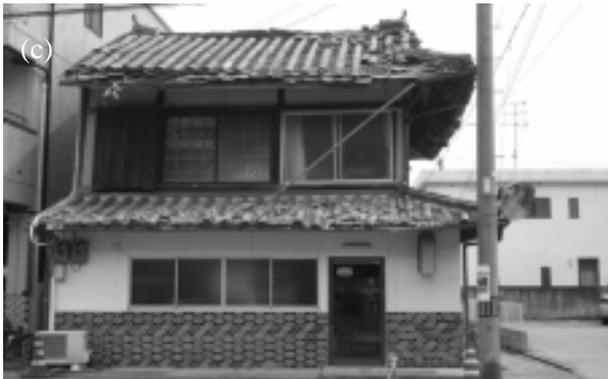
Fig.2 (c) Large deformation of the roofs and second story frame of a two story wooden house at Takenokuchi 2-chome.

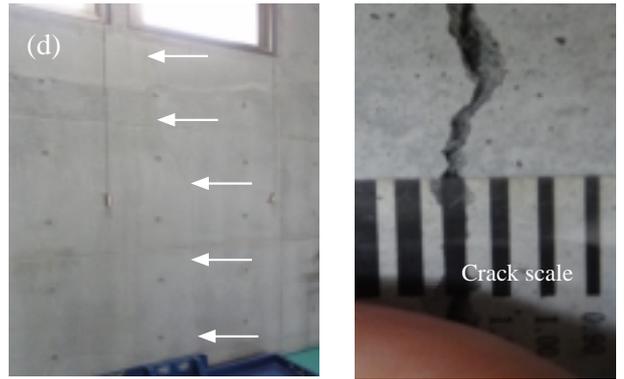
Fig.2 (d) Vertical cracks (1.4 mm width) on the wall of reinforced concrete building at Takenokuchi 1-chome.

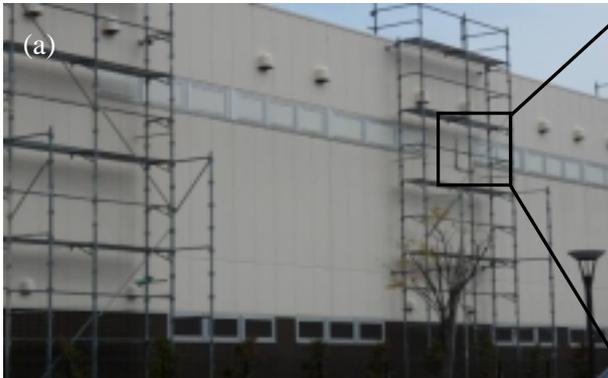
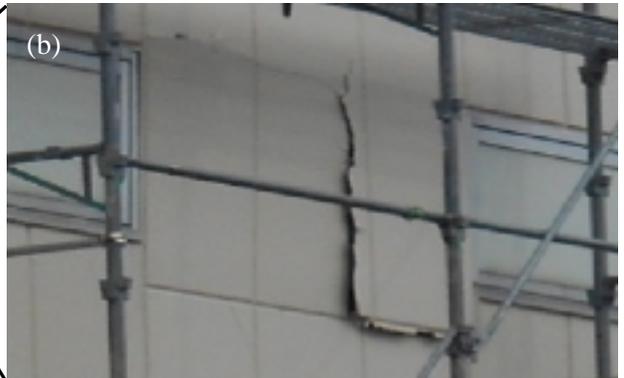
Fig.3 Slight damage to the exterior wall of a shopping center at Shioya 1-chome; (a) View of damaged exterior wall made of ALC panel; (b) out-of-plane deformation of ALC panel.

this area is reclaimed area. In this town, wooden houses were less and newly constructed reinforced concrete building were made earthquake resistant which resulted in less damage. A shopping center constructed over the reclaimed land on the old Sumoto River was slightly damaged as shown in Fig.3. The exterior wall made of ALC panels (autoclaved

lightweight aerated concrete panel) deformed out-of-plane due to earthquake motion.

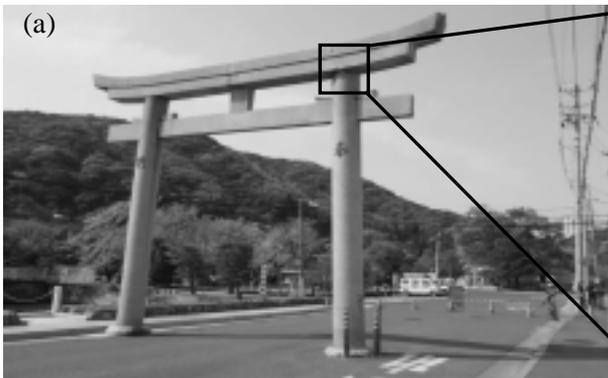
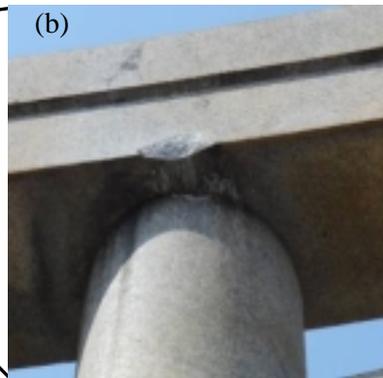
Fig.4 Earthquake damage to the first gate of Sumoto Hachiman Shrine; (a) Front view of gate; (b) Focused damaged portion; (c) Side view of gate showing sliding of horizontal member.

where only two wooden houses were damaged while this ratio was around 9% at Honmachi 7-chome and 8-chome. The first gate of Sumoto Hachiman shrine was damaged due to sliding and rocking of upper horizontal members supported by two columns during main shock as shown in Fig.4. In general, it can be said that area at the left bank side of current Sumoto River and areas where old Sumoto River used to flow were highly damaged. The soft sediment deposits might have amplified the ground motion during earthquake causing concentrated damage in these areas.

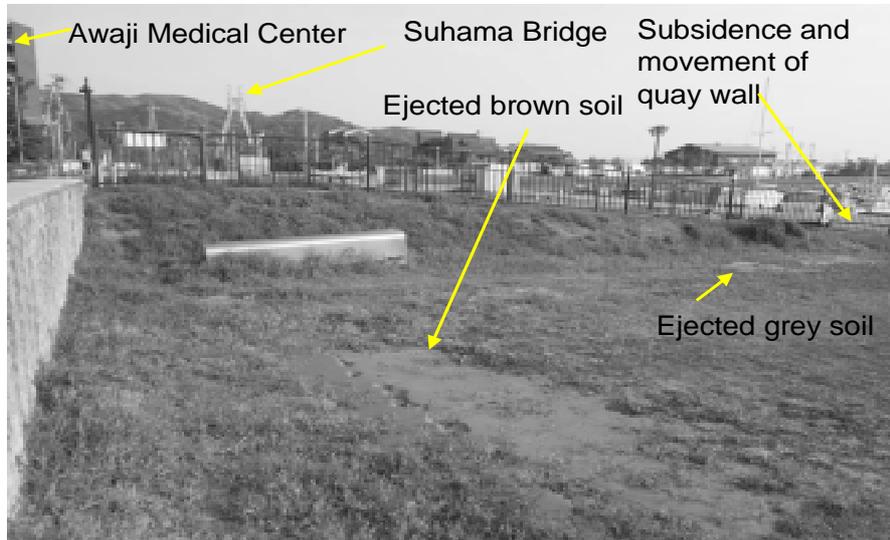
Fig.5 Liquefaction and liquefaction induced damage observed at Sumoto Fishery Port.

Liquefaction is considered as a common damage of an earthquake in the reclaimed areas when the intensity of the earthquake exceed 5. Some areas around Sumoto Fishery Port near to Awaji Medical Center were liquefied as indicated in Fig.5. Brown and grey soils were ejected, creating fissures in the ground parallel to the quay wall (Fig.6). Subsidence of ground behind quay wall was 13 cm due to liquefied soil eruption (Fig.7). Cracks due to differential settlement on an asphalt pavement were also noticed at the parking area of Sumoto pumping building.

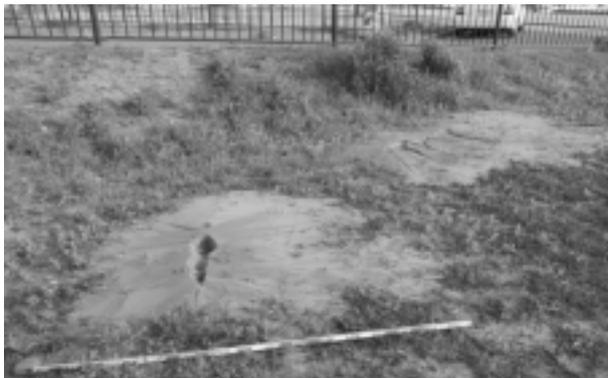
Fig.6 Liquefied grey soil creating fissures parallel to the quay wall.

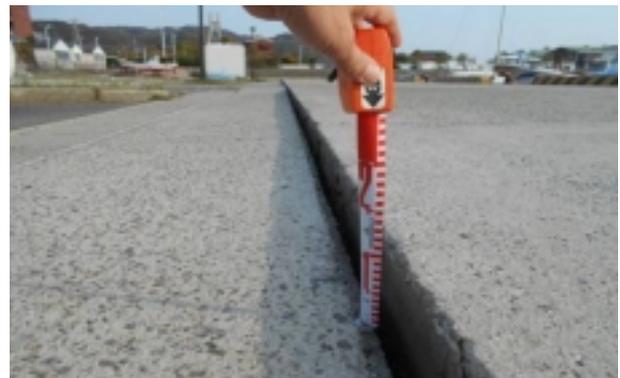
Fig.7 Subsidence of ground behind the quay wall and movement of quay wall toward sea

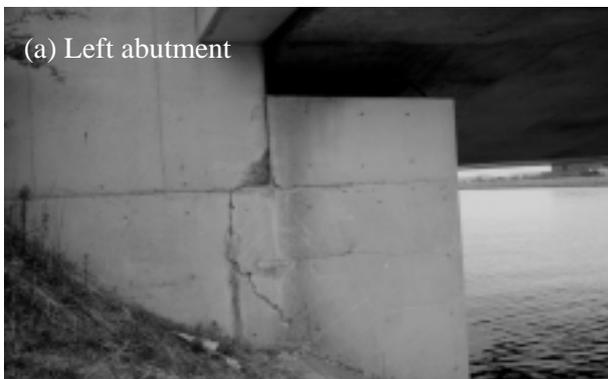
(a) Left abutment

Fig.8 Earthquake damage to the abutments of Suhama Bridge; (a) Cracks on the left abutment; (b) Cracks on the right abutment.

cracks on both abutments of this bridge was observed (Fig.8). The cracks were concentrated on abutments and no major crack and damage was observed in the bridge girder. The coupled interaction between bridge girder, stopper and abutment due to earthquake motion could be possible cause of shear cracks in the abutments. The failure mechanism of this bridge was discussed by Mori et al³⁾.

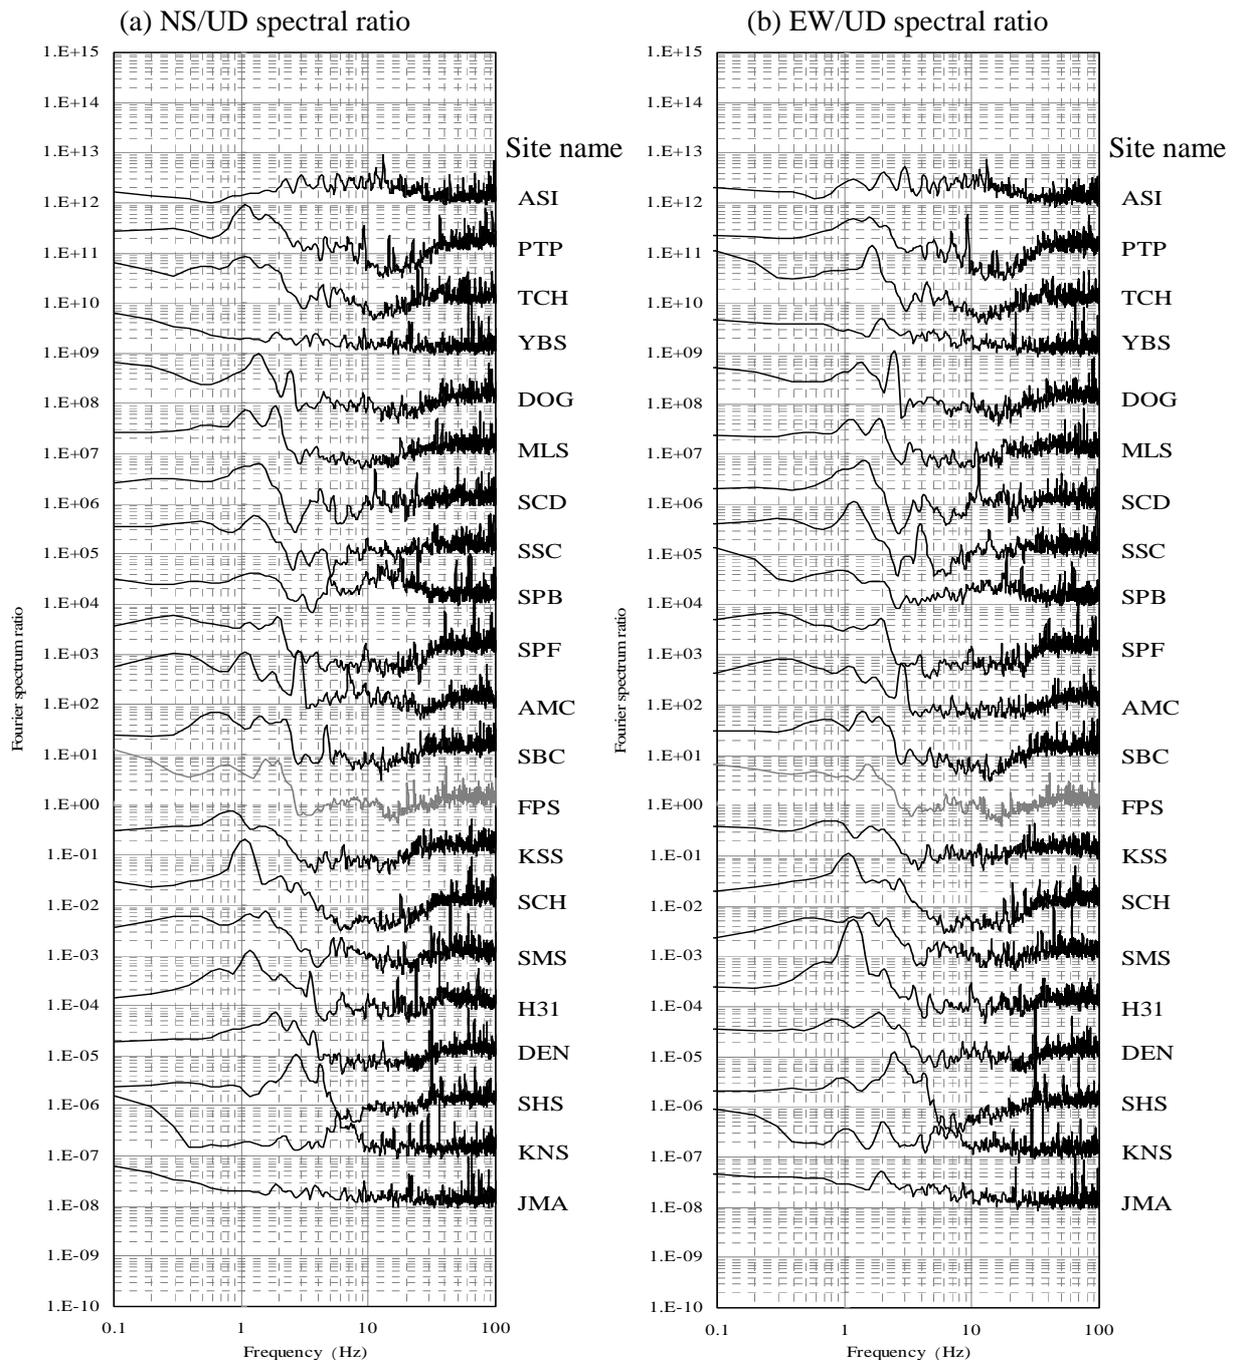
Fig.10 Fourier spectral ratio of microtremor measurement points along the Sumoto plain; (a) NS/UD spectral ratio; (b) EW/UD spectral ratio.

The Fourier spectral ratio of representative 21 sites was shown in Fig.10. For an easy understanding about predominant frequency of sites, the Fourier spectral ratio were arranged in single vertical column from JMA Sumoto Station (JMA) to Akiba Shrine (ASI). As stated earlier, the JMA site is starting point, a south edge of Sumoto plain and ASI site is ending point, a north edge of Sumoto plain. Thus spectral ratios from south edge to north edge of sumoto plain were arranged from bottom to top (Fig.10). The Fourier amplitude were multiplied by the integer of 10 to avoid the overlapping of spectral ratio. Thus the amplitude shown in Fig.10 has no any physical meaning. It should be noted that multiplication factor for FPS site (grey) is 1. Two sites JMA (south edge) and ASI (north edge) sites were over hard rocks. Thus spectral ratio of these sites shows the smaller peaks at higher frequencies. In contrast to

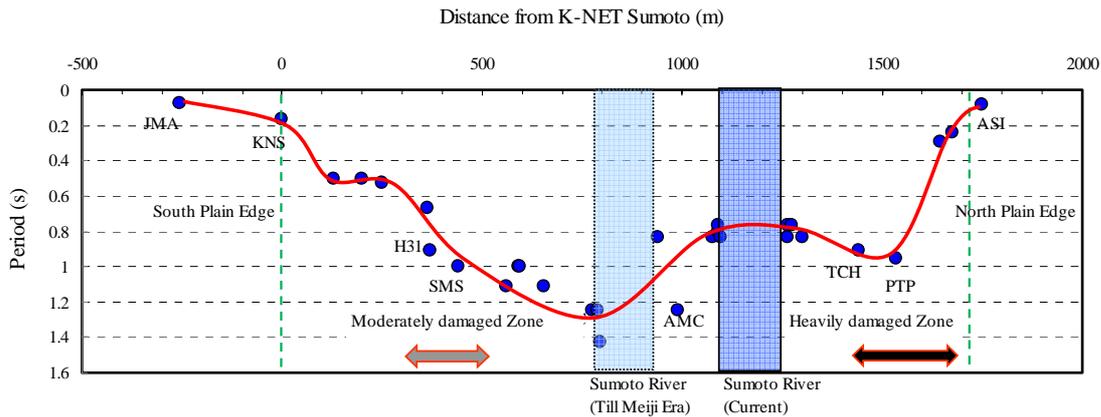
Fig.11 Distribution of predominant period at North-South profile of Sumoto plain.

these two sites, other sites are located on the sediment deposits. Fig.11 shows the variation of predominant periods along the cross-section of Sumoto plain, where abscissa represents orthogonal distance projected on the line joining the JMA (south edge) and ASI (north edge) sites and the ordinate represents the predominant periods obtained from Fourier spectral ratio. The predominant period become longer as sites are close to Sumoto River. There is increase of predominant periods from south edge to south bank of Sumoto river from 0.5 seconds to 1.25 seconds. The longer period on SBC and AMC sites was observed. These sites are located over old Sumoto river where thickness of soft sediment deposits may be high. The predominant period at Honmachi town was around 0.5 s-1.0 s. The predominant period around Sakaemachi was around 1.0 s-1.25 s. The old Sumoto river used to flow around Sakaemachi and it can be assumed that this town might be the flooding area of old Sumoto River. Thus thickness of soft sediment may be high causing longer period around this area. The Predominant period of ground adjacent to both abutment of Suhama bridge was around 0.8 s-0.9 s while the predominant periods at Takenokuchi town was around 0.2 s-0.3 s. Takenokuchi town represents the heavily damaged zones. The abrupt change in predominant period from 0.8 s to 0.3 s might influence on the concentrated damages in northern side of Sumoto Plain (around Takenokuchi area).
