# Situation of damage in and around Kathmandu Valley due to the 2015 Gorkha Nepal Earthquake

**Key Words :** Kathmandu Valley, damage estimation, scenario earthquake, building structure

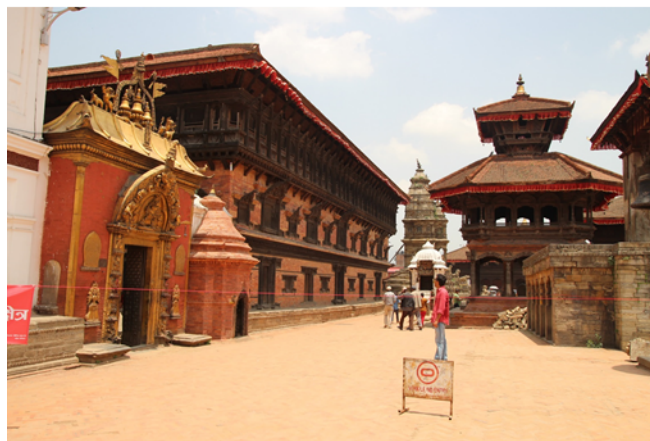
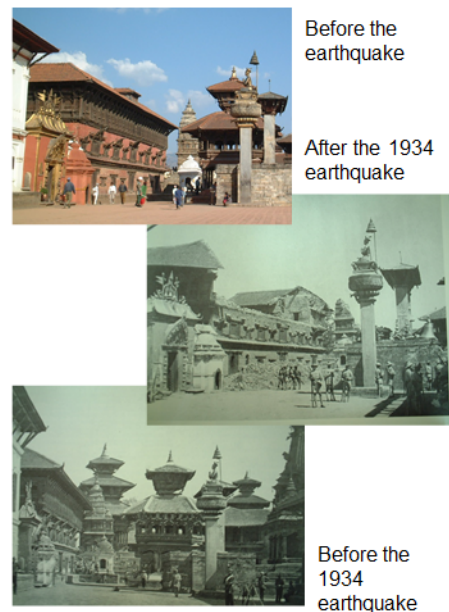
“*Bhakta*” means Devotee in Sanskrit, and “*pur*” means city. Thus, “*Bhaktapur*” is the city of devotees. The center areas of these palaces are called “*Durbar Square*”. Bhaktapur’s Durbar Square is a conglomeration of pagodas and many of Sikhara style temples in Bhaktapur’s Durbar Square were

severely damaged (**Fig.3.1**).

**Fig.3.1** Bhaktapur before / after the earthquake (Photo. by T. Ohsumi), before / after the 1934 earthquake in Bhaktapur (Courtesy of MoHA)

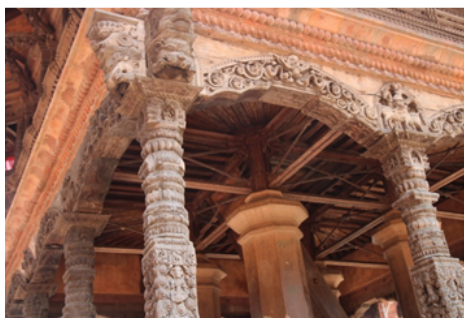
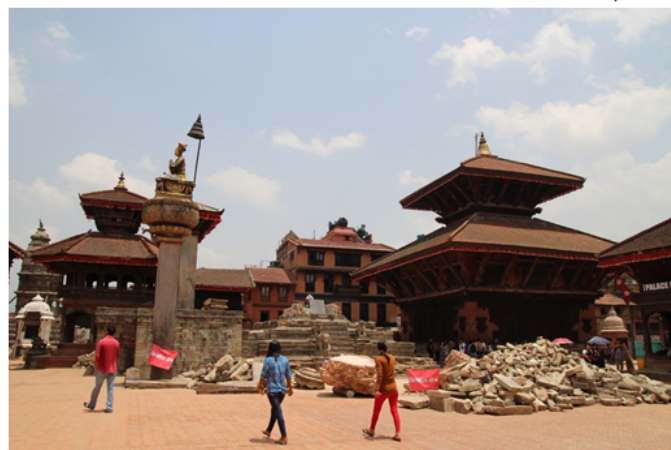
The steel frame reinforced Chayslin Duga temple (**Fig. 3.2a**). This temple was not damaged. During the 1934 earthquake Chyasilin Mandap was completely destroyed. The architects Götz Hagmüller and Niels Gutschow set about rebuilding this temple using metal reinforcements via GTZ funding. The Vatsala temple (**Fig. 3.2b**: center and **Fig. 3.2c**), which is a Newar style temple, was established ca. A.D. 1690, but destroyed. Yaksheshvara temple (**Fig. 3.2b**: right) survived.

**Fig.3.2** Reinforced Chayslin Duga temple (a and b: left) by steel frame, Vatsala temple (b:center and c) was destroyed and Yaksheshvara temple (b:right) survived, before / after 2015 earthquake in Bhaktapur (Photo. by T. Ohsumi).

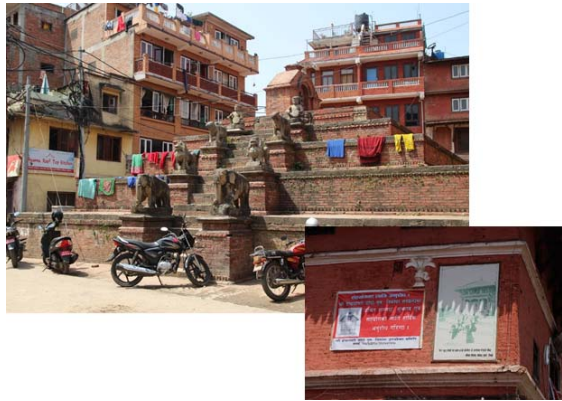
One of the temples in Bhaktapur collapsed in the 1934 earthquake, and has not been rebuilt (**Fig. 3.3**). If the reconstruction of historical buildings that have been lost during earthquakes does not proceed, this will be a major blow to future developments in Nepal's tourism-oriented country.

**Fig.3.3** This temple in Bhaktapur collapsed in 1934 earthquake, but has not been rebuilt (Photo. by T. Ohsu-mi).

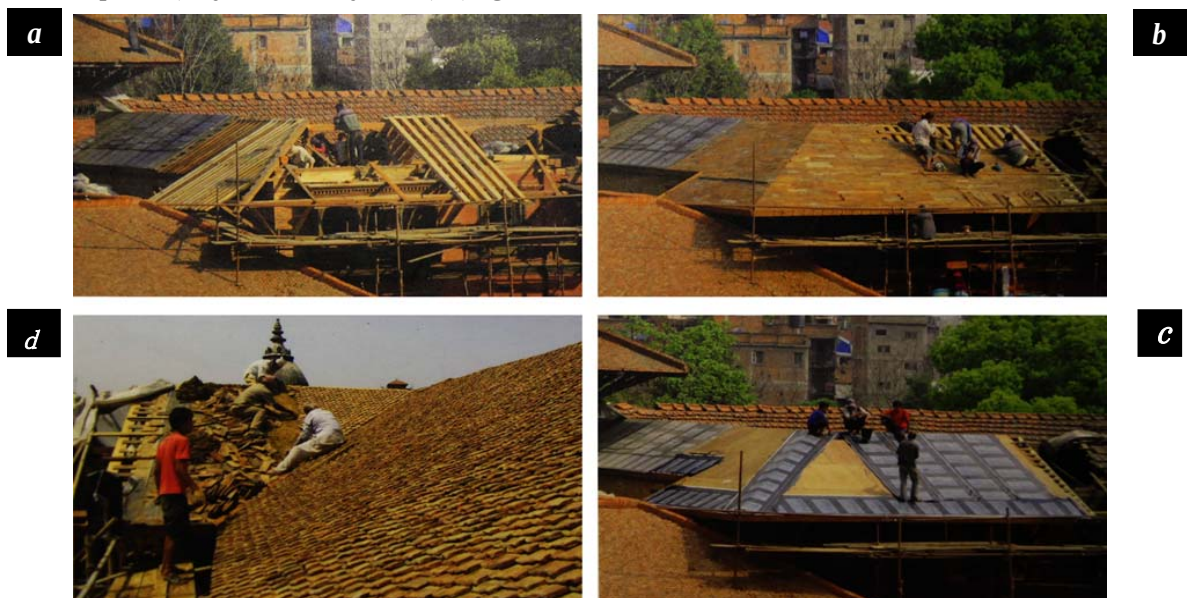
**Fig3.4** Renovation of the structure and the cover of the roof was carried out in 2011.

a: top left Installation of timber rafters, b: hand wood planking, c: waterproof membrane, d: traditional terracotta roof tiles on a mud-bed (from Information plate of Patan Museum).

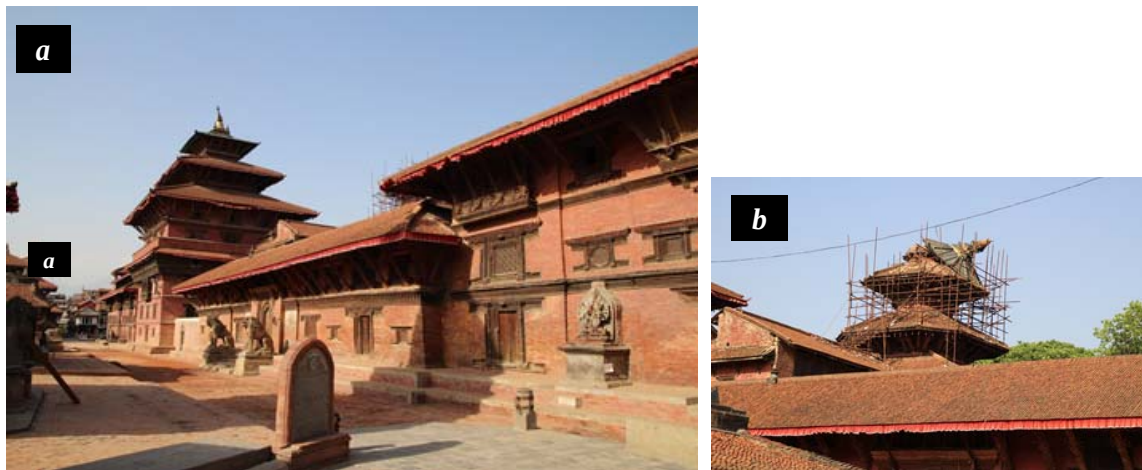
Patan is "*Lalitpur*" in Sanskrit, is called "*Yela*" in Newari, it means the city of beauty. The Patan palace was renovated with assistance from the Kathmandu Valley Preservation trust (KVPT) and the Sumitomo Foundation in 2013(**Fig. 3.4**). Thus, in Patan, after the earthquake, this place had only partial damage at top of structure parts (Gajur and Baymvah) (**Fig.**

**Fig3.5** In Patan, after the earthquake, this place (a) had partial damage at top of structure parts (Gajur and Baymvah) (b) (Photo. by T. Ohsumi).

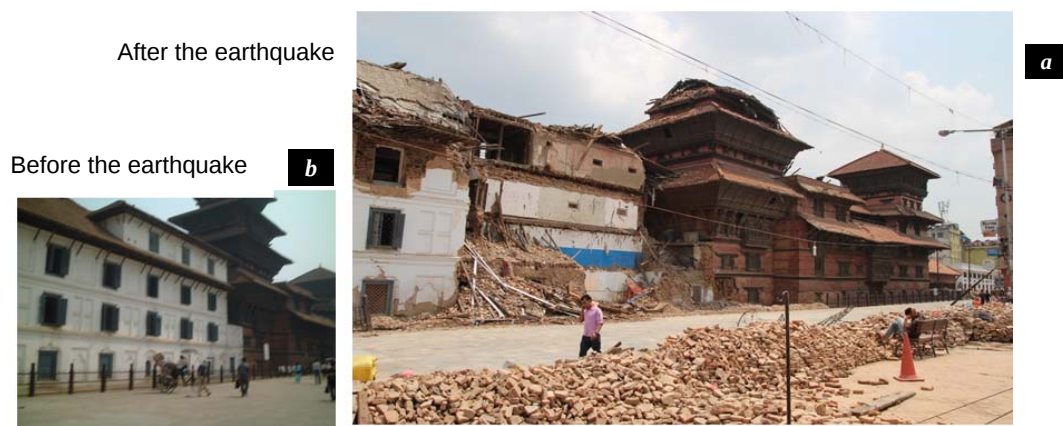
The old palace structures in Kathmandu's Durbar Square, which had not undergone renovations, had severe damage during the earthquakes (**Fig. 3.6**). In the photo on the left, the white structure is about 150 years old, built during the Rana Dynasty. In the photo on the right side, the four-tiered brown temple is about 300 years old, constructed during the Gorkha Dynasty.

**Fig.3.6** Kathmandu Durbar Square after the earthquake (a), before the earthquake (b) (Photo. by T. Ohsumi)

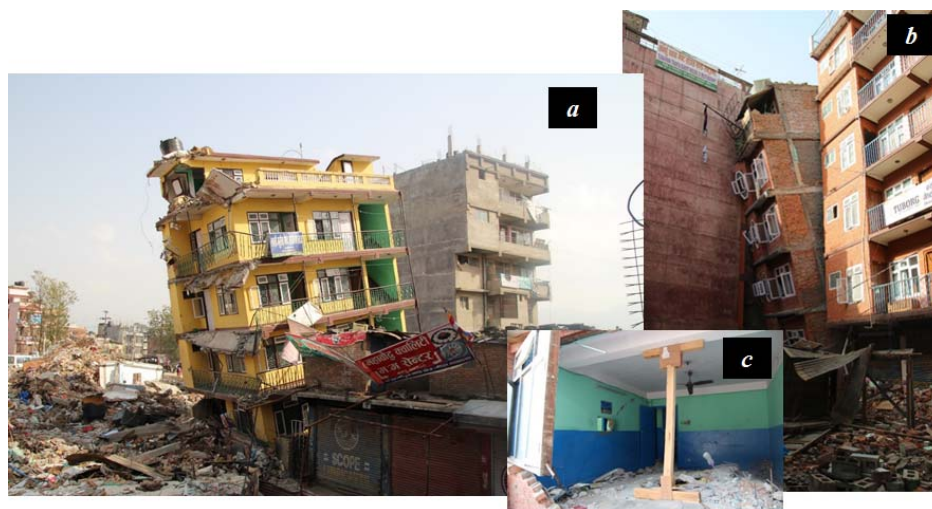
At places along the Kathmandu Ring Road, reinforced concrete (RC) frame buildings were damaged by tilting; however, most of the building damage in the city occurred in masonry buildings. At Gongabu, northwest of the Ring Road, many RC buildings were damaged; most of these were four to seven story structures or soft storied buildings. The damage was sometimes greater at locations with soft ground such as deltaic deposit near river branches (**Fig. 3.7**); however, some damage was also likely to have been caused by inappropriate construction methods. At Sitapaila, west of the Ring Road, some RC building collapsed at locations where the ground conditions on terraces were a bit stiff. At Balkhu, southwest of the Ring Road, RC frame buildings were tilted. This is near the confluence of the Bagmati and Balkhu rivers, where collapsed buildings fell onto and destroyed a neighboring building (**Fig. 3.8**). The ground conditions in Balkhu were soft because of the presence of riverbed sediments.

**Fig.3.7** At Gongabu, RC frame buildings were tilted (a,b). A shear crack in the first flower (c)

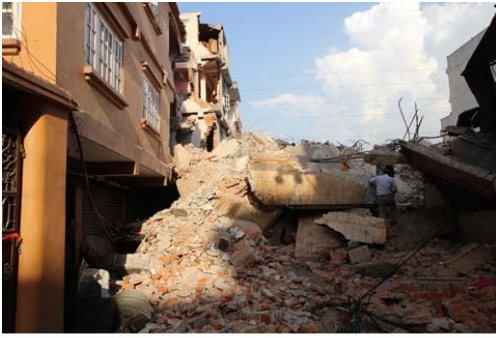
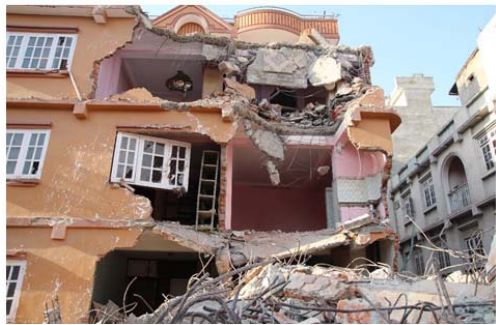
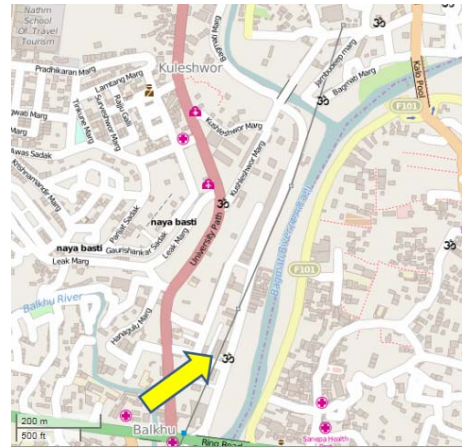
**Fig.3.18** At the branch point of the Bagmati River and the Transformer River, collapsed building fell onto and destroyed the next building (Photo. by T. Ohsumi).  
OpenStreetMap <https://www.openstreetmap.org/>

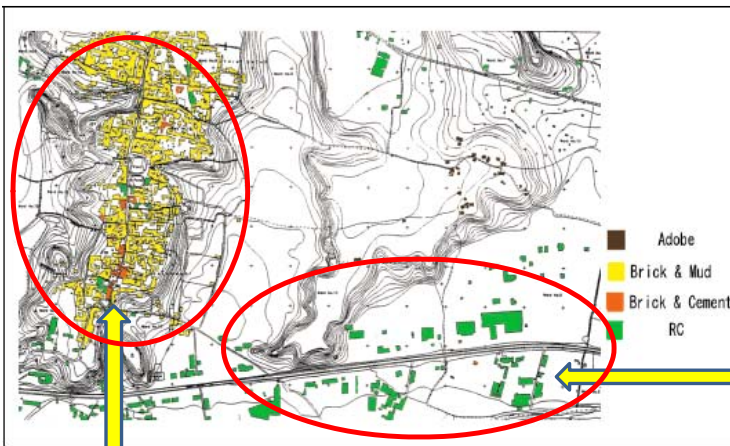
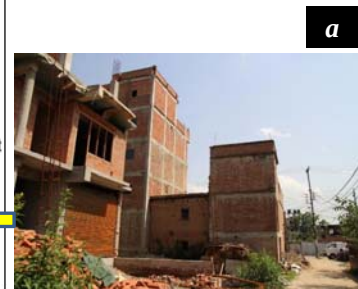
**Fig. 3.9:** The building type classification map in Thimi, Newer building area (a) and core area (b)  
(Photo. by T. Ohsumi)

In the JICA (2002) report, building types were classified for the whole Katmandu. The investigation was mainly based on visual observations (**Fig.3.9** upper). In newer building areas (**Fig.3.9 a**), the damage has been reduced in the building of the RC structures. The core area located on a small hill (**Fig.3.9 b**), the houses had been destroyed in 1934 rebuilt and again received severe damages .

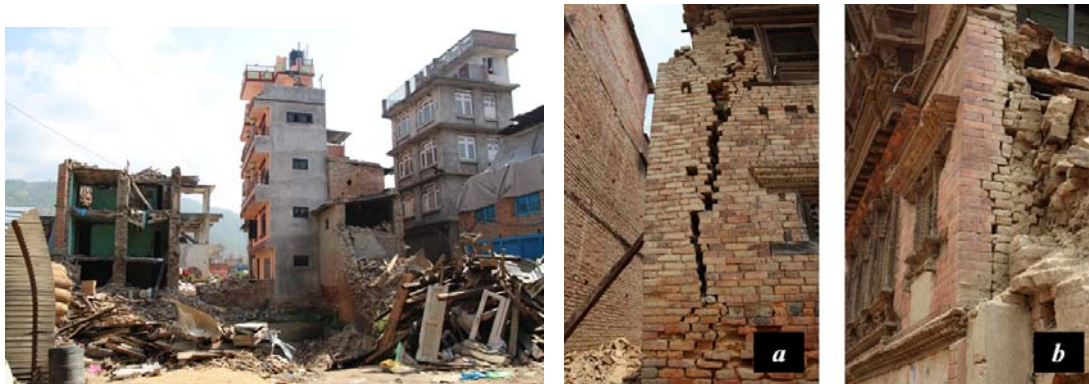
contrast, many of the non-engineered masonry structures that experienced complete collapse or partial damage were two to four story buildings in Sankhu (**Fig. 3.10: left**). Damage in non-engineered masonry structures was initiated by vertical cracks in the corners of the buildings (**Fig. 3.10: a**), which

contained no RC columns (**Fig. 3.10 b**). The outer wall structures of such buildings were generally burned brick with cement mortar joints to withstand rain. In several cases, the inner walls of buildings are adobe bricks with mud mortar.

**Fig.3.10** The damage to RC structures was generally minor. These structures were mainly five to six story buildings. Many of the non-engineered masonry structures that experienced complete collapse or partial damage were two to four story buildings in Sankhu (*left*). Damage in non-engineered masonry structures was initiated by vertical cracks in the corners of the buildings (*a*), which contained no RC columns (*b*). (Photo. by T. Ohsumi).

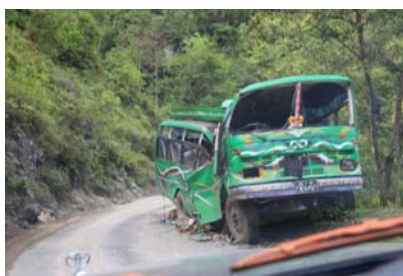
A numerous huge slope failures which occurred in the mountainous area buried villages and valleys, and provided the loss of many lives. We visited a landslide zone in Ramche, and it is located in the north-west of Kathmandu city in a mountainous area. Many of fallen rocks were on the roads, also we encountered a bus that hit by falling rocks (**Fig. 4.1**). Thick talus is deposited in the landslide area in Ramche, in

**Fig. 4.1** Bus was hit in falling rocks in Dhikure, on Baglung Rajmara High way. (Photo. by T. Ohsumi)

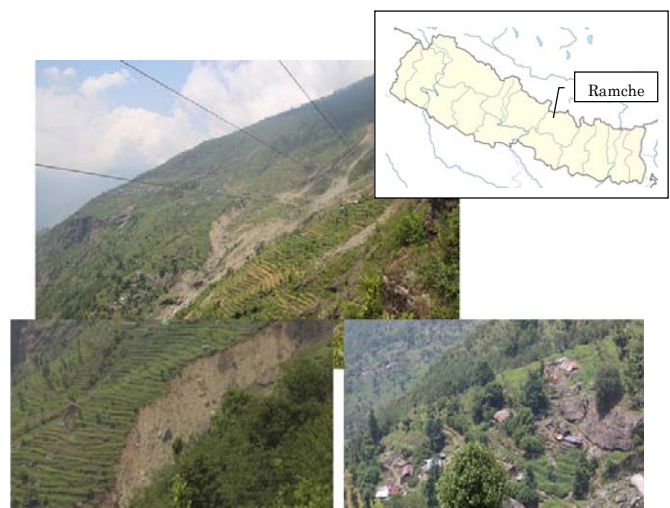
Rasuwa district (**Fig. 4.2**). The town is located at an altitude of 2,060 m. There are houses that had been caught in a landslide, but the damage was limited. However, the whole scope of the slope failures is not clear at the present time, because any detailed and total survey in the mountainous area has not been carried out. Thus, casualties will increase as they are found.

**Fig.4.2** Thick talus is deposited in the landslide area in Ramche. (Photo. by T. Ohsumi)

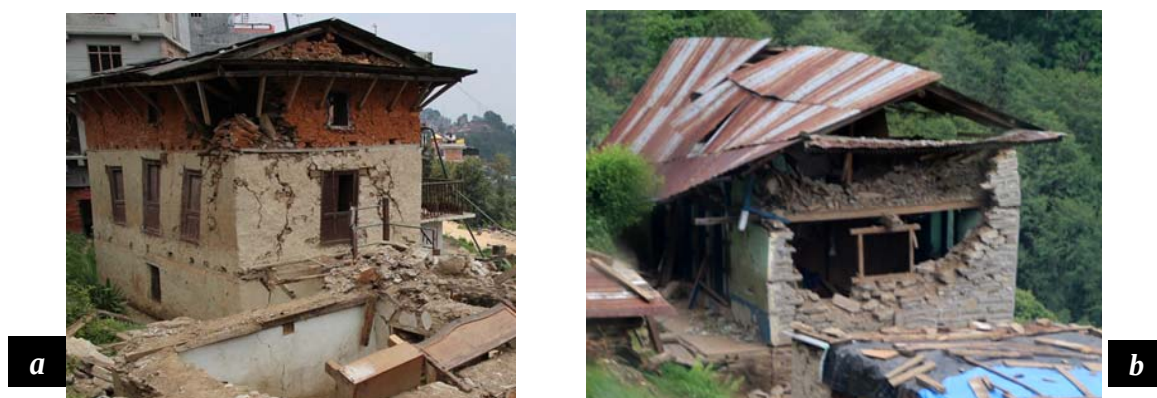
aftershock felt stronger than the main shock. This is understandable as the aftershock's hypocenter is located just below this area. Many houses collapsed in the aftershock (**Fig. 5.1 a**).

In Dolakha district, adobe style houses collapsed. Primarily, adobe houses collapsed as a result of cracks in the gables and corner foundations as a result of ground motion. Many adobe style houses were broken at their gables (**Fig. 5.1 b**). Stone houses could also collapse as a result of delamination. Stone style houses also collapsed by delamination.

**Fig.5.1** Adobe style houses (a) and Stone style house (b) in Charikot, (Photo. by T. Ohsumi)
