GROUND DEFORMATION BUILT UP ALONG SEISMIC FAULT ACTIVATED IN THE 2016 KUMAMOTO EARTHQUAKE

Kazuo KONAGAI¹, Masataka SHIGA², Takashi KIYOTA³ and Takaaki IKEDA⁴

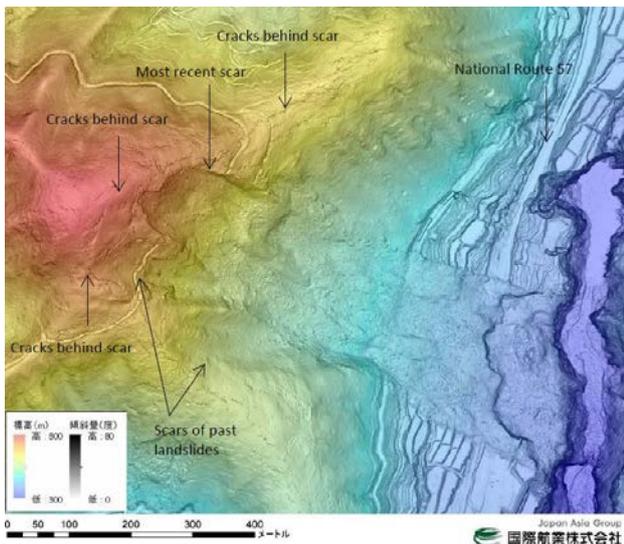
LiDAR, Laser based altimetry, can penetrate through tree canopy, revealing detailed feature of bare earth left behind by past natural hazards, and the LiDAR image of the mountain slope along the outer rim of the Aso crater shows evidence of past landslides as well as the most recent one that has hit an important location for traffic, transmission lines and a waterway leading to a penstock (Fig. 1)¹. Moreover cracks are seen along the exposed scar indicating future risk. Ministry of Land, Infrastructure, Transport and Tourism, MLIT, thus, has a plan to remove a greater part of the unstable soil mass remaining behind the exposed scar². However this will be a long-lasting project, and MLIT is currently taking a 2 billion JPY urgent countermeasure stabilizing the uppermost slope face of 30,000 m² and constructing 7 m high and 300 m long retaining wall near the toe of the slope using unmanned construction machinery to protect reconstruction works for national route 57 and Hoho railway line².

Fig. 1 Scars of past and most recent landslides and cracks appearing behind the scars indicating future risk (LiDAR image from Kokusai Kogyo Co. Ltd)¹⁾

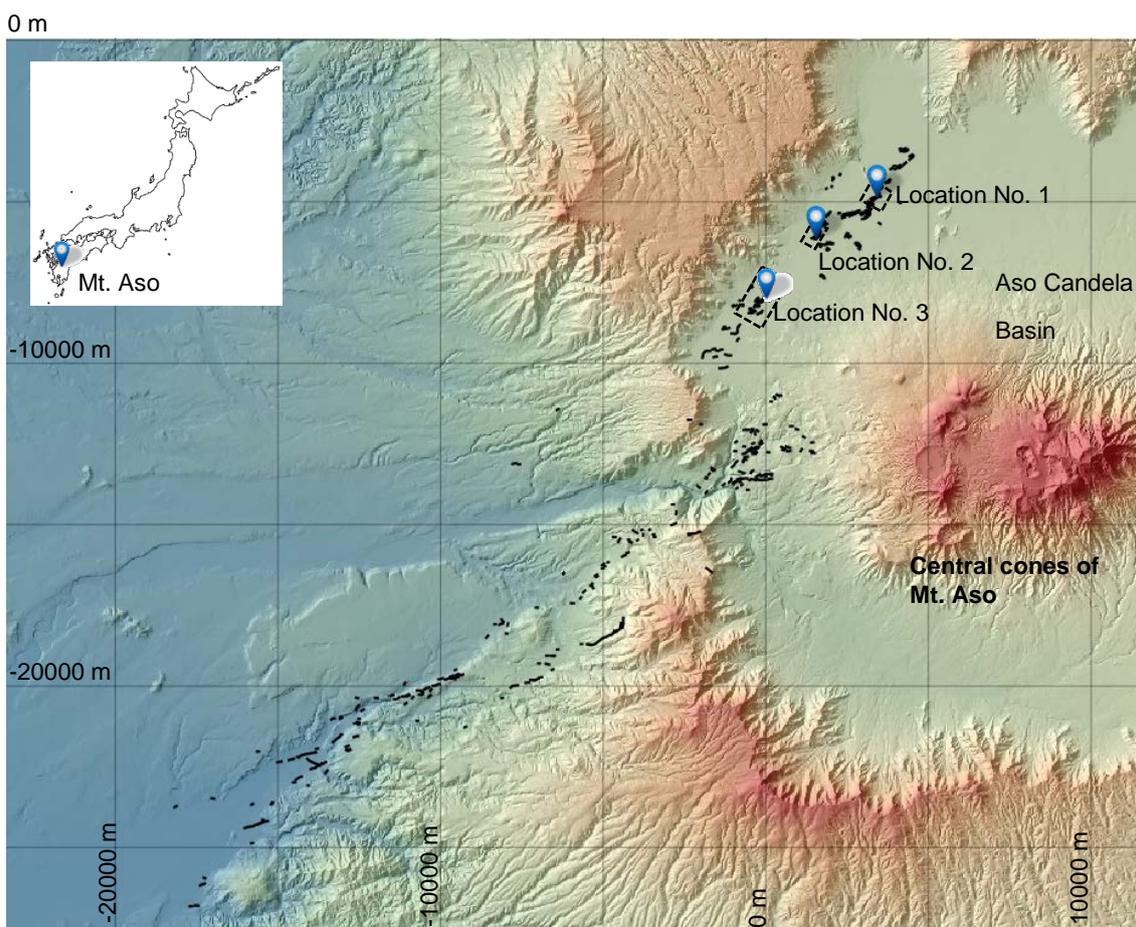
Fig. 2 shows cracks that appeared on the ground surface. Aerial photo-interpretations of southwestern and northeastern segments of cracks were made by the Geospatial Information Authority of Japan³⁾ and Kokusai Kogyo Co. Ltd.¹⁾, respectively. They include every visible cluster of cracks no matter what their causes are. Majority of cracks of the southwestern

Fig. 2 Aerial photointerpretation of cracks that appeared on the ground surface⁴⁾: Interpretations of southwestern and northeastern segments of cracks were made by the Geospatial Information Authority of Japan³⁾ and Kokusai Kogyo Co. Ltd.¹⁾, respectively. Authors' survey was conducted within areas enclosed in boxes of dashed line . UAV was flown over Locations 1, 2 and 3 (Coordinate reference system: JGD2000 / Japan Plane Rectangular CS II)

segment appeared along the Hinagu and Futagawa fault system, whose presence had been recognized, while northeastern segment of cracks exhibits a complex, interwoven pattern of fractures diagonally across the basin sediment of Aso Caldera. The latter is the abovementioned swath of ground depression that extends fragmentally over about a 10 km distance.

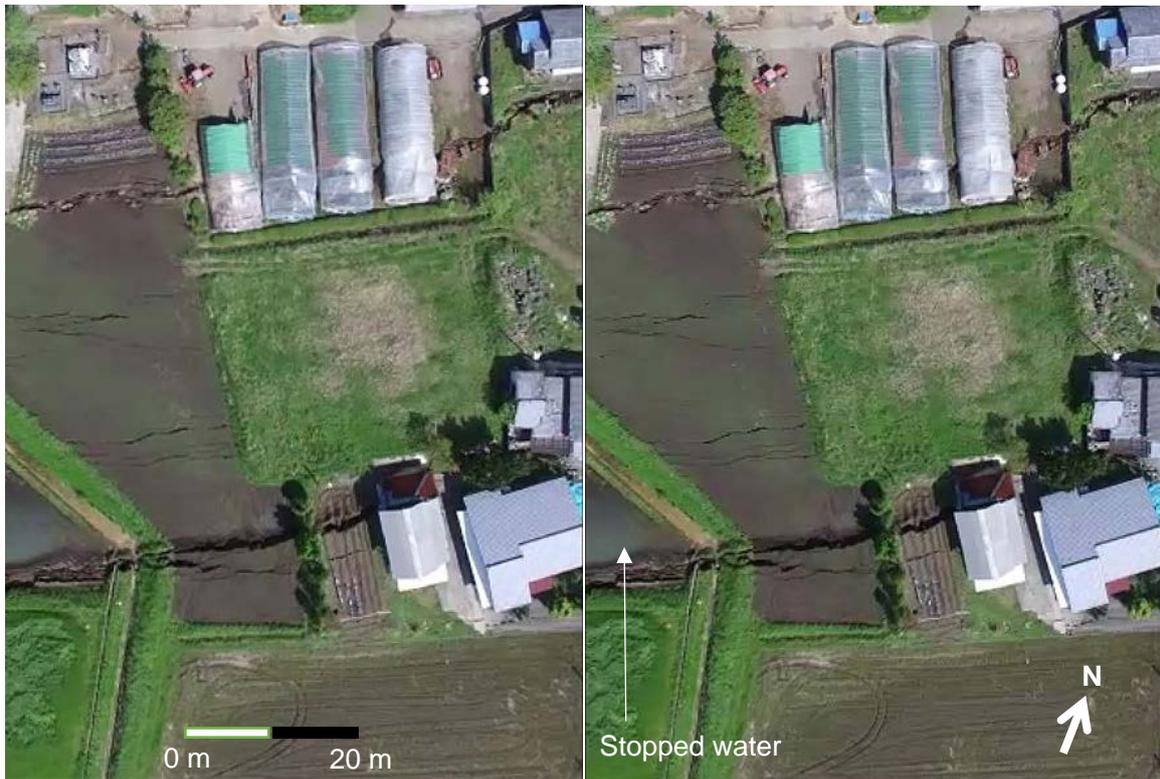
Fig. 3 A pair of UAV photographs of ground depression with the center of each photograph located at around N32.9662°, E131.0364, Location No. 1 in Fig. 2 (Flight altitude: 75m)⁴⁾

Flying over at a particular point at around N32.9662°, E131.0364 for example, one notices that the swath of ground depression is about 40 to 50m wide and 1 to 1.5 m deep. A pair of UAV photographs of this location shown in Fig. 3 can be perceived as a single image in terms of depths. As can be perceived, southeastern ends of plastic greenhouses dropped down onto the depressed ground. Water is stopped along the southern vertical offset of the ground. No clear indication of either right-lateral or left-lateral offset can be seen.

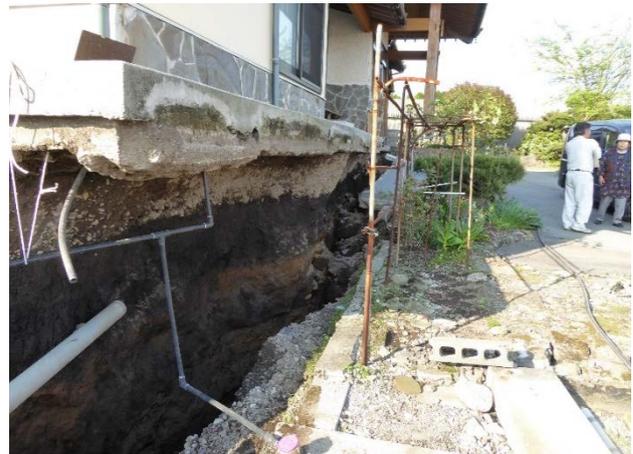
Being located several 10m NNE off the UAV picture frame (Fig. 3), there is a house standing by the edge of northwestern offset of the ground at N32.9568°, E131.0368 (Fig. 4). The exposed soil wall shows a stratified structure of brownish volcanic ash, pumice and andosol, which is highly porous and dark-colored developed from volcanic ash mixed up with organic matters. The crack here was more than 1 m deep with no clear indication of sand ejecta. A lady, the owner of the house standing by the car on

Fig. 4 House hanging a little over the northwestern offset of the ground at N32.9568°, E131.0368 (near Location No. 2)⁴⁾

the right, witnessed that “her neighbor’s house behind her dropped all at once, keeping its shape as it was, immediately when the intense shake of the main event of April 16th hit it. The drop of the ground was anything but slow”.

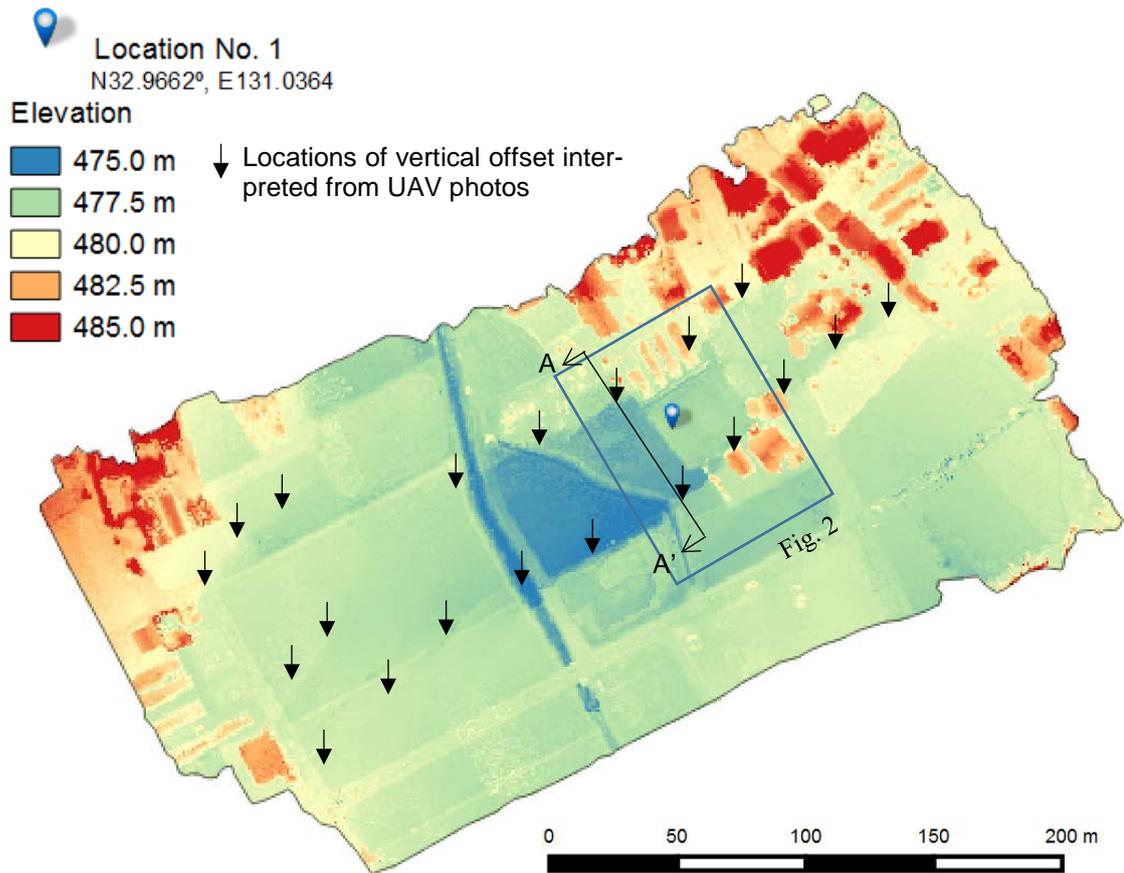
Fig. 5 Digital surface model of one part of swath of ground depression (Location 1, at N32.9662°, E131.0364°)⁴⁾

Though the cloud of points extracted from DSM shows not only the bare ground surface but also vegetation and artificial objects, the swath of ground can be clearly seen particularly in the middle of the covered area where the swath is narrowest and deepest enough to stop water. A cross-section was taken along Line AA' in Fig. 5 (Fig. 6). A pair of two clear ground offsets shows that the swath has fallen by about 1m here. The swath of ground depression

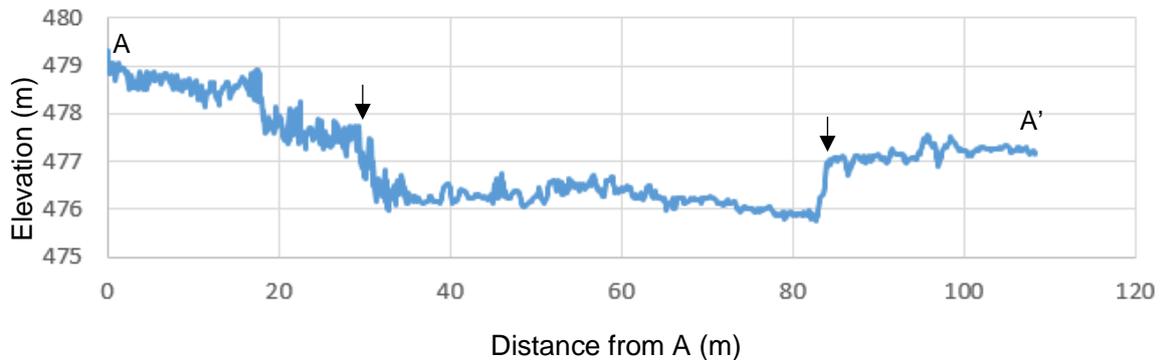
Fig. 6 Cross-section A-A' in Fig. 4⁴⁾

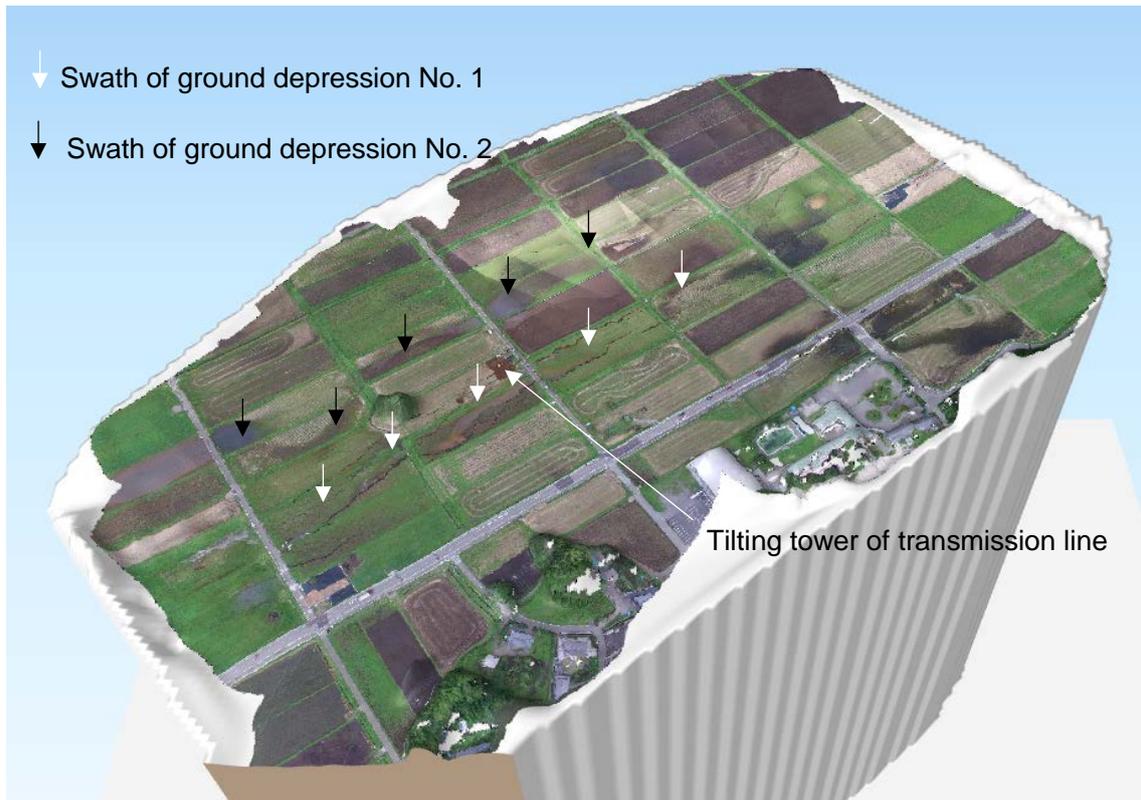
One more location of UAV flight No. 3 (on July 2, 2016) is shown in Fig. 2, and an extracted 3D image is shown in Fig. 7. There is a clear swath of ground depression, No. 1, which extends along an electric power transmission line. One of its tower tilted with its southeastern foundations embedded in the depressed ground. One more swath of wet soil (No. 2 in Fig. 7) is seen on this image, which was considered to have emerged after the torrential rain of June 20 and 21.

Fig. 7 3D terrain image extracted from UAV photos (Location 3 in Fig. 2)

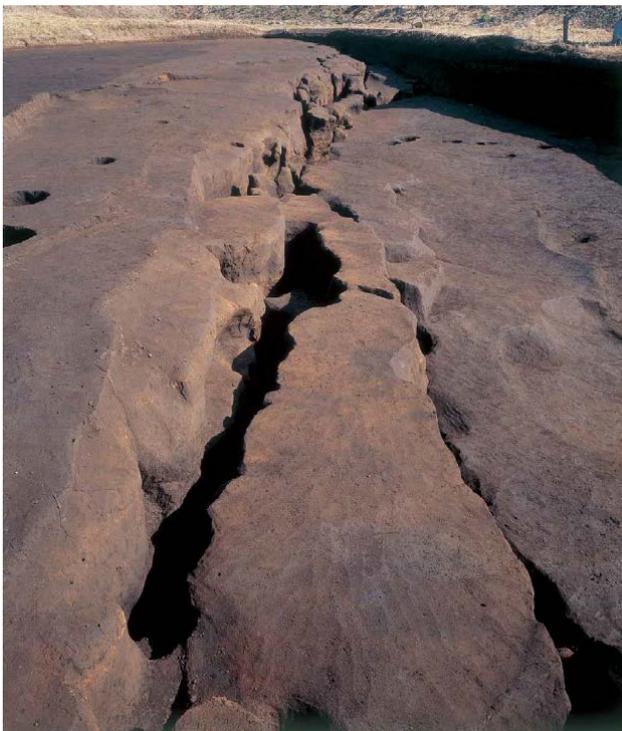
Fig. 8 Fault trace excavated at Onobaru Ruin near Location No. 2 in Fig. 2 (Kumamoto Prefecture)⁶⁾

There was no clear early indication of presence of the hidden swath of ground depression. However the educational board of Kumamoto Prefecture reported in 2015 that a normal fault trace was found in Onobaru Ruin of Yayoi Period (c. 300 bce–c. 250 ce) of Japanese Iron Age at N32.95056°, E131.0261° (Fig. 8)⁶⁾.

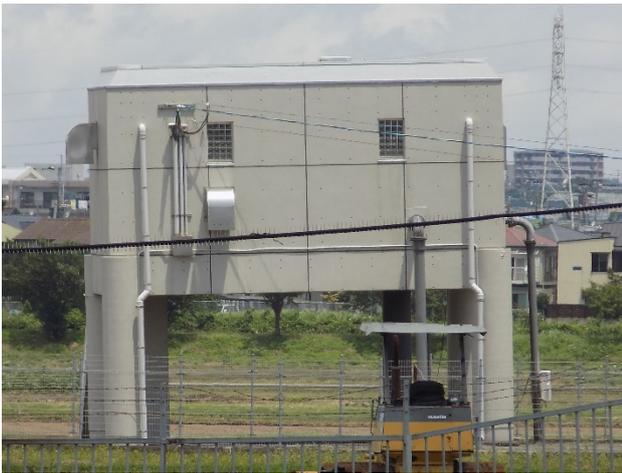
Except for ground ruptures that appeared along the known trace of Futagawa fault, no clear sign of large ground deformations was seen on the flood plain of Akitsu and Kiyama rivers. However some RC housings for pumping facilities were found tilting near Akita clean water distribution field (Fig. 9). Kumamoto city depend 100% on groundwater from

Fig. 9 RC housing of pump for clean water well near Akita clean water distribution field (Location: N 32.767028°, E 130.778574°)

nearly 200 wells, and the main shock was the most damaging, resulting in nearly 460,000 customers outages⁷⁾. One of the primary reasons for the outages was rather artificial due to regulatory requirements for clean water quality. Kumamoto city has set a standard on the allowable turbidity in drinking water. When the turbidity of 5 is reached in any well, its pump stops automatically⁷⁾. If pumps in the tilting housings have stopped due to the increase of turbidity, it may suggest that the soil grain crushing may have occurred in their common aquifer beneath the flood plain due to large strain build-up. These tilting RC well-pump housings, which are supported by about 22 m long piles reaching isolated lenses sandwiched in the soft deposit, can be a sign of residual deformation of the soil deposit.

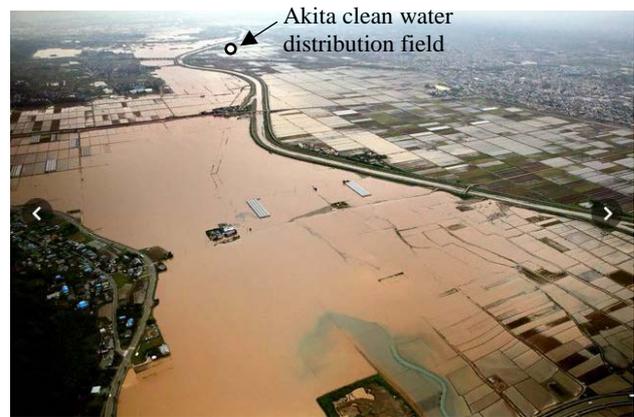
The area spreading east of Akita clean water distribution field was flooded in the torrential rain of June 20 and 21 as shown in Fig. 10. It was reportedly due to a burst in the left bank of Kiyama river. However it will be necessary to study the inundated area during the flooding in the light of ground deformation buildup.

Fig. 10 Inundated flood plain near Akita clean water distribution field (Photo: Asahi Shinbun Digital, <http://www.asahi.com/articles/ASJ6P4VM7J6PTIPE01Y.html>)⁸⁾
