# EVALUATION OF SURFACE LAYER CHARACTERISTICS IN KOIWAGAWA WHICH CAUSED A LOT OF TILE ROOF DAMAGE IN THE 2019 OFF THE YAMAGATA PREFECTURE EARTHQUAKE

Limin TENG<sup>1</sup> · Takaaki IKEDA<sup>2</sup> · Haruki SUZUKI<sup>3</sup> · Takeshi YOSHIKAWA<sup>4</sup>

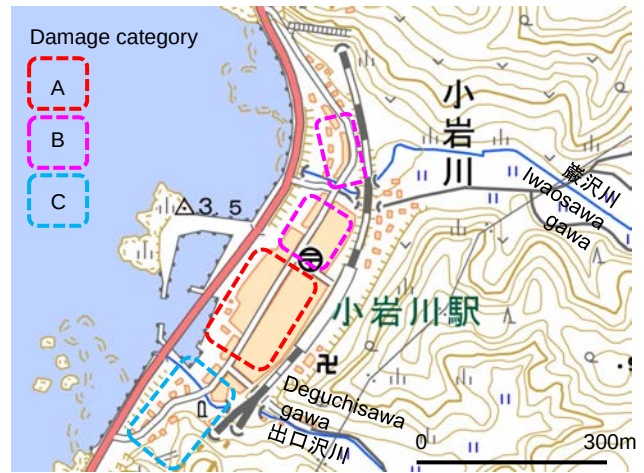
Figure 4 shows aerial photograph taken by 8 days after the earthquake (June 26<sup>th</sup> 2019)<sup>8)</sup>. Figure 5 shows tile roof damage in Koiwagawa taken by 20<sup>th</sup> June. This photograph was taken from point P in Figure 4. There were many houses covered with blue sheets. These houses can be considered a roof damaged house. Some damaged houses had already begun to be repaired. Damaged houses are mostly found on the center of the area. On the other hand, there are small number of damaged houses in northern side and southern side. It was known that damage situation of houses was varies along the longitudinal direction of Koiwagawa. Figure 3 shows the damage classification into three areas based on aerial photographs and field investigations. Category A was the highest damage rate area. Category C is mostly no damaged area. Category B is medium damage rate area.

**Fig.3** Map of Koiwagawa and damage classification. Category A which indicate red colored broken area, has a lot of roof damaged houses and category C has a small number of roof damaged houses. The base map is a reproduction of the Digital Topographical Map 25000 published by Geospatial Information Authority of Japan<sup>7)</sup>.

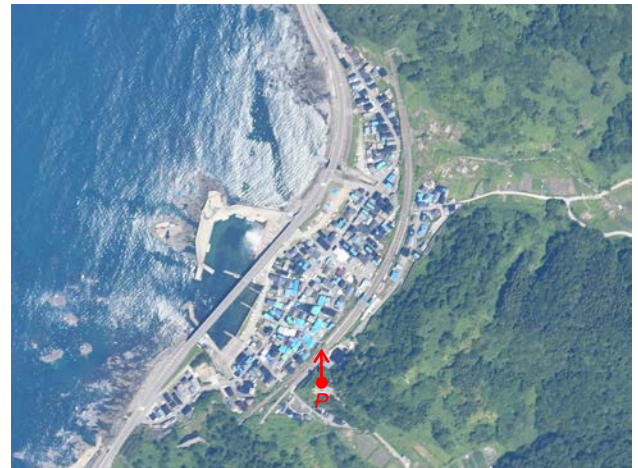
**Fig.4** Aerial photograph in Koiwagawa on June 26<sup>th</sup>, 2019<sup>8)</sup>. There are many houses covered with blue sheet. In this study, houses covered with blue sheets were considered as damaged houses.

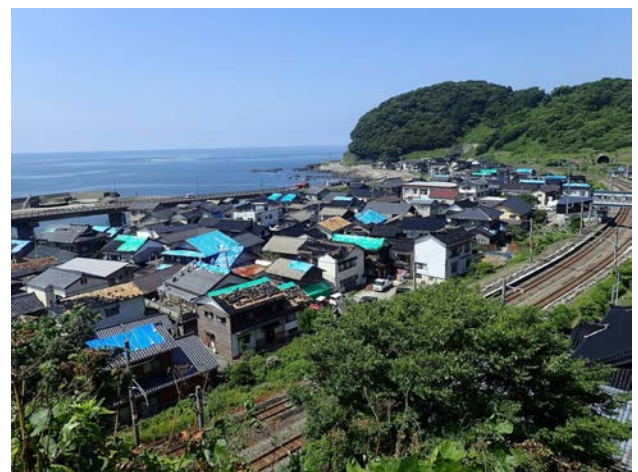
**Fig.5** Damage situation of roof tile in Koiwagawa on June 20<sup>th</sup>. Some houses have begun to have repaired.

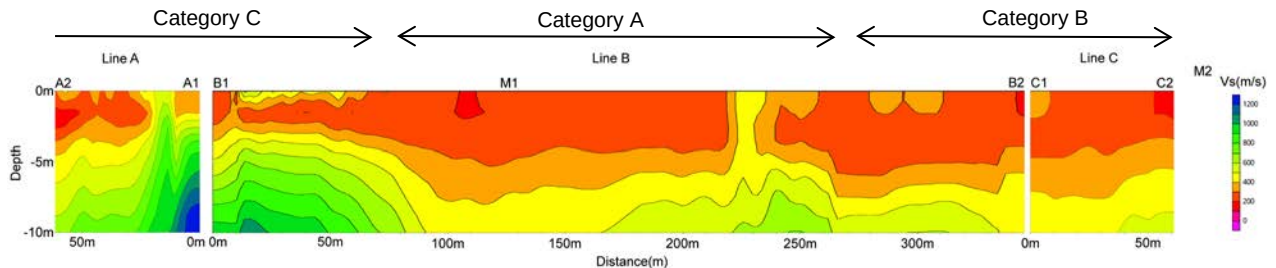
**Fig.8** S-wave velocity structure of the Koiwagawa evaluated by SWS method. Thickness of surface layer is different by sites. The surface layer thickness of the damaged area is thicker than undamaged area.

$V_s$  value near the ground surface is about 200 m/s. However, there is a difference in the layer thickness which has  $V_s = 200$  m/s. The layer thickness of the area classified as category C is thinner than another categories area. If the layer of  $V_s$  less than 400 is defined as the surface layer, thickness of surface layer at category C is clearly thinner than other categories.

The thickness of surface layer is qualitatively consistent with the roof damage situation. The surface layer thickness of the areas classified as category A and B are about 7-8 m. On the other hand, the surface layer thickness in category C is about 3-4 m.

We can find high  $V_s$  area near ground surface at range of 220-230m from B1 on Line B. During the field survey, we could not find the cause of the high  $V_s$  in this range. It is possible that the accuracy of the analysis result in this area is not enough.

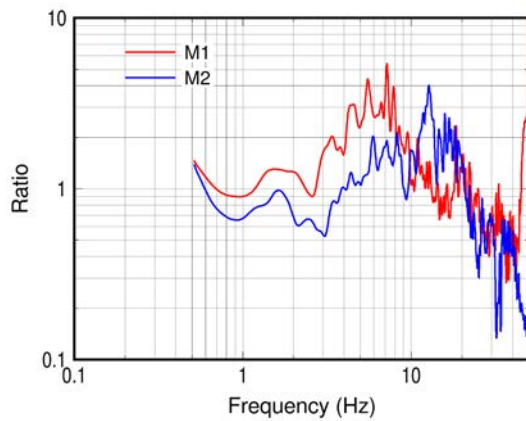
**Fig.9** H/V spectral ratio at M1 and M2. Peak frequency of H/V spectral ratio at M1 and M2 were 7.0 Hz and 12.0 Hz respectively.

meaning the natural frequency of the site<sup>13),14)</sup>. Peak frequency of H/V spectral ratio at M1 and M2 can be found at 7.0 Hz and 12.0 Hz respectively. Therefore surface layer properties were different between M1 and M2. Estimating the thickness of the surface layer using the 1/4 wavelength method from the natural frequency, were 7.1 m and 4.1 m. These results are consistent with the SWS results.
