A STUDY ON THE VIBRATIONAL CHARACTERISTICS OF RIGID-FRAME BRIDGES
AFTER THE HYOGO-KEN NAMBU EARTHQUAKE

(Translation from Proceedings of JSCE, No.550/V-33, November 1996)

Some of the elevated rigid-frame bridges on the New Tokaido line were damaged by the Hyogo-ken Nambu Earthquake. After restoration, the dynamic percussion test was performed by the authors on the Shinkansen's rigid-frame bridges throughout the disaster area.

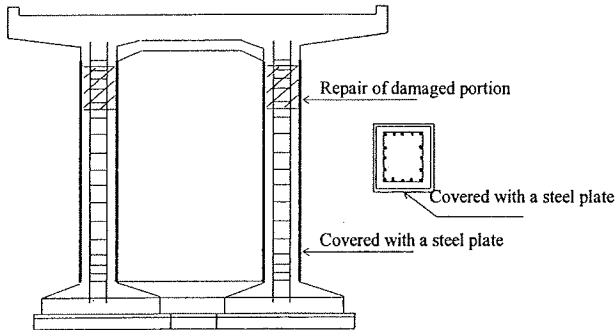
Fig. 2(a) Diagram of the Restoration of a Rigid-Frame Bridge (Class A, B)

The columns that received Class-A, -B, or -C damage were restored with steel-plate covers (Fig. 2-(a),(b)). When even one column in a rigid-frame bridge block required steel-plate restoration, the columns of the entire block were reinforced with steel plates, in order to maintain equilibrium in each column's rigidity.

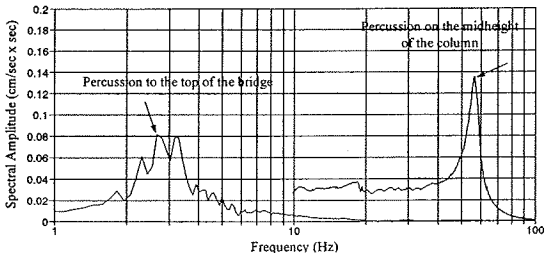
Fig. 5(a): Bridge A pre-earthquake
(For the percussion on the midheight of the column, only the frequency band of 10 Hz - 100 Hz is shown.)

Figure 5(a) shows the Fourier amplitude spectrum transformed from the impact-response waveforms measured prior to the earthquake. The peak on the left side of the Fourier spectrum (marked with an arrow in the diagram) is the first natural frequency of the overall structure. While the waveform of the response generated by the dynamic percussion test is a damped free vibration, this response is excited by an artificial external force. Hence, the natural frequency of the waveform determined based on the response velocity is not only confirmed as the peak of the Fourier amplitude, but also as the frequency indicating a phase-difference angle of 180° from the moment when external force is applied to the bridge, in the phase-difference response spectrum.

Likewise, the peak at the right side of the Fourier amplitude spectrum is the second natural frequency of the columns. When the Fourier spectral amplitude corresponding to the frequency of this peak was used to draw a diagram of the column's vibration mode, the resultant modal form exhibited its maximum amplitude in the middle of the column, as shown in Fig. 5(c). Therefore, it was concluded that the peak on the right side of the Fourier spectrum is the second natural frequency of the column as shown in Fig. 4.

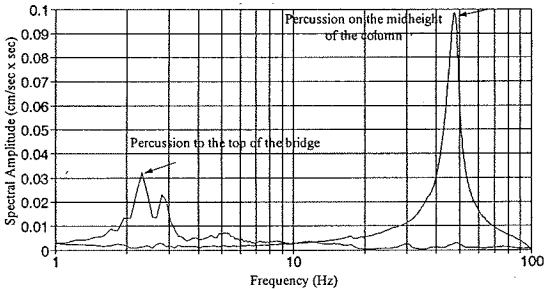
Fig. 5(b): Bridge A post-earthquake

Figure 5(b) is the Fourier amplitude spectrum of the response waveform measured after the earthquake. Comparing Figures 5(a) and 5(b), we can see that after the earthquake, the first natural frequency of the overall structure and the second natural frequency of the columns had declined by 0.4 Hz and 12 Hz, respectively.

Based on the analytic results, column rigidity after the earthquake decreased to approximately 70% of its pre-earthquake level. This magnitude of the decrease is consistent with a state of slight cracks on the column surfaces.

On comparing the ground spring constants before and after the earthquake, the horizontal spring constant was found to have decreased by 50%. This decrease is consistent with the results of an inspection after the earthquake, which confirmed that the earthquake caused separation of approximately one centimeter between the columns and the soil. The mode shape of the lower portion of the column (see Fig. 10(a),(b)) exhibits this phenomenon.

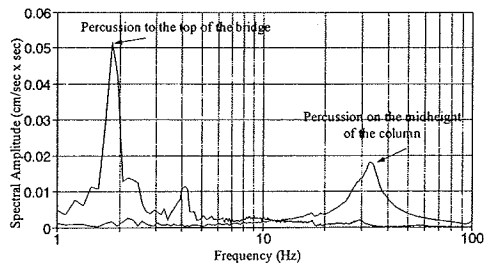
Fig. 6(a): Bridge B pre-injection

Bridge B is a three-span (3m + 3 x 6m + 3m) standard rigid-frame bridge (Fig. 6) with isolated footings. After the earthquake, openings were found in the bottom section of its columns. These openings were subsequently filled with cement paste. We performed the dynamic percussion test before and after this repair work.

Figure 6(a) is the Fourier amplitude spectrum prior to the repair work, while 6(b) is the Fourier amplitude spectrum after the repair work. The natural frequency of the overall structure increased by 0.2 Hz following the repair work.

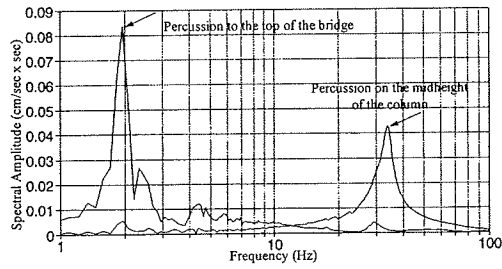
Fig. 6(b): Bridge B post-injection

On comparing the values for the horizontal ground spring constant subsequent to the earthquake with those after the injection, the latter was increased by tenfold. This increase is attributable to the cement paste that was poured into the openings around the bottom of columns, which had been found, by a visual inspection conducted shortly after the earthquake. As a result, the horizontal spring constant of the ground was increased. In other words, because the soil was loose shortly after the earthquake, cement paste was injected into the ground and spread to the openings. Consequently the looseness of the soil was rectified, and the horizontal spring constant was increased.

On the basis of the above analytic results, the increase in the natural frequency of the bridge from 1.8 Hz to 2.0 Hz is considered attributable to the increase in the horizontal spring constant of the ground that resulted from the injection of cement paste shortly after the earthquake.

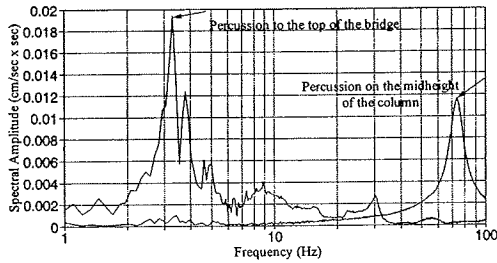
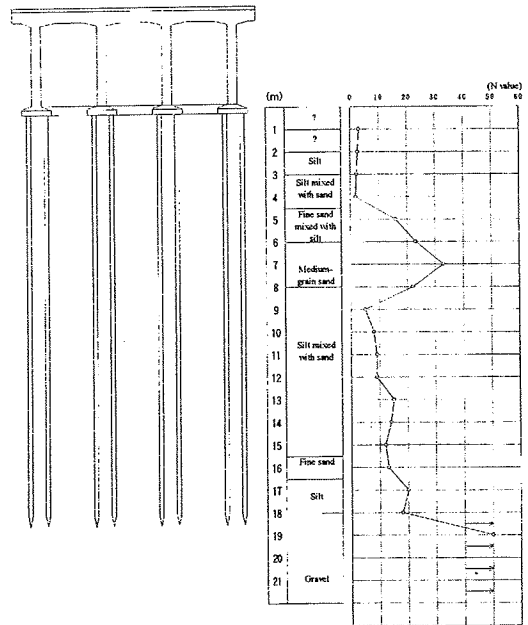
Fig. 7-1: Bridge C after Reinforcing

Bridge C is a three-span (3m + 3 x 6m + 3m) standard rigid-frame bridge (Fig. 7), with footings connected by underground link beams. Its columns were damaged by the earthquake and reinforced with steel plates. The dynamic percussion test results revealed that the natural frequencies of Bridge C, after restoration, (Fig. 7-1) are higher than those of an undamaged rigid-frame bridge of the same type (Fig. 5(a)).

The analytic results are shown in Table 4. The dynamic percussion test had not been performed on Bridge C prior to the earthquake. Bridge C had Class-A damage, and all columns were reinforced with steel plates. Although Bridges A and C do not have the same soil conditions, in terms of the type of rigid-frame bridge, they are identical. Accordingly, by performing a comparison based on the first natural frequency of their overall structures, it is possible to relatively evaluate the effect of reinforcing the columns with steel plates.

The difference between the natural frequencies of Bridge C following reinforcement and that of Bridge A prior to the earthquake is 0.5 Hz. In light of the effect of the soil of Bridges A and C (as a comparison of Tables 2 and 4 shows, the ground spring constant of Bridge C is generally low), it is clear that this difference in natural frequency is attributable to the increased rigidity due to the restoration of the columns with steel plates.
