FIELD INVESTIGATION OF DISASTERS IN SRI LANKAN RIVERS CAUSED BY
THE 2004 INDIAN OCEAN TSUNAMI

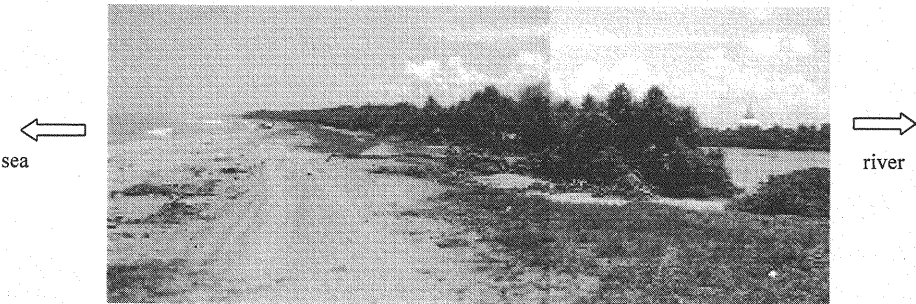
Photo 3 Erosion due to overtopping tsunami on the sand spit

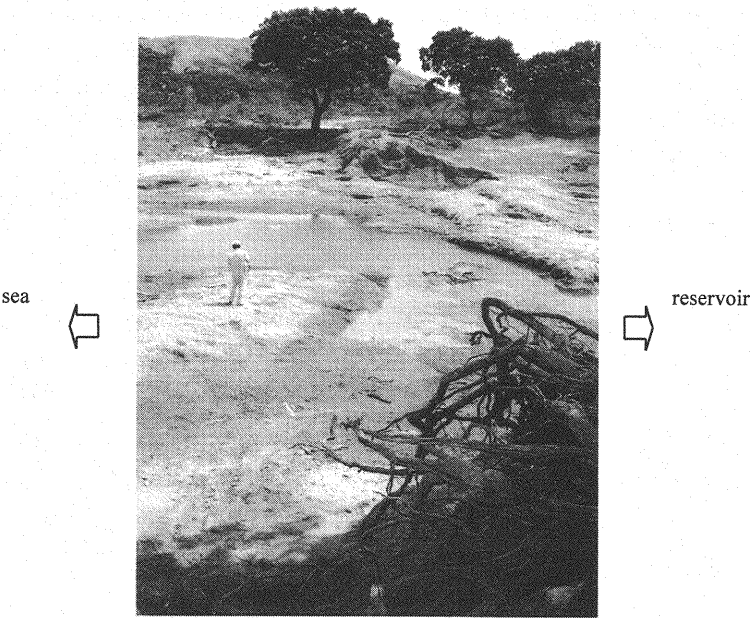
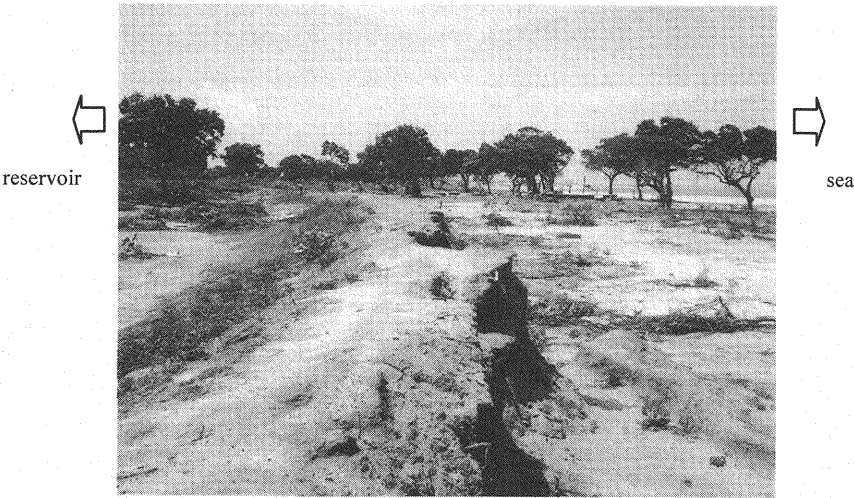
Photo 7 and Photo 8 show the damages to the road, which also acts as a levee for a small reservoir behind the lodge. The tsunami ruptured the levee as shown in Photo 7. In the ruptured area in Photo 7, there was a channel that had not existed before the occurrence of the tsunami. The water in the channel was stagnant at the time of the field investigation, and its mouth facing the sea was already closed due to sediment deposit by waves.

The destruction of this road was characterized by severe erosion of the slope facing the ocean, whereas the other slope facing the reservoir was not affected by erosion as shown in Photo 8. The distinct difference of erosion on the both sides is probably caused by the following process. When the first tsunami wave reached this area, the water level rose instantaneously far over the height of the embankment, and did not show a form of an overflow during the landwards propagation of tsunami. During the tsunami backwash, however, the sea water which had accumulated in the reservoir was discharged forming an overflow. As it eroded the sea-side slope of the road, it then ruptured the levee

and resulted in formation of the channel seen on the left hand side of Photo 7. A more detailed explanation of the mechanism of levee breaching can be found in another study (Tanaka et al. (10)). Such a mechanism conforms to the bridge-damaging mechanism caused by the return flow which will be described in a later section of this paper.

Photo 7 Road damage in Yala

Photo 8 Road damage in Yala

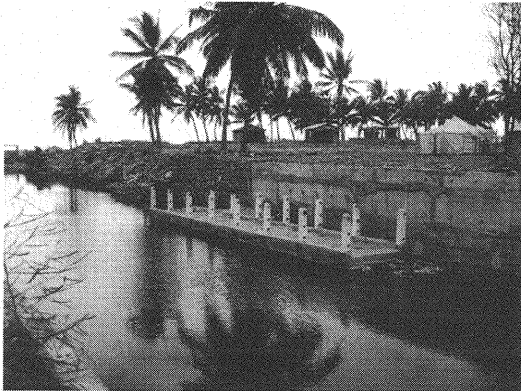
This is the only case of loss of concrete girder due to tsunami wave force in our investigation. The span length, the width and the thickness of this bridge are 13.3m, 1.6m and 0.3m, respectively. The pedestrian bridge which was washed away by the wave force is shown in Photo 9. The supporting base columns (abutments) are shown in Photo 10. The left side of the Photo 9 is sea side and the bridge was about 125m far from the shoreline. The tsunami wave carried the concrete girder about 24m upstream without overturning it in the channel about 1.6m deep. However it can be observed in Photo 10 that by the time the tsunami wave struck, the girder had not been connected to the base columns permanently.

Photo 9 Damaged situation of concrete deck

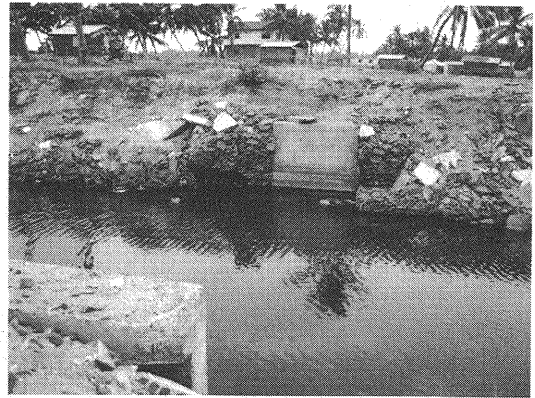
Photo 10 Supporting base columns of a damaged bridge

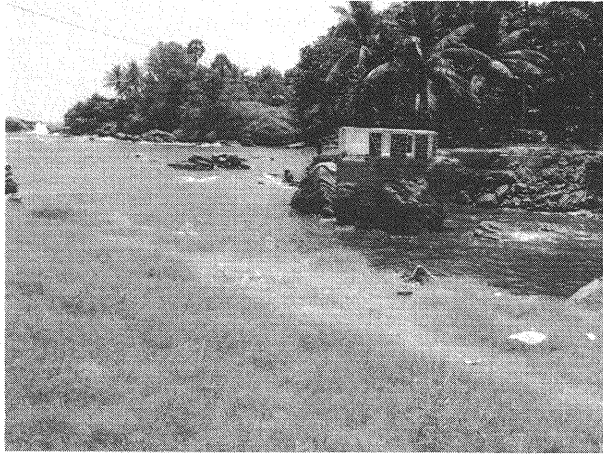
Butterfly Bridge (Photo 12) leading from the esplanade to Dharmapala Park in Galle City is about 175 m upstream of the above-mentioned undamaged pedestrian bridge shown in Photo 11. Photo 13 depicts the situation after the tsunami wave struck. Photo 12 indicates that it is a wooden structure. The drag force acted on this bridge is presumed to be similar to that acted on the narrow undamaged pedestrian bridge downstream in Photo 11 because of the small distance between these two bridges. The destruction of the wooden bridge is attributed to its relatively light weight and wooden structure as well as to the fact that it might have not been firmly clamped to the abutment.

Photo 13 Struck situation of Butterfly Bridge

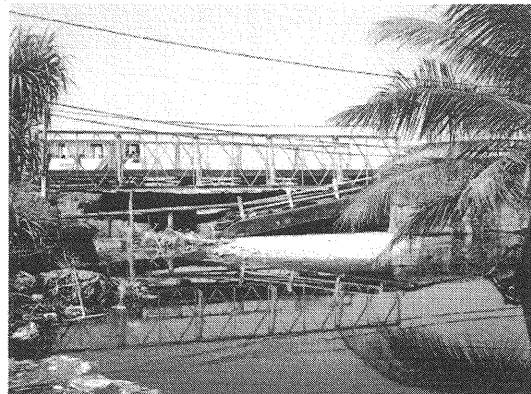
Seaside of the 8.3m long bridge that handles one way traffic left undamaged by the tsunami is shown in Photo 14. The damaged sustained to landside is clearly visible in Photo 15. This bridge is located in a beach shore protection area. The left bank side was destroyed and the river bed around the bridge was eroded.

Photo 15 Land-side of the bridge shown in Photo 14

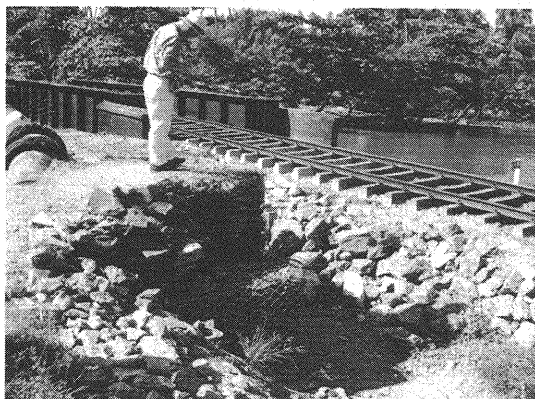
away by the rapid tsunami flow over the tracks, especially the bridges in small rivers. An example of a repaired railroad abutment section is shown in Photo 16.

Photo 16 Railway bridge where abutment installation has been damaged

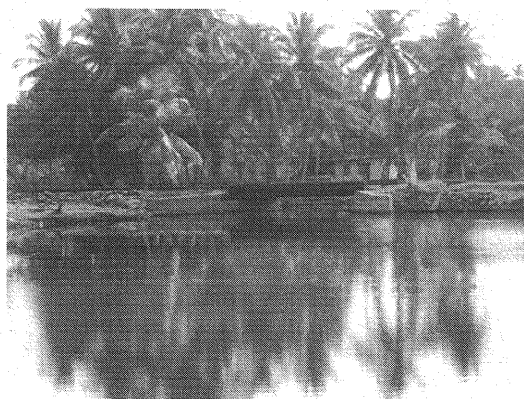
In Photo 17, the case of a railway track floor of the abutment approach being washed away and the repaired railway track is shown. The abutment was newly constructed and there is strong possibility that the abutment had been destroyed by the tsunami wave. Furthermore, in coastal areas of Sri Lanka, the railway tracks are laid on earth fills inside the lagoons and small bridge openings provide the passage for small magnitude of river discharge. As aforementioned, these small openings are not sufficient to pass high water volume. Therefore, the risk of damages to bridges and approach embankments is high.

Photo 17 Railway Bridge where bridge installation part flows out

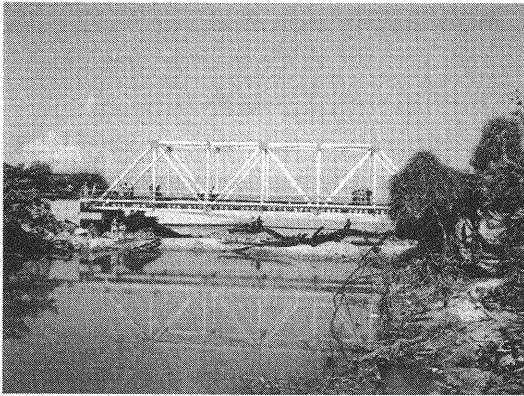
A steel girder plate type railway bridge under construction had been washed away by tsunami force. Girder of the destroyed bridge has carried away about 30m and was visible during the time of field investigation. This bridge is only about 50m far from the shoreline. Insufficient opening and a weak structure was identified as reason for the collapse of the bridge. A new truss bridge was under construction in May 2005 as shown in Photo 18. Part of the middle pier was visible under the center of the new bridge.

Photo 18 A temporary girder bridge near the river mouth

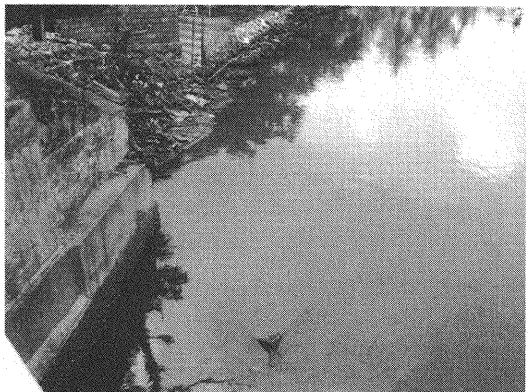
In Photo 20 a relatively large bridge of 205m in length, and height of 3.0m from the water surface to the girder is shown. The damaged situation of the left bank protection located just downstream of this bridge is shown in Photo 21. Because of the greater height between the bridge bottom and water surface in large rivers the tsunami wave did not reach the girder, hence there was no apparent damage to the girder and to the hand rails. However, the damages to the bridge approach are observed in many places.

Photo 21 Damage of left bank downstream of the bridge shown in Photo 20

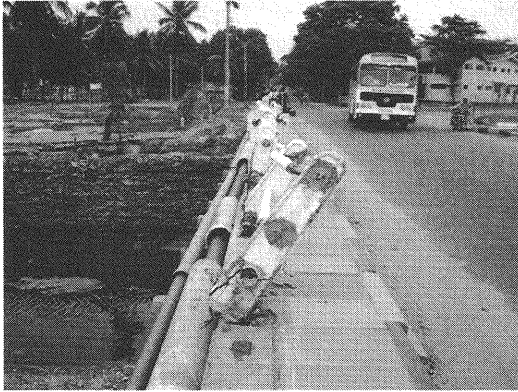
One example of damaged hand rails of a bridge in Hambantota is shown in Photo 22. The bridge is about 320m far from the shoreline. The hand rail on the lagoon side tilted towards the seaside. It was surmised that the gigantic tsunami wave that flowed into the lagoon was returned seaward direction with strong velocity. On the other hand, the hand rail on the seaside has fallen on the lagoon side. Therefore, hand rails on both sides of the bridge have fallen on the sidewalk hindering the pedestrians. Even after four months tsunami wave struck, the destruction of infrastructure is quite obvious.

Photo 22 Handrail column on land side of bridge

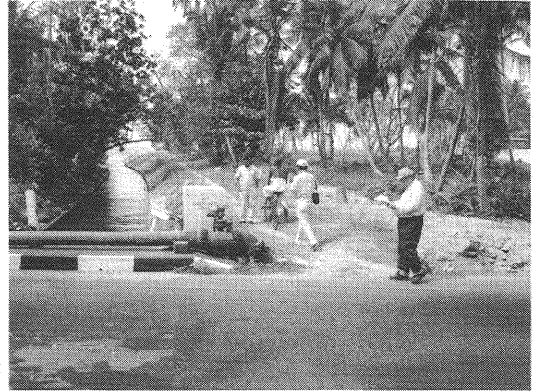
of a seaside high column handrail of a road bridge of 6.7m in length and 1.7m in height from the water surface is shown in Photo 23. The waterway is perpendicular to both shoreline and road. Therefore, high speed tsunami wave stuck the hand rails and damaged the structure.

Photo 23 Damaged seaside guardrail of a road bridge
