AN INVESTIGATION ON FATIGUE STRENGTH FOR TRANSVERSE CHORD OF STIFFENING TRUSS

By Kenji SAKAMOTO*, Masahiko YASUDA*, Makoto FUKAZAWA** and Chitoshi MIKI***

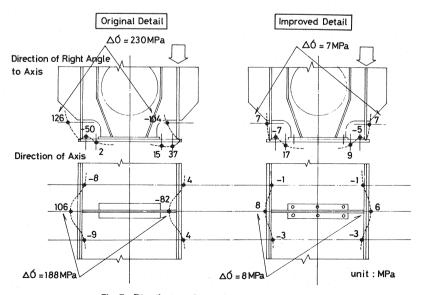
Fig. 7 Distribution of out-of-plane bending stresses.

Typical out-of-plane bending stresses of the web and the flange near the loading point section (a in Fig. 6) were measured by strain gauges. Strains near the terminating of the fillet welds were measured at a distance of 10mm from the weld toe. Fig. 7 shows the distribution of out-of-plane bending stresses.

In the original detail, out-of-plane bending stresses are large in the direction of both the specimen axis and it's right angle. Bending stress at the unloaded side web is converse to that of

the loaded side web. Stringer reaction is alternately applied to each web to simulate the passage of a train. Thus, the bending stress range at one particular point is considered to be the sum of the stress at these two points. So, bending stress range at the terminating of the fillet weld at the scallop is expected to be $\Delta \sigma = 230$ MPa, and $\Delta \sigma = 188$ MPa.

From previous studies on the transverse fillet weld^{3),4)}, it is known that the bending fatigue strength is almost equal to axial fatigue strength in nominal stress, and stress concentration at a distance of 10mm from the fillet weld toe is nearly 1.0. Measured bending stress ranges in this specimen are sufficiently high to result in the origination of the fatigue crack. On the other hand, in the case of improved detail, the out-of-plane bending stresses are small in both directions. It is clear that when the diaphragm is bolted to bottom flange, there is no significant out-of-plane web bending stress.

The result of a torsional loading test, disclosed that the diaphragm should be connected with the bottom flange. In practical fabrication, connection by the fillet weld was applied for the purpose of doing it water-tight. Consequently, allowable fatigue strength at the side of the tention bottom flange was reduced by two degrees from category A to C.

Accordingly, to reduce the applied maximum bending stress, the bottom flange plate was thickened from 22mm to 28mm, or a cover plate 16mm thick and 450mm wide was added almost the full length of the lower stress region.

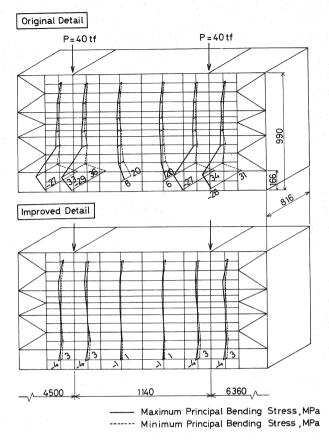
Fig. 8 Result of finite element analysis.

was carried out. Fig. 8 shows the distribution of the principal bending stresses of the loading side web plate. Bending stress at the scallop in the improved detail is about one-seventh of that in the original detail. This shows the same result as given in the test result.

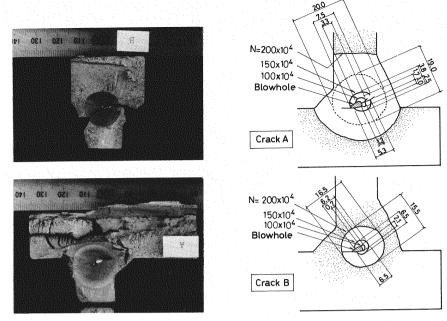
Photo, 4 Fatigue crack surfaces.

In order to observe weld defects and fatigue cracks which originated at the root of the corner joint, the root of outside welds were exposed along the weld line. This examination was conducted on areas where weld defects were indicated by ultrasonic inspection. The inside fillet weld was not examined because no defects were indicated by the ultrasonic inspection. As a result of this examination, in the region of maximum bending stress, two fatigue cracks originated from blowholes of 2mm wide×4mm high (Crack A), and 1.5mm×4.5mm (Crack B). Both blowholes are over the tolerable size of 1.5mm wide and 4mm high⁵⁾, regulated for a class A truss chord member made of quench and tempering type high strength steel. Photo. 4

shows these fracture planes. Beach marks at 1 000 000 cycles and 1 500 000 cycles were left on the fracture surfaces.

The relation among the initiation of crack, size of blowhole and applied stress range is shown in Fig. 11. Only two cracks are not enough to derive apparent relation. Fatigue cracking however, tends to originate from relatively large blowholes at a higher applied stress range region.

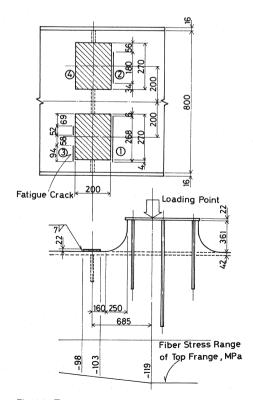
Fig. 14 Fatigue cracks in fillet welds of bedplates.

Fatigue cracks were discovered along the fillet welds of the bedplate on the top flange for the sidewalk at 1 938 000 cycles. The location of these cracks is shown in Fig. 14. The cracks appeared in three of the four front fillet welds. Appearance of a typical crack is shown in Photo. 5. A crack was found in the root of the fillet weld

with no surface crack, as skeched in Fig. 15. However, no relation is apparent between crack origination and weld defects, such as blowholes and slag-inclusions at the root. The exposure of every crack surface confirmed that the cracks propagated through the weld throat from the root.

The bedplate for the sidewalk were on the top compression flange where a bending fiber stress range of 0 ~103MPa was applied. Allowable design stress range of this weld joint, which is classified in Category C, is 134MPa. This suggests that the transverse fillet weld of the attachment cause a substantial reduction in fatigue strength. There are many reports about fatigue strength of the plate with welded attachment? However, the crack initiation at the root, and especially the crack on the compression side, have received little attention.

As the actual member will be under the same stress of -98MPa as the specimen, enlargement of the fillet weld size would increase fatigue strength.

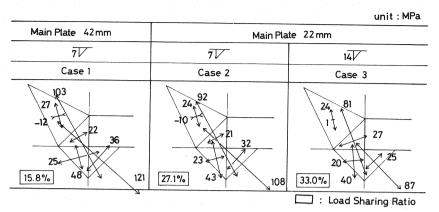
Fig. 17 Principal stress diagram about root.

The following results were proved by these analysis. When the main plate is under the compressive axial force, the gap between the main plate and the attachment plate is enlarged, and tensile stress acts on the root of the fillet weld. A principal stress diagram of the root is shown in Fig. 17. The load sharing ratios which were calculated by the supporting reaction in y-direction are given in this figure. In case-1, corresponding to the test specimen, the maximum principal stress at the root is 103MPa. The relationship between the direction of the actual crack, which penetrated through the throat, and that of calculated

principal stress can not be clearly explained. It is supposed that the direction of the principal stress could be changed by the modelling of the element at the root, and that cracks originate due to this tensile stress.

In comparison with this case, maximum principal stress decreases with the thinner main plate in case-2 and with the larger fillet weld size in case-3.
