WELD REPAIR OF CRACKED BEAMS AND RESIDUAL FATIGUE LIFE

By Kentaro YAMADA, Yoshinaga SAKAI**, Akimasa KONDO***
 and Yoichi KIKUCHI*****

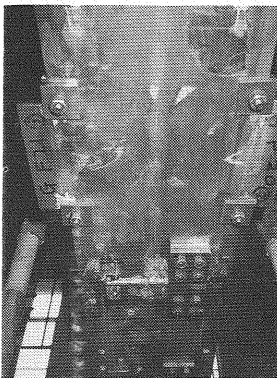
Photo 1 Fatigue cracked tension flange looking underneath. Stopholes drilled at leading edge of cracks are stiffened with high strength bolted splices.

The stophole was further strengthened by a pair of splice plates bolted from both sides of the cracked details. Fatigue tests were then continued to observe fatigue cracking from other details. Practically all gusseted details exhibited fatigue cracking. Photo 1 shows the tension flange of the test beam where high strength-bolted splices were attached to stiffen the cracked parts.

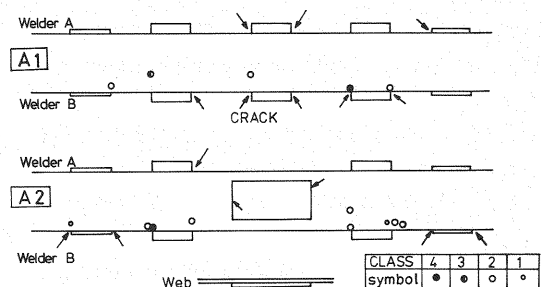
Fig. 9 Non-destructive test results at the groove weld repair by ultrasonic test.

In order to verify the weld quality of the groove weld repair, ultrasonic test and X-ray radiographic test were carried out based on JIS Z 3060 and JIS Z 3104, respectively. The test results are shown in Figs. 9 and 10. The arrow indicates that fatigue cracking was observed when fatigue tests were carried out after the repair. The welders A and B indicate who made the repair welds. Numerous weld defects were detected in the repair weld due to the fact that the welding condition was relatively unfavorable. No additional repair was made, even though large defects were detected by the non-destructive tests.

Classification of Weld Defects : Majority of the repaired welds were classified into class 3 or class 4 by the X-ray radiographic test. The ultrasonic test, however, failed to detect such defects and only a few were classified into class 3 or 4. It may be due to the fact that the ultrasonic test had some difficulty to scan near the end of the gussets where weld defects were significant. Both tests showed that the experienced welder introduced less weld defects than the unexperienced one. This was especially significant on the repair weld of T-type gussets.

The ultrasonic test failed to detect the weld defects near the fillets which were influential to the fatigue resistance. When this test is carried out on the repair welds, care must be taken to ensure the soundness of the welds especially where stress concentration affects.

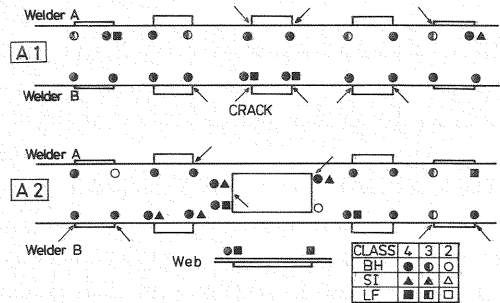
Type of Weld Defects : The X-ray radiographic test revealed that blowholes (BH) frequently existed in many repair welds while a few slag inclusion (SI) and lack of fusion (LF) were observed. These weld defects were mainly observed at or near the drilled holes and near the edge of the flange plates. It implies that the plug welding of the drilled holes and the start-stop position tend to cause weld defects.

Fig.10 Non-destructive test results at the groove weld repair by X-ray radiography.

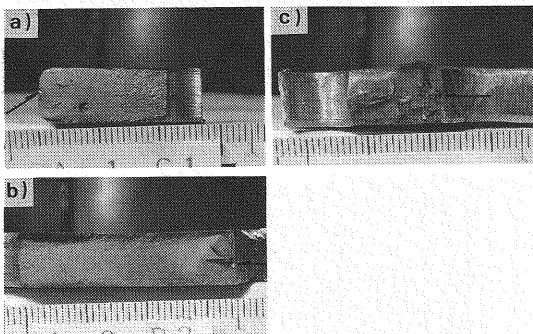
G-type Gussets : Eight out of 20 repair welds exhibited fatigue cracking. The fatigue crack initiated from the fillet of the gusset ends and propagated in the direction perpendicular to the principal stress. Typical fatigue fracture surfaces are shown in Photo 2. Photo 2 a) shows a fracture surface with few weld defect. Fatigue cracking seems to occur from grinding marks at the fillet, and it showed the longest fatigue life among the failed details. In Photo 2 b), blowholes exist near the fillet, and the fatigue crack initiated from these blowholes. It resulted about an average fatigue life of the failed data. The most harmful to the fatigue resistance was large and numerous defects near the fillet, as shown in Photo 2 c). Fatigue cracking seems to occur from these defects and coalesced to a large crack. It showed the shortest fatigue life.

Compared to the previous test data of the gussets with ground ends of 20 to 30 mm radius⁷⁾, it revealed that the present test data showed somewhat shorter fatigue life. It may be due to the weld defects near the fillet, which seems to trigger early fatigue cracking and thus reduce fatigue life.

Photo 2 Typical fatigue fracture surfaces of groove welded gusset ends (G). Weld defects were visible on the surfaces.

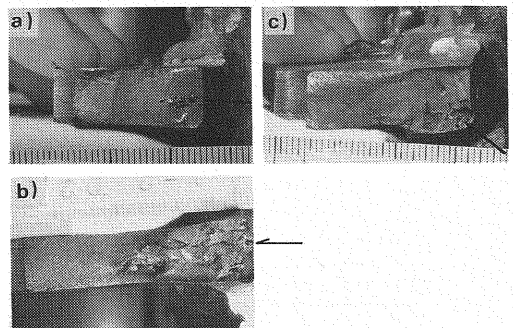
Photo 3 Typical fatigue fracture surfaces of fillet welded gusset ends (T). Numerous weld defects were visible near the end of gussets (left).

propagated from the weld defects near the fillet. Typical fracture surfaces are shown in Photo 3. A number of weld defects such as blowholes, slag inclusion and lack of fusion can be seen on the fracture surfaces, as shown in Photos 3 a) and 3 b). Fatigue cracks initiated from these weld defects, and it resulted relatively short fatigue life. In Photo 3 c), a number of small and spherical defects can be seen near the fillet, where the fatigue crack initiated. The fatigue life of this detail was one of the longest among the failed T-type gussets.

As shown in Photo 3, relatively large weld defects were introduced near the fillet of the T-type gussets, because of the unfavorable welding condition. The stress concentration due to the gussets was superimposed to these weld defects, and it yielded to low fatigue strength, despite the ground fillet at the end of the gussets. This detail can be classified into detail class G, if it is as-welded. It may be appropriate to use the same detail class for the repair weld, provided that the gusset ends are ground to achieve smooth transition.

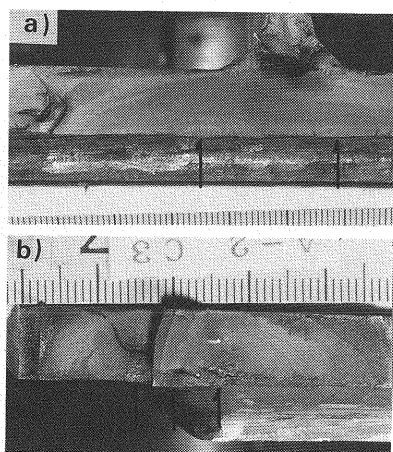
Cover Plate : Photo 4 a) shows the fracture surface of the cover plate ends, where a crack of 4 mm long was observed at 630 000 cycles. Several cracks initiated at the transition from the flange to cover plate, and propagated in semi-elliptical shape. The radius of the fillet of this side was relatively small and the grinding marks were left on the surface. This may cause early fatigue cracking. The fracture surface revealed that sizable weld defects existed at the junction of the flange and the web, where the repair weld was placed from three sides. These weld defects, however, were not the major crack initiation points. Photo 4 b) shows the fatigue cracking occurred from the plug welding of the stophole near the end of the transverse fillet weld. A few cracks initiated in the different plane and joined together as they propagated.

Photo 4 Fatigue fracture surfaces of tension flanges at the end of cover plates. Repair was made by groove weld.

data of the repair weld showed somewhat lower fatigue strength than the cover plated details with tapered end welds. The weld defects introduced by the repair weld may have caused the reduction of fatigue strength. Therefore, it may be safe to use the same allowable stress ranges for the repair weld with ground end weld of cover plate, although the cover plates with tapered end welds to 1 : 2 was classified into detail class C in the JSSC recommendation⁴⁾.
