FATIGUE STRENGTH OF WEATHERED AND DETERIORATED RIVETED PLATE-GIRDER

In this study, a detailed review of the fatigue test results of riveted joints which have been performed in Japan, is conducted. A fatigue test is carried out on a plate-girder bridge which has been used in a railroad about 70 years. The fatigue strength and the initiation and propagation behavior of fatigue cracks of weathered and deteriorated riveted plate girder is discussed.

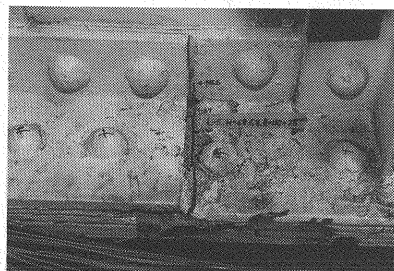
Fig. 6 illustrates the loading history. At about 10^4 cycles a crack (L_A crack) initiated near the edge of a corroded groove of the horizontal angle leg (reduction of sectional area was about a half that of the original shape) at the end of the splice angle in the vicinity of A-A section of the left girder. Photo 1 shows the ultimate state of this crack. This crack was observed to coalesce into new ones which developed later.

Photo 1 Crack which initiated from Edge of Corroded Groove (Crack L_A).

L_A crack (Photo. 1 and Fig. 13) is differently characterized from the above three types of cracks. One feature is that the crack in the flange angle starts not from the rivet hole but from a corroded surface. Another feature is that L_A crack starts from the rivet holes in two symmetric sections with respect to the connection of P_2 plate, whereas the other types invariably start from the rivet holes in the same section (Fig. 9). In the outside flange angle a number of cracks initiated from notches on the rough irregular surface of its horizontal leg where the sectional area had been reduced to half the original area as a result of corrosion, and they coalesced into one, leaving seven beach marks which were as many as the load reductions with no cracks starting from rivet holes. In the inside flange angle no cracks initiated. L_D crack in the flange angle behaves just like L_A crack in the flange angle; that is, the crack initiated at the surface

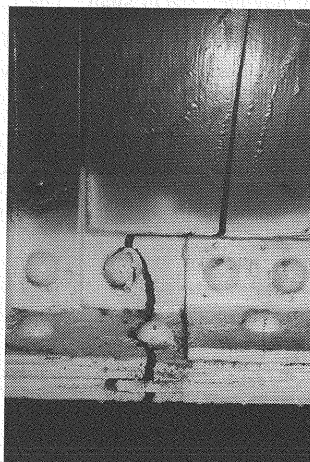
At 68.6×10^4 cycles, the crack near A-A section of the right girder had grown so large that the testing was interrupted. As seen from Photo 2, the right girder then had all its flange cut through, with the crack

Photo 2 Crack which penetrated through Lower Flange (Crack R_A).

advancing up to near-half of the web (R_A crack). Photo 3 indicates that in the left girder the cracks on the upper cover plate and the splice plate had developed respectively from the rivet holes in two symmetric sections with regard to the connection of the lower cover plate (L_A crack). The splice plate completely failed, while the upper cover plate was not cut through. As shown in Photo 1, the crack of one flange angle propagated up to about $1/3$ length of the vertical leg, but no crack was observed on the other flange angle opposed to it across the web. This seems to be an accelerated failure, because no crack was observed in a visual examination which was done 1.6×10^4 cycles earlier.

Fatigue testing was resumed after the repairing of failure sections by splices with high-strength bolts. At 79.3×10^4 cycles, a crack was observed to initiate from a rivet hole of the splice plate near C-C section of the left girder (L_c crack). At 83.9×10^4 cycles, with the flange failure and the crack propagating up to half the web, the testing was terminated. Immediately thereafter, the right girder had its paint film stripped at a symmetric position to the failed section of the left girder, revealing that, as indicated in Photo 4, the surface of the flange had been cracked and the upper cover plate had been cracked up to the end of its plate (R_c crack). In the presence of painting film, no crack can yet been revealed in such a case. The painting film was 7 years and 5 months old.

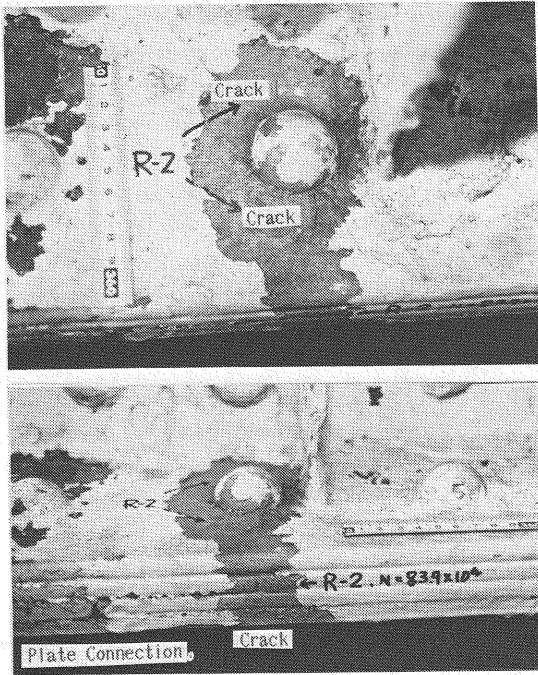
Photo 4 Crack found by Stripping Paint Film (R_c).

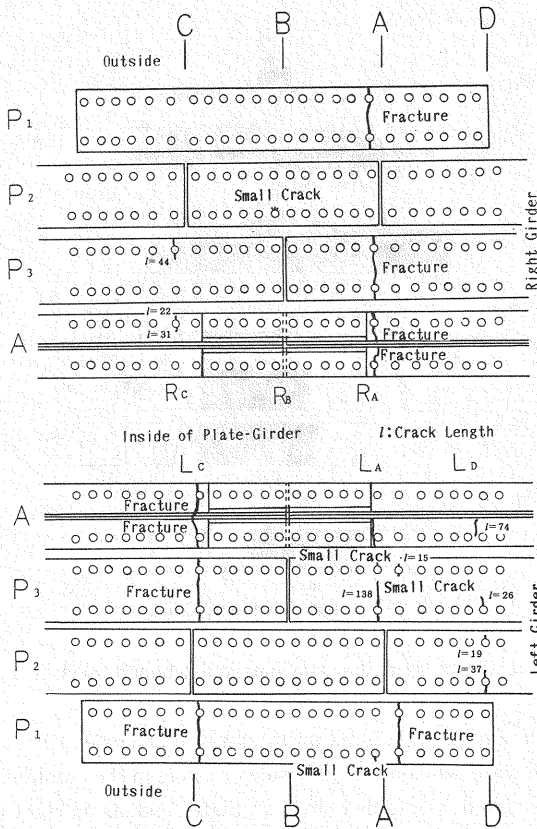
The results of crack observations are summarized in Table 1 and Fig. 9. In the figure the outside and the inside mean respectively the inside and the outside of the bridge with respect to the web. A, P_3 , P_2 , and P_1 represent the flange angle, the upper cover plate, the lower cover plate and the splice plate respectively. Near A-A and C-C sections at the connections of the lower cover plate, cracks were found during the fatigue test (L_A crack, R_A crack, L_C crack and R_C crack). Near B-B section at the midspan of the right girder a single tiny crack of less than 1 mm long was discovered at the rivet hole edge by the crack observation after the fatigue test (R_B crack). Near D-D section at the end of the splice plate, the same observation revealed a crack in the left girder (L_D crack). These cracks in tension flanges invariably initiated from the rivet hole closest to the plate connection of the spliced part and from the position where the sectional area had been reduced to less than one half of the original area on account of corrosion, but no cracking was observed at other rivet holes. In the compression flanges, cracks initiated from four spots of heavily corroded cover plates at the end of the splice plate.

Fig. 9 Results of Crack Observations.

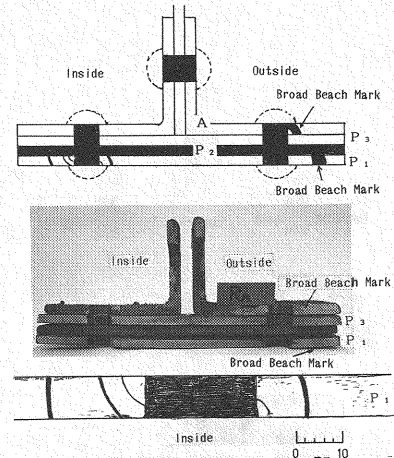
The beach marks of R_A crack were found to be three on the left side of a inside rivet hole of P_1 plate, two on the right side of it, and one with broad width on the right side of an outside rivet hole of P_1 plate. In the outside flange angle a broad beach mark was observed on the right side of a rivet hole. These broad beach marks are evidence that the crack rapidly propagated even when the load range was reduced to half. P_3 plate and the inside flange angle exhibited no beach mark. Considering the number, spacing and breadth of beach marks, the fatigue crack is likely to initiate and propagate in the following process. First, a fatigue crack initiates at the left top edge of a inside rivet hole of P_1 plate. Next a crack initiates at the right bottom edge of the same hole. Then the left crack arrives at the left edge of the plate, while the right crack

Fig. 10 Failure Surface of Crack R_A .

rapidly propagates beyond the outside rivet hole until P_1 plate is wholly broken, leaving the last beach mark. In the outside flange angle, by the time that P_1 plate almost fails, a crack starts from the right bottom edge of a rivet hole and rapidly causes a failure, leaving a broad beach mark. And at the 1.6×10^4 cycles after final half-reduced load the inside flange angle and P_3 plate quickly come to a failure. Number of half-reductions of the load is 7 in total till the cracks are repaired and the total number of beach marks recognized on the failure surface is four. From this it follows that the first beach mark emerged at 37×10^4 cycles.

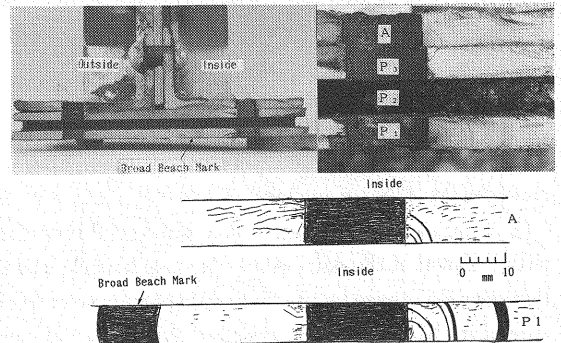
Fig. 11 Failure Surface of Crack L_c .

The beach marks of L_c crack [Fig. 11] were found to be five on the right side of a inside hole of P_1 plate, one with broad width the left side of it, and three on the right side of a hole in the inside flange angle. There were no beach marks recognized on the P_3 plate and on the outside flange angle. From the detailed observation of beach marks, the initiation and propagation behavior of fatigue cracks in this failure surface are considered as follows. A fatigue crack happens at the right bottom corner edge of a inside hole of P_1 plate, leading to a failure of the right section. By that time, a crack starts from the left side of the hole, causing a sudden failure of the whole section of P_1 plate leaving a broad beach mark. The beach marks on the right side of a hole of the inside flange angle are three and the half-reductions of the load after repairing of A-A section are three, indicating that a crack has started from the right bottom edge a short time before the repairing. This crack propagated with relatively stable manner up to the final half-reduction of the load and then quickly advanced to a failure during the succeeding 5.3×10^4 cycles, and in the meantime the outside flange angle and P_3 plate came to a sudden failure. In other words, after the time that the whole section P_1 plate had failed, the cracks in the other elements of the flange suddenly extended, causing a failure of these elements. The half-reductions of the load of these cracks were ten and

the beach marks observed were six in total. Therefore it can be said that the innermost beach mark has emerged at 47×10^4 cycles.

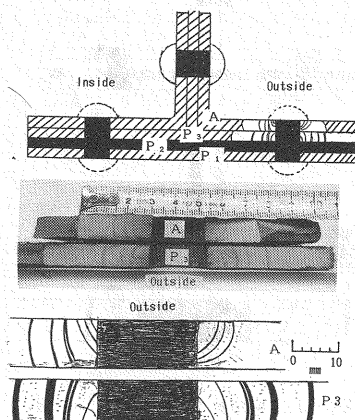
Fig. 12 Failure Surface of Crack R_C .

R_C crack [Fig. 12] is one which was found just after the fatigue test is interrupted and it can be exposed with removal of the paint film. The beach marks revealed were seven on the left side of a hole in the outside flange angle; three on the right side of it; five on the left side of a outside hole of P_3 plate; and six on right side of it. No cracking occurred in P_1 plate which had been most heavily stressed. From the observation of these beach marks, it can be speculated that cracks initiated nearly at the same time before 37×10^4 cycles at the left top edge of a hole in the outside flange angle, and at the left and the right bottom edge of a hole in P_3 plate, followed with a little delay by a crack at the right top edge of a hole in the flange angle. And just before the test was finished, the crack on right side of a outside hole of P_3 plate arrived to the right end of P_3 plate. These cracks propagated with relatively stable manner.

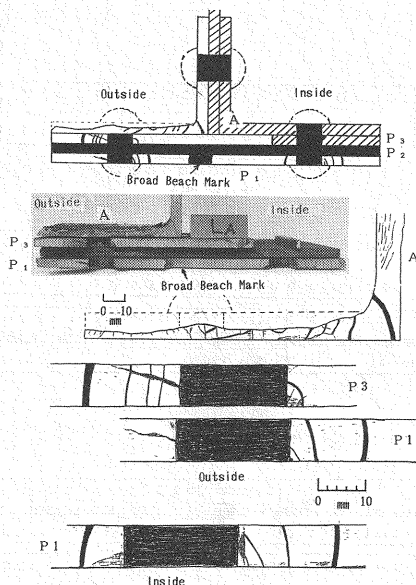
Fig. 13 Failure Surface of Crack L_A .

where the sectional area has been corroded to less than half the original area.

Observations of failure surface of L_A and L_D cracks indicate that (a) when the sectional area has been reduced to a half by corrosion, as the stress concentration results in being large at the notches on the rough irregular surface, a crack is more liable to start there than in the riveted part and (b) a crack which initiates from the corroded surface behaves more stably than one initiated from the riveted part and the former is a little easier to detect than the latter, accordingly more likely to be detected and repaired at the time of inspection in service.
