# MECHANISM OF PIPELINE FAILURES CAUSED BY SOIL LIQUEFACTION DURING THE 1983 NIHONKAI-CHUBU EARTHQUAKE

Nobuaki NISHIO<sup>1</sup>

**Key Words:** earthquake, soil liquefaction, buried pipeline, steel pipeline, seismic damage

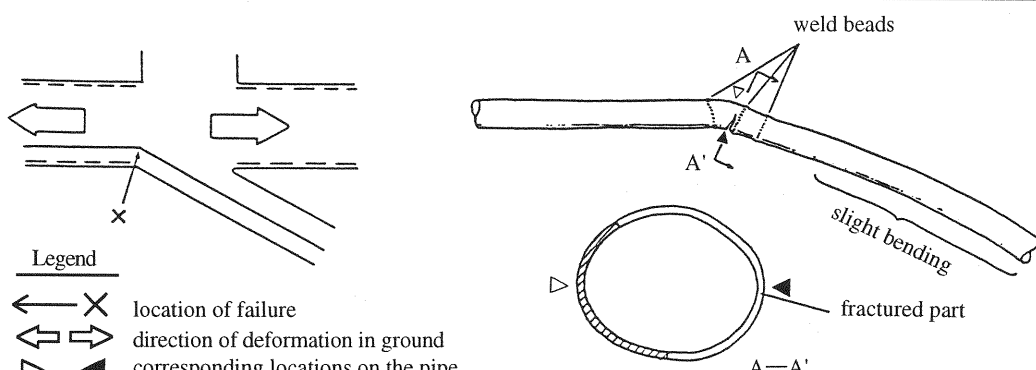
Fig. 3 Failure, Noshiro-No.1

The direction of elbow flattening in Fig. 3 (Noshiro-No.1) was perpendicular to the plane

Address	Nagane, Noshiro	Nominal diameter/Thickness	80/4.2 mm
Location of break	22.5° elbow, heat affected zone		
Primary cause of failure	Static tensile deformation (?)

containing the pipeline axis. This elbow deformation, therefore, is attributed to tensile load (refer to Fig. 2). A slight bending at the straight part also suggests that tensile force was predominant in this location.

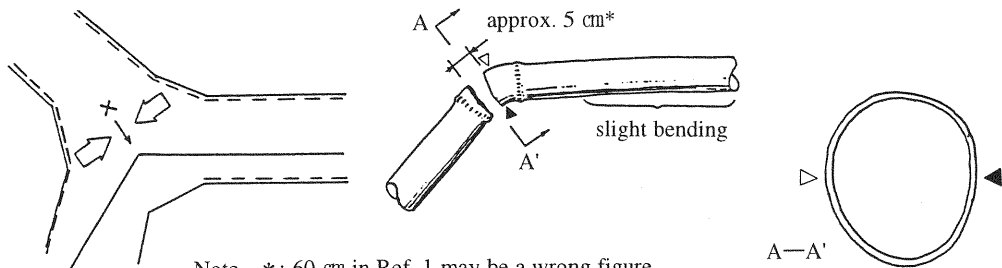
Fig. 5 Failure, Noshiro-No. 3

Address	Nagasaki, Noshiro	Nominal diameter/Thickness	80/4.2 mm
Location of break	45° elbow, heat affected zone		
Primary cause of failure	Tension preceded by slight buckling (due to compression)		
<div>

The failures at Noshiro-Nos. 3 and 4 (Figs. 5 and 6, respectively) show that final fracture was due to tension. They also show, however, the direction of flattening at the elbows is parallel with the plane containing the pipeline axis. This indicates the occurrence of buckling due to compressive force prior to tension. Especially, severe deformation in cross section at Noshiro-No. 4 suggests that both compression and tension occurred more than once prior to fracture. The plastic deformation (flattening) in the elbows due to compressive ground deformation is considered to have been the cause of easy fracture occurrence when subjected to the succeeding tensile force.

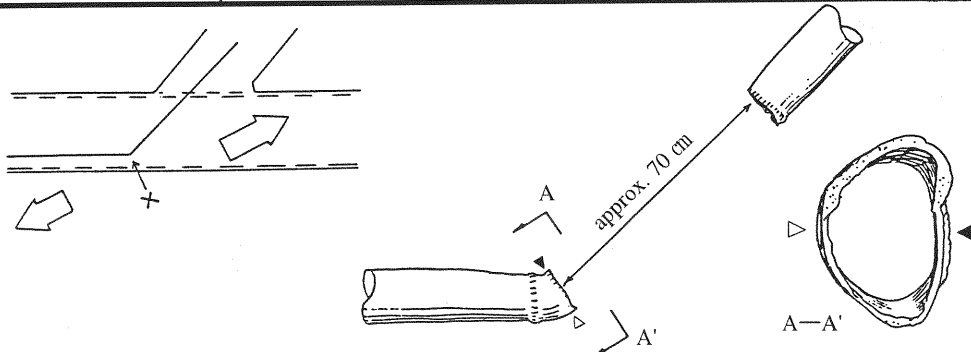
Fig. 6 Failure, Noshiro-No. 4

Address	Nagasaki, Noshiro	Nominal diameter/Thickness	80/4.2 mm
Location of break	45° elbow, weld bead and heat-affected zone		
Primary cause of failure	Repeated compression and tension (finally separated due to landslide)

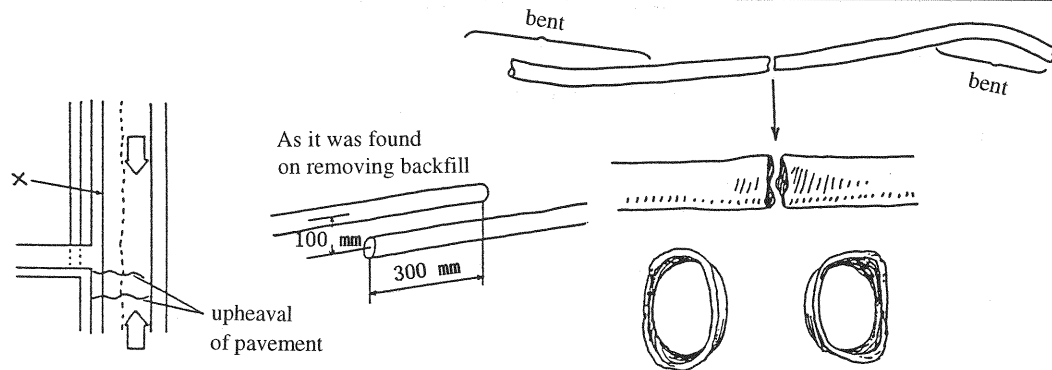
Fig. 8 Failure, Wakami-No. 4

Address	Tamanoike, Wakami	Nominal diameter/Thickness	40/3.5 mm
Location of break	Pipe body (straight part)		
Primary cause of failure	Repeated compression and tension (broken by tension at buckled part)

The failure of Wakami-No. 4 (Fig. 8) clearly shows the evidence of beam-mode buckling. As a result, the pipe was bent to cause the flattening of the cross-section at the fractured part. This is very similar to what has been explained schematically in Fig. 1b. Of course, the fracture took place during the cycle of tensile deformation in the ground, although the final (permanent) deformation was compressive.

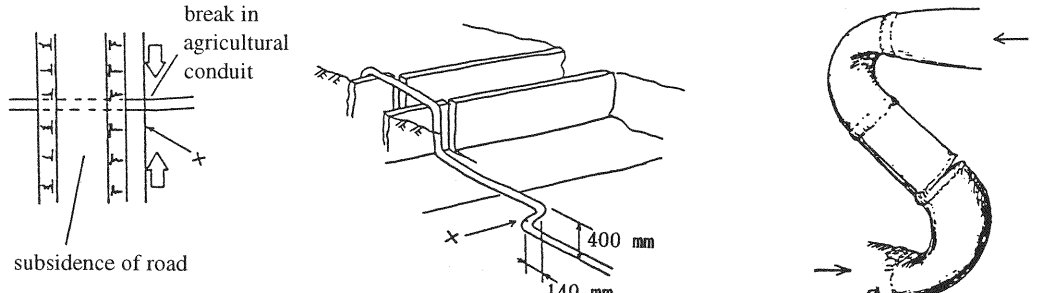
Fig. 9 Failure, Wakami-No. 5

Address	Ohgata	Nominal diameter/Thickness	80/4.2 mm
Location of break	Weld bead of 90° bend		
Primary cause of failure	Static compression (poor quality of weld)

The remaining failures, i.e., Wakami-No. 5, Oga-No. 1, and Oga-No. 4 (Figs. 9, 10, and 13, respectively), all took place at the weld beads. These failures may be due primarily to poor welding. A poorly-welded joint may sustain failure due to static deformation if the degree of deformation is great. The failure of Wakami-No. 5 may not have occurred were the welding of better quality. The failures of Oga-Nos. 1 and 4 are difficult to account for by static ground compression, although the flattening at the elbows shows the action of compressive force. It will be more natural to assume that the cracks in the weld beads were due to tension preceded by compression.

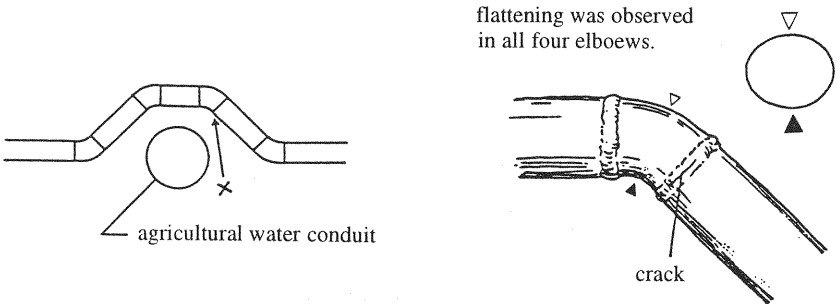
Fig. 10 Failure, Oga-No. 1

Address	Iriai, Oga	Nominal diameter/Thickness	80/4.2 mm
Location of break	Weld bead of 45° elbow		
Primary cause of failure	Compression (slight buckling) followed by tension; primarily, poor weld		
<div>

<p>agricultural water conduit</p><p>crack</p><p>flattening was observed in all four elbows.</p></div>

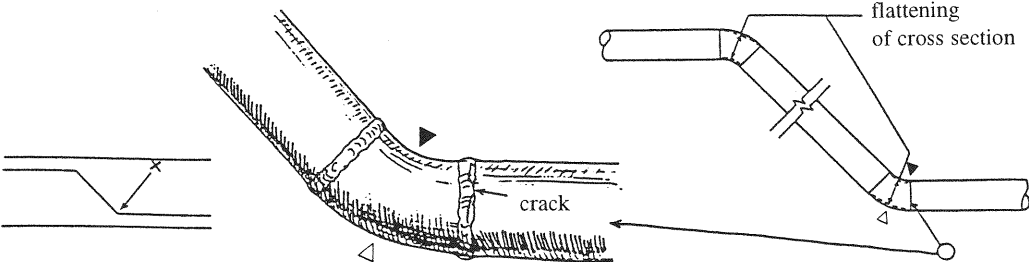
Fig. 13 Failure, Oga-No. 4

The failure processes at Oga-Nos. 3 and 4 (Figs. 12 and 14, respectively) are considered to be more or less similar to that of Noshiro-No. 2. It should be noted that the cross-section at the

Address	Wakimoto, Oga	Nominal diameter/Thickness	100/4.5 mm
Location of break	45° elbow, heat affected zone and weld bead		
Primary cause of failure	Probably tension preceded by compression (slight buckling)
