Dynamic Characteristics of an Overpass Bridge during Destructive Test

University of Tokyo	Member	Dionysius N
University of Tokyo	Member	Tomonori
University of Tokyo	Fellow	Yozo FUJI

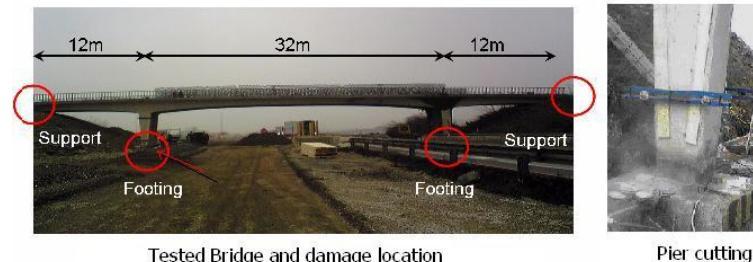
Figure 1. Tested Bridge and damage in progress

The tested bridge is an overpass located in Reibersdorf, Upper Austria west side of Vienna Austria. It is a post-tensioned concrete bridge with the main span of 32 m, two side spans of 12 m, and the width of 6.6 m. The deck is continuous over the piers and is built into abutment (Figure 1). Although there were no known structural problems, the bridge had to be demolished to allow a space for additional lane of highway underneath. Before demolition series of vibration test was carried out by the Vienna Consulting Engineers (VCE).

Damage was introduced to the structure by slicing the pier above the footing. The cutting was made twice, the first was 2cm layer of column (named hereafter as Damage 1) and the second was also 2cm (marked as Damage 2). When the pier had completely severed from the footing cap, a temporary support was gradually released until the pier was completely suspended. During this time, vertical settlement of the bridge was recorded continuously until the final settlement reached 2cm (Damage 3 and Damage 4). Finally, the pier was completely suspended and no further settlement was observed (Damage 5). At the last stage, a steel plate was inserted to close the gap between pier and the footing. In this condition the pier rests on the plate and the stage is named 'retrofitted' stage. Throughout damage process an ambient response of the bridge was recorded at the sampling rate of 100 Hz. The records were divided into 37 frames of 5 minutes signal.

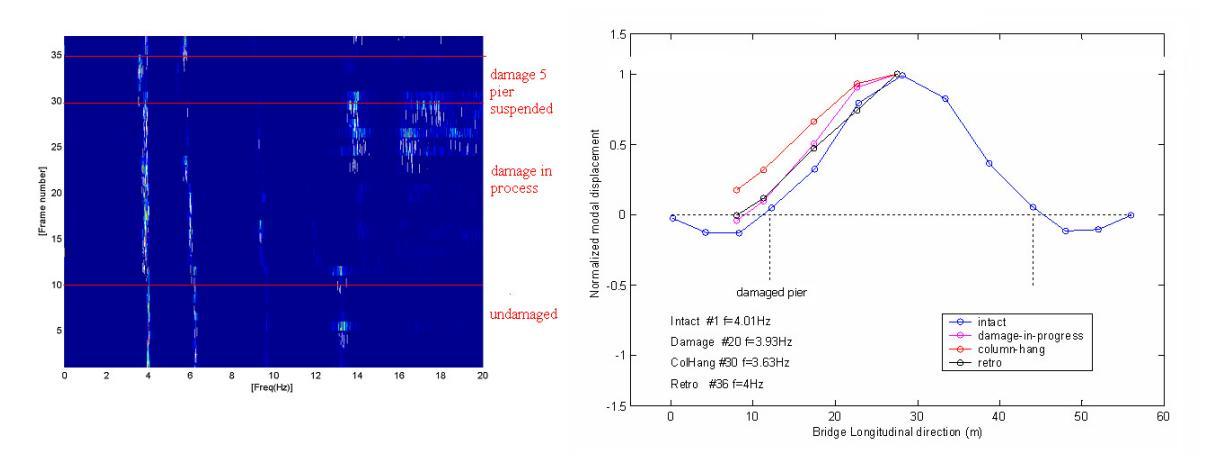
Figure 2. Spectrogram of vertical acceleration

Figure 2 shows the spectrogram of Reference sensor throughout the measurement. The dominant frequencies at the girder in vertical direction appear in the range of 1-15 Hz. In the undamaged part, one can see four distinct vertical lines representing four natural frequencies within the range of 3 to 14 Hz. Starting from frame number 11 one can observe the leftward shift of natural frequencies especially the forth mode (13 Hz). The other modes show apparent shift starting from frame 20 onward, which correspond to the time when the bridge experienced 2cm of vertical settlement. Leftward frequency shift of the first, second and third mode continues until frame number 34. Largest shifts were observed at the time when the pier was completely suspended indicating the significant reduction of stiffness.
