BEARING MALFUNCTION IDENTIFICATION OF STEEL BEARINGS FROM RESPONSE MEASUREMENT

The University of Tokyo Student member OHafiz Ahmed WAQAS The University of Tokyo Regular Member Di SU The University of Tokyo Regular Member Tomonori NAGAYAMA

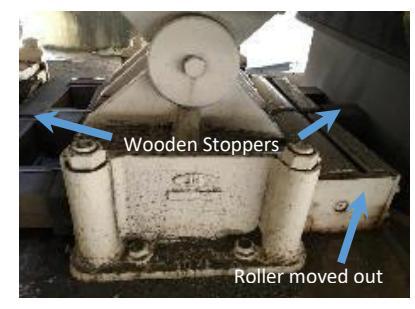
Simply supported span of one steel girder bridge in Yokohama city was considered. One of the pin-roller bearing was found damaged with partial unseating because of earthquake. The bearing was temporarily retrofitted which restricted the bearing movement in longitudinal direction and caused the sliding malfunction (figure 1). The malfunctioned and good condition bearings located side by side were instrumented with laser displacement sensors and wireless acceleration sensors, with sampling frequency of 1000 Hz and 100 Hz, respectively. Figure 2 shows the instrumental setup of laser displacement sensors and reference axis adopted for discussion. Two sets of wireless acceleration sensors were firmly attached with double sided tapes at above the bearings on the girder flanges and on the piers. Measurements were carried out for about 6 hours to record possible effect of temperature also. Bridge span comprises of two lanes namely the slow lane and fast lane. Malfunctioned bearing was located at slow lane end and good condition bearings was located at the fast lane end. For the sack of comparison the input to the bearings should be identical and for this reason a test vehicle was ran in either lane close to each bearing to impose the same input actions. During the test vehicle movement over the bridge, there were no other vehicles present and if any vehicle appeared on the bridge the response information was not taken into account. Results of experiments are presented in the following section.

Fig .1. Retrofitted bearing on site

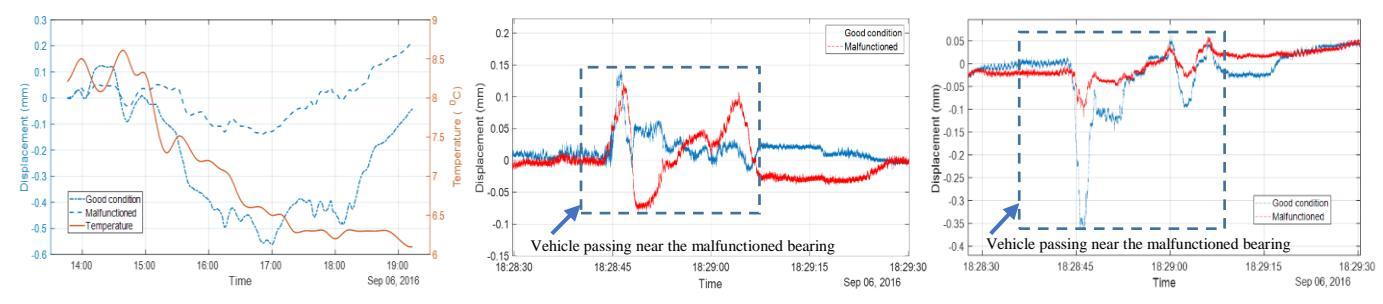
Laser displacement sensor response recorded both the traffic and temperature effects in terms of visible peaks and nonlinear response, respectively. Thermal effects were isolated by low pass filtering with cutoff frequency of 1×10^{-3} Hz. Temperature and isolated thermal displacement response of bearings in longitudinal direction are plotted in figure 3(a) and bearing with good condition is appeared to be following the temperature change. Laser displacement response under the test vehicle driven near the bearing is shown in figure 3(b) and 3(c).

Fig. 3 (a). Temperature and longitudinal response plot (b). Vertical displacement response (c). Longitudinal displacement response

Bridge girder at malfunctioned bearing location had upward and downward vertical displacements while the girder at other location has only downward vertical displacement (figure 3(b)). This behavior is linked with the rotational capability of girder and difference is actually due to the sliding restrictions as can be seen in figure 3(c) that is the longitudinal displacement of malfunctioned bearing is close to zero. Normally when vehicle passes over the bridge, bearing slides in longitudinal direction and girder rotates which is reflected as downward displacement response and then finally equilibrium is attained. Whereas in case of malfunctioned bearing under the input action it does not slide and energy is dissipated via rotation only which is reflected as both upward and downward displacement response and it continues until the equilibrium is attained. Similar phenomenon was observed when vehicle was passed closer to the good conditioned bearing. Observation of restricted longitudinal displacement is compatible with actual site condition and increased bearing rotational demand is perceived from response that is due to difference of sliding mechanisms of both bearings.

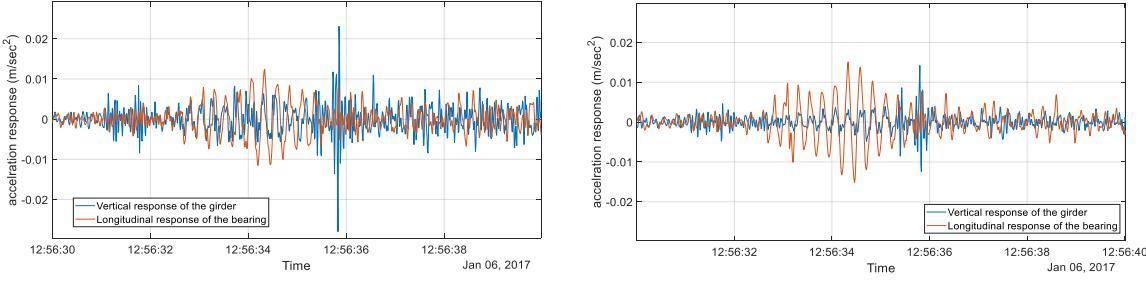
From the aforementioned discussion, difference in vertical acceleration response of girders and longitudinal acceleration response of pier under the same input could be expected and hence simultaneously considered. Acceleration data was high pass filtered to eliminate the very low frequency components. Vertical acceleration response of girders at good condition bearing location was found to be higher (figure 4(a)) than the response at malfunctioned bearings (figure 4(b)). This is because the vertical displacement of girder at properly functioning bearing was only in downward direction which continue to increase or decrease whereas vertical displacement of girder at malfunctioned bearing had upward and downward movement which changes more frequently and result in lower acceleration response. Additionally, longitudinal acceleration response of pier at malfunctioned bearing location was also found to be larger in value (figure 4(b)) which is mainly due to its virtue of attracting greater share of imposed actions from superstructure as a result of longitudinal restrained condition of bearing.

Fig. 4 (a). Response at good condition bearing (b). Response at malfunctioned bearing
