第 部門 GIS Analysis of Damage Pattern in Nagaoka Water Pipelines during the Niigata-Chuetsu Earthquake

1- Abstract

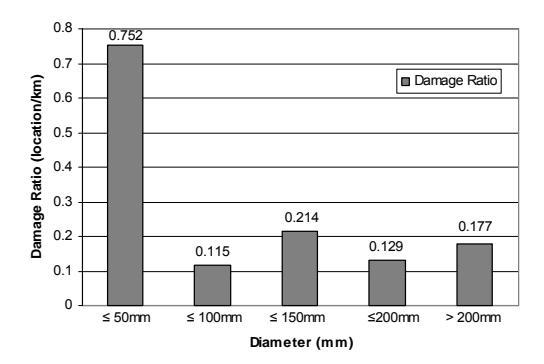
group of pipelines the damage ratio is calculated by dividing the number of damage by the total length of water pipelines in each grid. For example, overlaying the pipeline network and damage locations with Nagaoka District as well as damage ratio of pipelines in each mesh with respect to different diameters are shown through the Fig. 2 to Fig. 4. Also number of pipe damage in any type of geomorphology due to the pipe diameter is presented in Fig. 5. From these figures, it can be illustrated that in the case of large pipes diameter, pipe damage shows higher values in natural slope compared with other geomorphologies. In addition, damage ratio of the medium pipe diameter has higher values in both slope on mountain and natural slope. Furthermore, damage ratio with respect to the small diameter shows higher values in natural slope, valley plain and gravelly terrace.

Fig. 2. Damage pattern of pipelines with small diameter

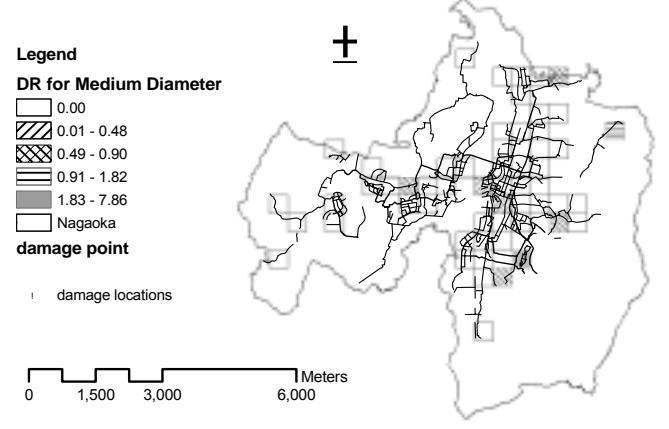
Fig. 3. Damage pattern of pipelines with medium diameter

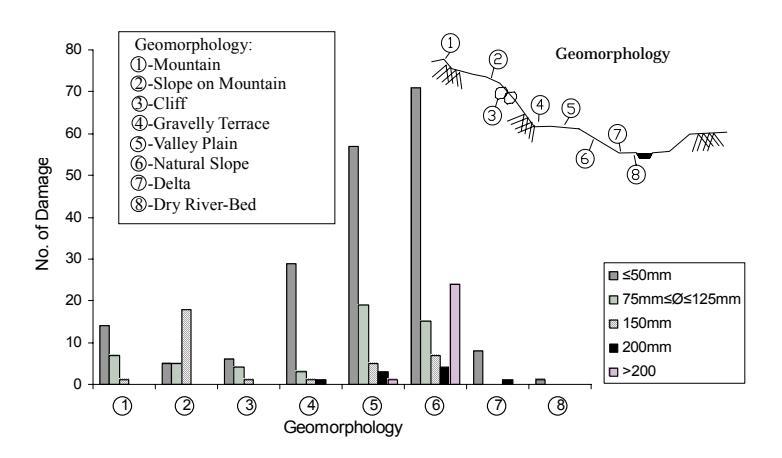
Fig.5. Number of damage for different diameters due to geomorphology
