Damage to Structures in Rikuzentakata Region Due to Tsunami

1. Introduction

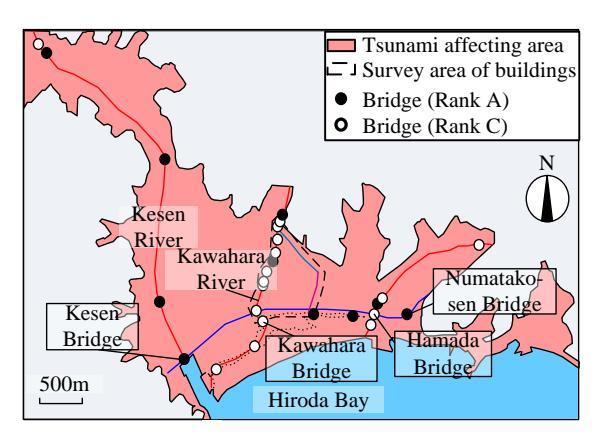
Fig. 1 Research Region for Rikuzentakata

For bridges, damage conditions of 26 bridges can be referred from Fig. 1. Rank A (girder flowed out) occupies 38.5% (Fig. 2 (c)) while Rank C (girder survived with slight damage) takes 61.5%. In Fig. 1, it is found 80% bridges in the Kesen River suffered Rank A (4 in 5); while only 18% in the Kawahara River (2 in 11). Using distance measurement of Google Earth, Kensen River has greater size (width about 120m) than Kawahara River (width about 15m). Direct run-up of tsunami in the greater size river is considered the reason for more serious damages to the related bridges.

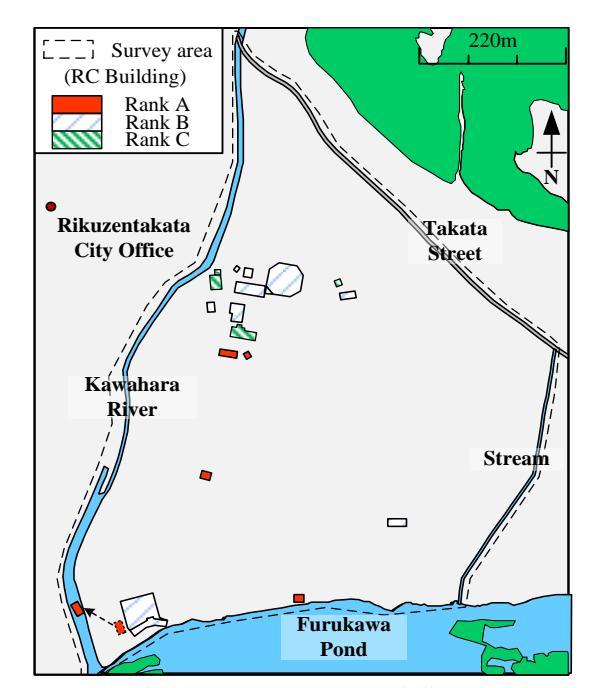
Fig. 3 Survey Area to Buildings

The survey area for buildings, (Fig. 3) being flat and close to the coastline, suffered great damage. Among total 16 RC buildings (Fig. 2 (a)), proportion is 31%, 50% and 19% for Rank A (structural elements damaged), B (non-structural elements damaged) and C (slight damage), respectively. Around 70% of RC buildings suffered non-structural damage (sum of Rank B and C). While 100% of all 612 timber buildings are washed away (Rank A, Fig. 2 (b)). Thus, RC buildings have greater resistance to tsunami impact. Fig. 3 presents the distributions of RC buildings in survey area. There is the trend that Rank A buildings are in smaller size inducing smaller stiffness to resist tsunami impact. Further, Rank A buildings are mainly distributing in regions relatively closer to the coastline.
