## Investigation on Corrosion Pit Characteristics of Severe Corroded Weathering Steel

Kyushu University Student MemberOQidi WANGKyushu University Fellow MemberShigenobu KAINUMAKyushu University Regular MemberMuye YANG

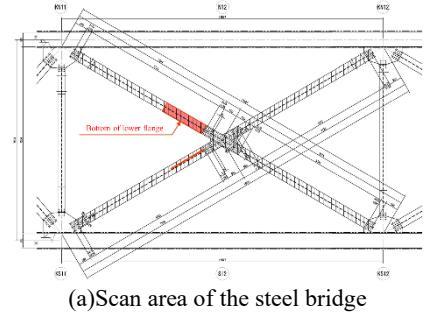
During this investigation, scanned the shape of the corrosion pits on the upper flange, the web, and the lower flange as shown in Fig1(a), and summarized the characters of the corrosion pits of weathering steel. The surface parameters of the corrosion pit are measured by the 3D LED scanner (decomposition energy as 0.01 mm) based on the structured projection phase shift method<sup>3,4)</sup>. The measured scanning step is 0.2mm. The chosen scan area is the center of the corrosion area with 100mm in length and 80mm in width. The scanned area is shown in Fig.1(b), and the scan result is the spatial coordinates of the corroded surface, drawn as a 2D image as shown in Fig.1(c).

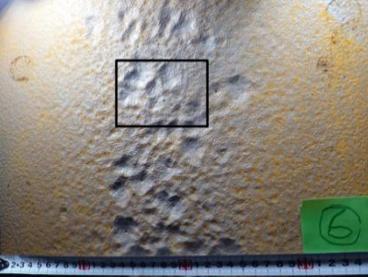
(b) Corrosion pits on the lower flange Fig.1 Corrosion pits of weathering steel structure

The corrosion pits of weathering steel are almost independent pit and do not overlap with each other, as shown in Fig.1(b). The most severe corrosion occurred at the bottom of the lower flange plate, mainly in the middle of the flange, where rain and dew are always concentrated. The width of the lower flange plate of the steel bridge is 360mm, and the width of the corroded area is about 120mm, accounting for 1/3 of the entire lower flange plate. The corrosion degree of the inner side of the upper flange plate of the lateral bracing is lower only by the bottom of the lower flange plate, and the corrosion pits are also in the middle part of the flange, but more concentrated in the area close to the web, which is caused by the flowing tendency of water. On the web, obvious corrosion pits only be found in the upper part. The corrosion pits at the web should be formed by the rainwater and dew condensation water flowing down from the upper flange and web plate.

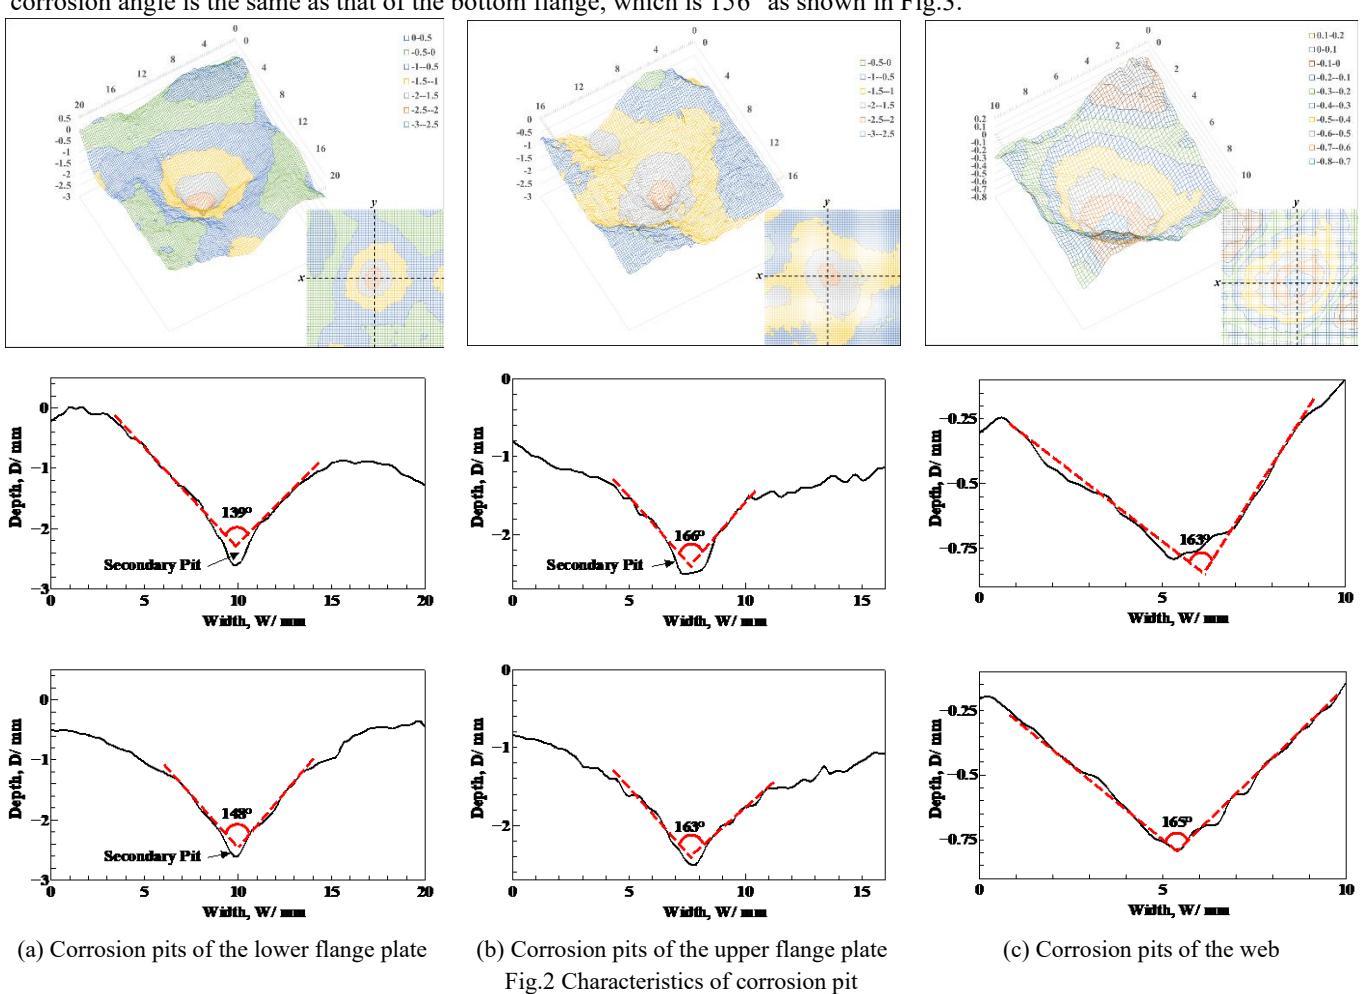
In the investigation of the upper flange, scanned the surface of the inner side of the upper flange of the lateral bracing, chose 16 corrosion pits from this area for analysis. The corrosion depth of these pits is from 1.10mm to 3.39mm, smaller than the pits on the lower flange. Among these corrosion pits, only five of them have secondary corrosion pit. The corrosion depth of these corrosion pits also exceeds 2mm. As shown in Fig.2(b), corrosion pits of the top flange are also cone shape, and their average

The corrosion pits on the web are significantly smaller than the flange. Scanned the upper part of the web and chose 14 corrosion pits for analysis, the maximum corrosion depth the chosen pits is 1.14mm, and no secondary corrosion pits in them. As shown in Fig.2(c), the corrosion pits on the web are also cone shape. The average angle of the corrosion pits on the web is  $166^{\circ}$  as shown in Fig.3, larger than the pits on the flange.

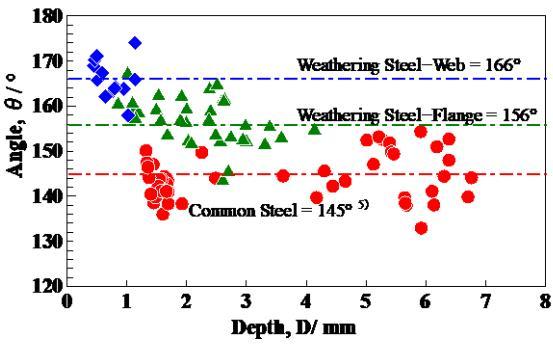
Fig.3 Relationship between pits' angle and depth

corrosion angle is the same as that of the bottom flange, which is 156° as shown in Fig.3.

The previous research analyzed 27 corrosion pits from two corroded components from a common steel bridge in Kitakyushu expressway<sup>5</sup>). These corrosion pits appear on the upper side of the steel beam, and most of them overlap each other. The average cone angle is around 145° like shown in Fig.3.
