# DAMAGE TO TUNNELS IN THE OCTOBER 23, 2004 CHUETSU EARTHQUAKE

Key words: Chuetsu earthquake, landslides, active folding, tunnels

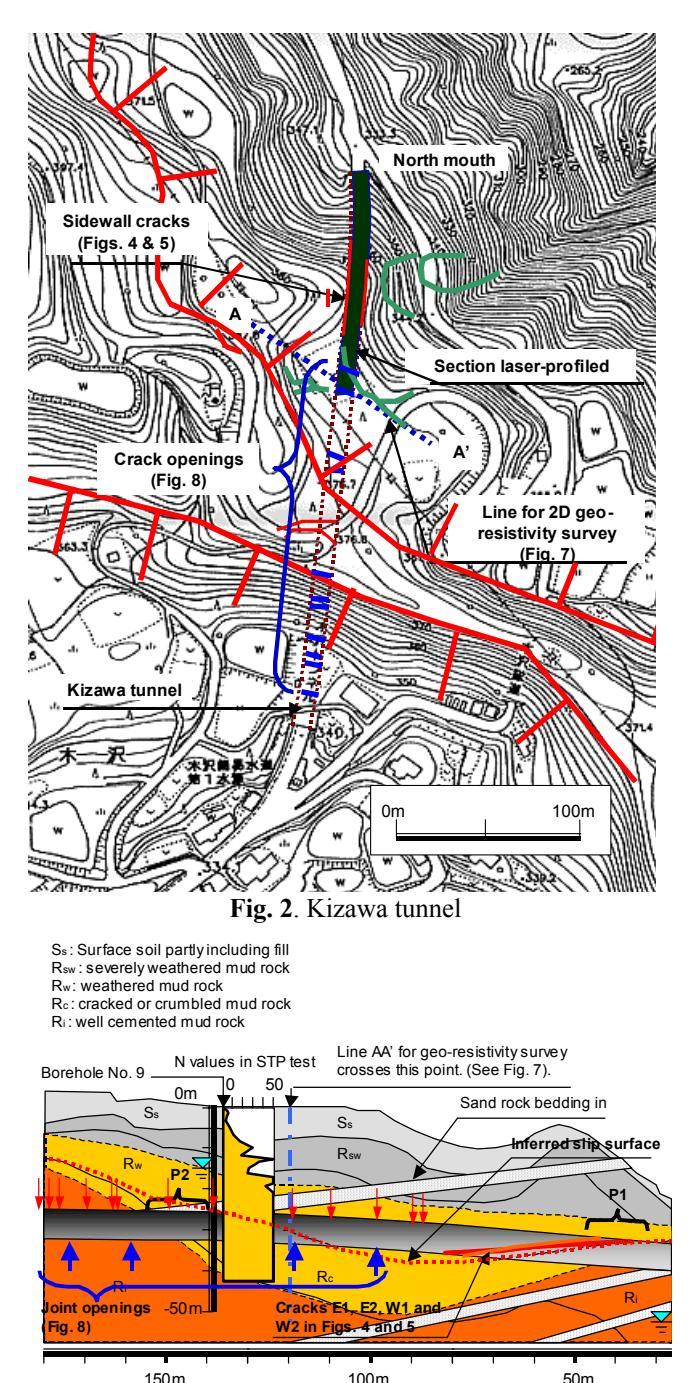
Fig. 3 shows the soil/rock profile along the tunnel. Though the rock layers forming this mountain show a normally stratified geological structure sloping about 18 degrees towards SW (Yanagisawa et al.<sup>2)</sup>), a different image of structure appears when the rocks are described in terms of their strengths. The northern part of the tunnel crosses, at points P1 and P2, a severely cracked and/or weakened mud rock layer lying over a depressed surface of an almost intact mud rock.

**Fig. 3**. Soil/rock profile along Kizawa tunnel <sup>1)</sup>: Downward thin arrows on the tunnel crown show locations of cracks cutting the tunnel axis upright and diagonally crosswise, while upward thick arrows show locations of joint openings (see Fig. 8).

As has been mentioned, the northern part of the tunnel crosses at two locations, P1 and P2, a severely cracked and/or weakened mud rock layer (Fig. 3). The cracks E1, E2, W1 and W2 shown in

Fig. 4 seem to have appeared in this weakened mud rock zone P1 near the north tunnel mouth. On the other hand, Cracks that appeared on the concrete lining (downward thin line arrows in Fig. 3) over some longer distance (100-180m) covering P2 zone, cut the tunnel axis upright and diagonally crosswise. This pattern of cracking seems to suggest that the tunnel was slightly bent towards the east-sloping mountainside. A lot of water reportedly came out of

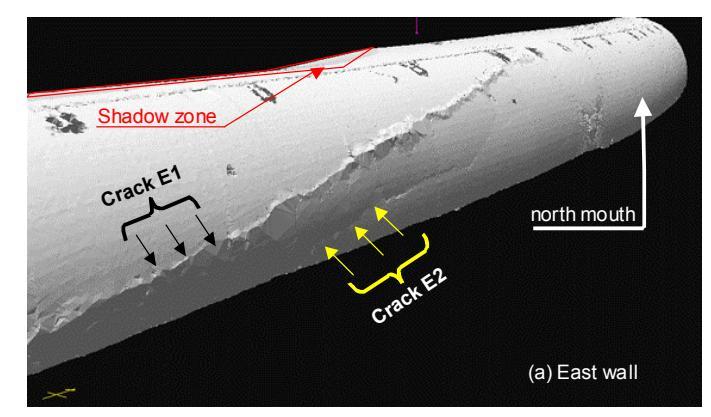
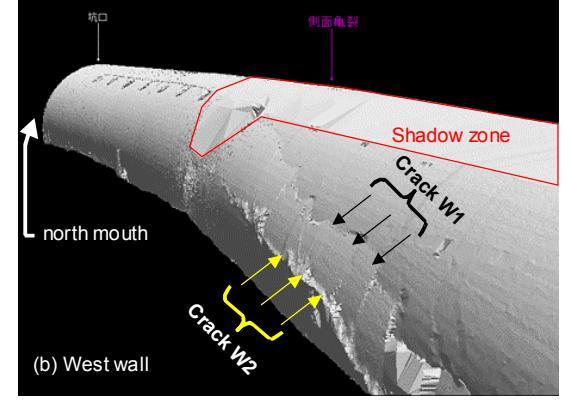
**Fig. 4**. Laser-profiled north segment of Kizawa tunnel: Laser-profiling was conducted after a steel frame was put up in the damaged section for protection of vehicles against possible danger. Therefore, there was a shadow zone where a laser beam did not reach.

The Northern 120m segment of Kizawa tunnel (Fig. 10) was laser-profiled. Fig. 4 shows that two pairs of major cracks, E1, E2, and W1, W2, go diagonally up through the tunnel (see Fig. 13). The cracks, E1 and E2 on the east wall (Figs. 4(a) and 5(a)), extend over the 45 to 83m distance from the north tunnel mouth, while W1 and W2 (Figs. 4(b) and 5(b)) over 38m to 88m distance on the west wall. Fig. 6 shows three cross-sections at 51, 55 and 59m points together with an intact cross section measured at 100m point. It is clear from this figure that the pairs of cracks on the wall became hinges for the upper half of the tunnel cross-section that was pushed 40 to 50 cm east and about 10 cm down.

This part of the tunnel passes 20 to 30 m to a mountainside sloping to the east, and the damage is considered to have been caused by the motion of the soil/rock surrounding the tunnel, which motion was not clear in appearance from outside. Some minor cracks found on the ground surface were mapped on Fig. 2. As we find more cracks hidden there, a clearer image of the landslide mass will emerge.

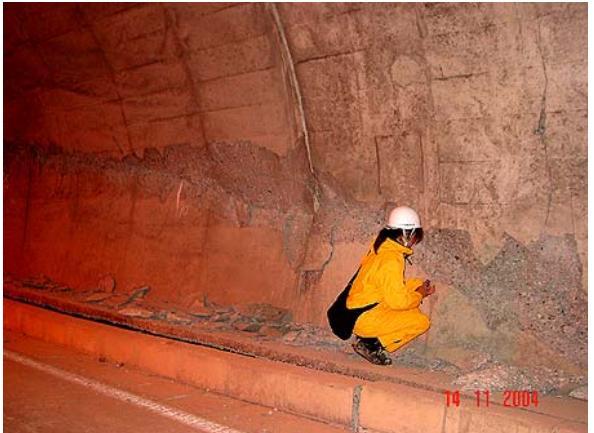
(a) Crack E1 on east wall

**Fig. 5**. Cracks appeared on the north segment of Kizawa tunnel

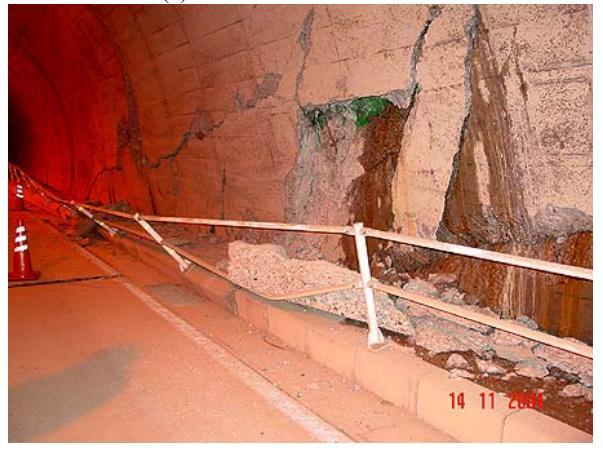
(b) Cracks W1 and W2 on west wall

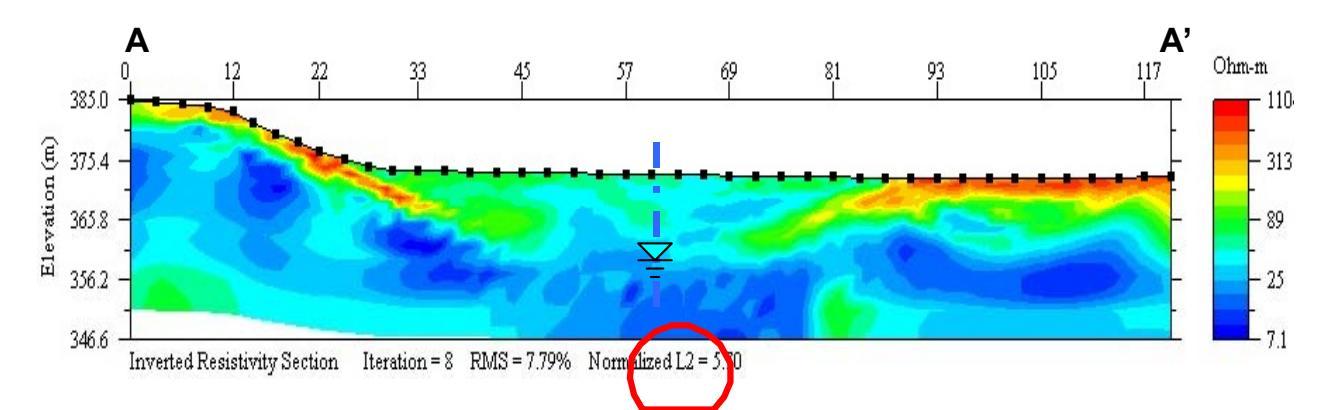
Fig. 7. Spatial distribution of geo-resistivity across Kizawa tunnel

Near this borehole, a 123m-long line, A-A', was taken along a depressed ground surface for geo-resistivity measurement (see the broken line A-A' in Fig. 2). This line crosses in its middle over the tunnel at an angle of 60 degrees. The possible pattern of geo-resistivity distribution, obtained from an inverse analysis (Fig. 7), shows a shallow zone with high resistivity of about 300-2000 Ohm·m suggesting the presence of the original ground surface (0-36m and 72-123m). Low resistivity zones underlie this zone. In the middle of Line A-A' over the most depressed and flat configuration (26-90m), the surface soil deposit of about 15m-thickness is underlain by a lower resistivity zone (about 7-20 Ohm·m) whose upper surface is about identical to the underground water level in Borehole #9. This zone with an inclusion of the tunnel near the deepest bound of the geo-resistivity measurement (red circle in Fig. 7) is a little asymmetric. The presence of the tunnel may be affecting the underground water flow.

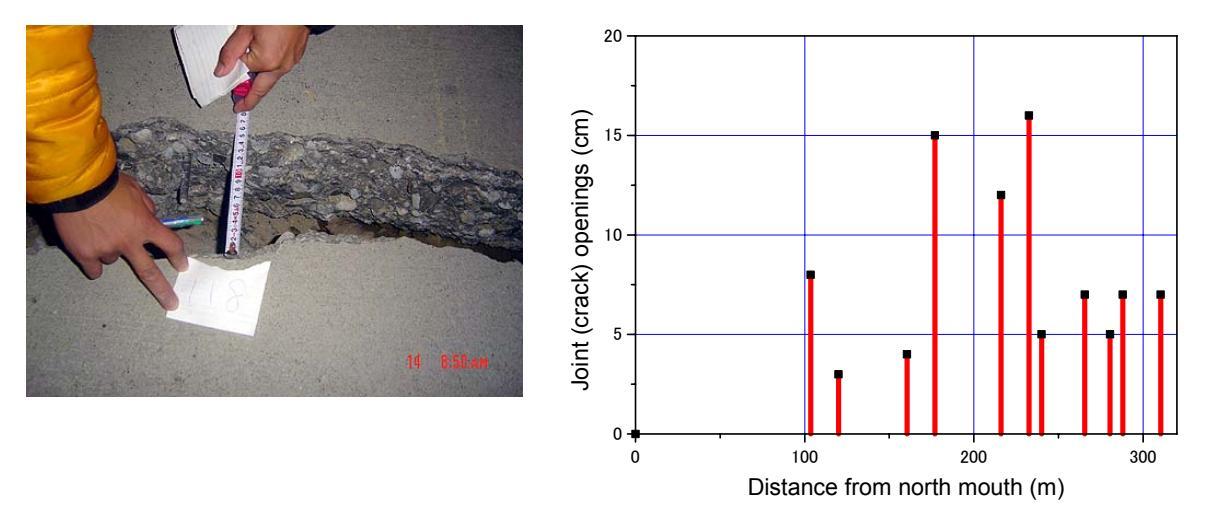
Fig. 8. Openings of the joints with respect to their distances from the north tunnel mouth

Expanded pavement joints were mostly found over a segment 100 to 305m from the north tunnel mouth, namely, southern two thirds of the tunnel. Fig. 8 shows the openings of the joints with respect to their distances from the north tunnel mouth. The figure says that the tunnel was expanded 89 cm axially. Figs. 1 and 2 suggest that the expansion of the tunnel axis may have caused partly by the motion of the surrounding soil near Escarpment XX'.

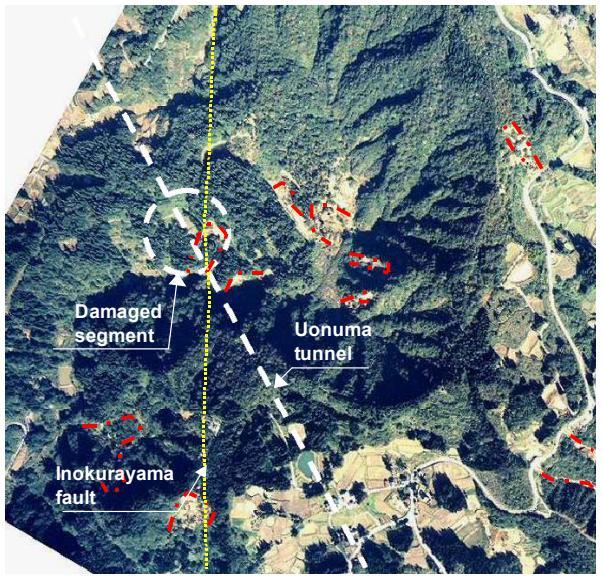
**Fig. 11**. Arial photograph of the area above the damaged segment of Uonuma tunnel (Photograph provided by Geological Survey of Japan).

As seen in Fig. 11, some landslides occurred above the tunnel damage location. Other researchers and also the authors research group have made field trips to different areas along the Inokurayama fault, but no direct evidence, such as soil offsets and/or cracks indicating a fault-reactivation, was found.

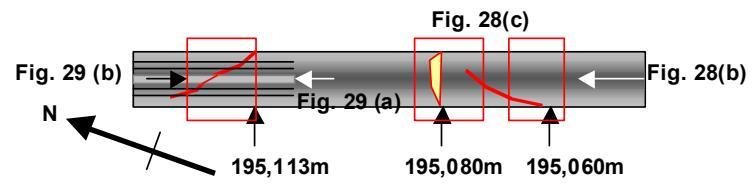
Cracks and a development photo of the damaged tunnel segment (Fig. 12(a)) between 195,060 and 195,080 m (distance measured from Tokyo station) are given in Figures 12 (b) and (c). Several cracks cut the tunnel diagonally from the south to the center of the damaged area. These diagonal cracks merge at their southern ends to form a thrust dislocation showing about 13 cm shortening of the lining at this point. At the center of the damaged segment, the concrete crown broke up into large pieces, and fell in onto the rails and their slabs. The spalled part of the tunnel crown in Fig. 12(c) exposes steel supports. In Figure 12(c), the south part of the damaged area is to the right and the central part to the left. The northern part of the damaged segment (195,113m -) has lighter damage and the rail foundation was not deformed as much as in the south part (see Figure 13(a)).

(a) Damaged segment of Uonuma tunnel. Boxes correspond to location of photos in c) and d)

Due to the tunnel depth at the damage location, the shallow landslides above the tunnel could have nothing to do with the damage. Most likely the tunnel was damaged due to a minor slip on a possible small fault segment crossing the tunnel and/or the overall horizontal compression due to movements of a nearby fault. This should have been responsible for the apparent shear plane failure pattern as shown in Figure 12(a).

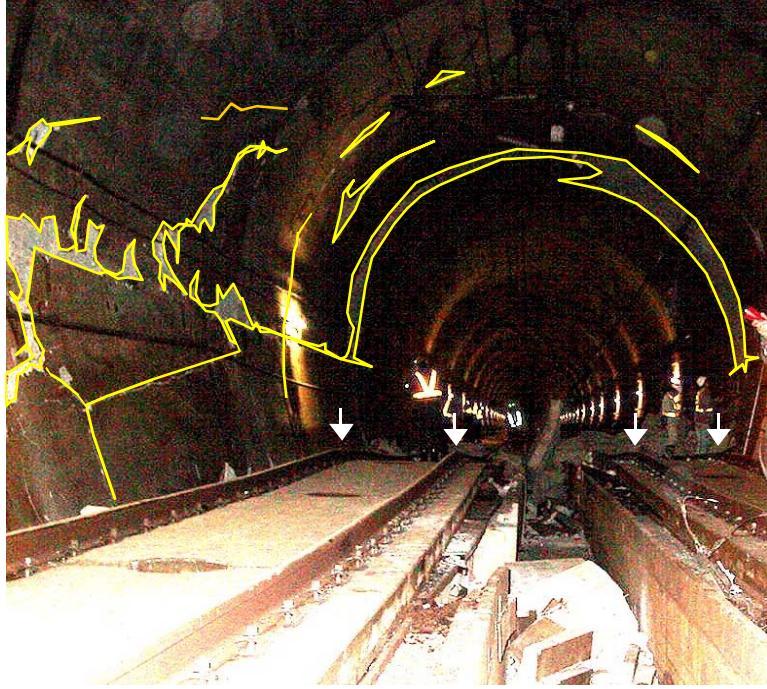
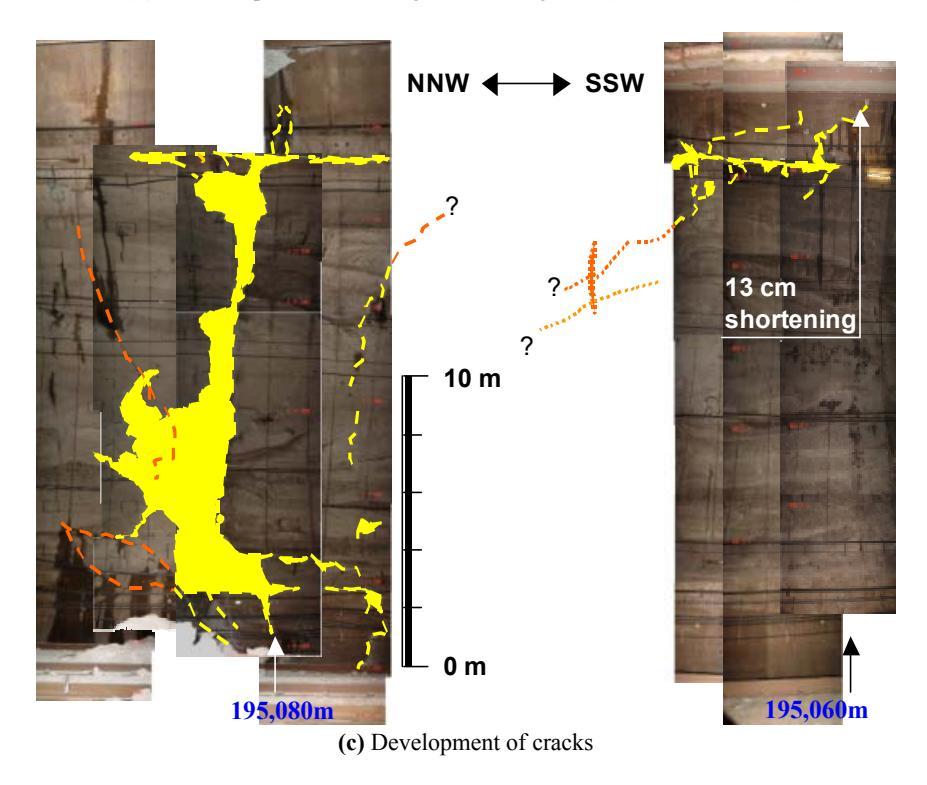
(b) Southern part of the damaged tunnel segment (from south to north)

Fig. 12. Cracks in the southern part of the damaged segment of Uonuma tunnel (195,060-195,080 m)

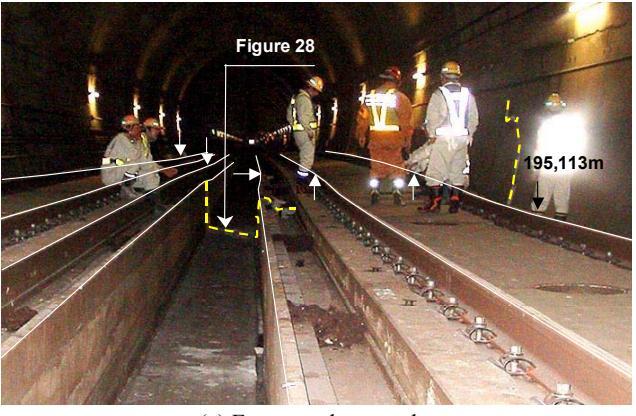
(a) From south to north

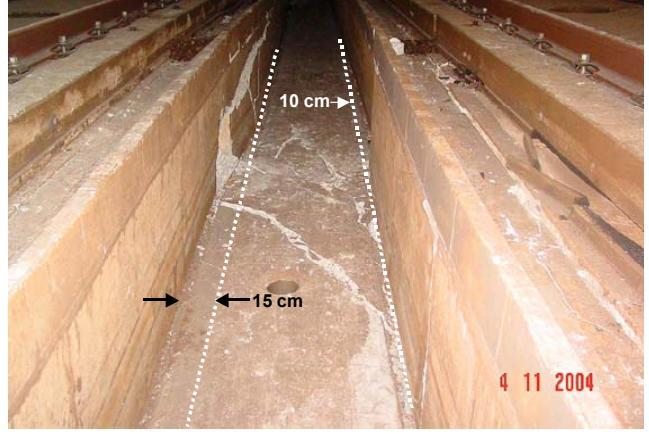
(b) From north to south

However the center ditch along the rails shows a clear right-lateral shift of about 10-15cm where it is crossed by crack. NW-SE trending diagonal cracks were prevalent there (Fig. 13(b)).

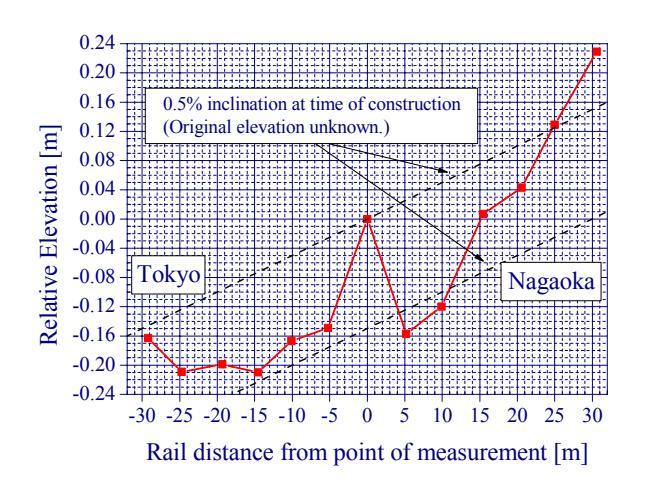
Figure 14 shows the relative elevation of the rail measured with the help of laser range-meter, which was put on the high point in the damaged area about 10 meters south of downfallen concrete block (white arrows in Figure 12(b)). Buckling deformation of the rail slabs is clear from the figure. Between 0 and 5 meters there was a maximum vertical difference of 18cm compared to the 2 cm difference due to the 5% inclination at the time of construction.

**Fig. 14** Relative elevation of the down-traffic rail (origin = 195,070m from Tokyo)
