FIELD INVESTIGATION ON THE DAMAGE OF PRAMBANAN TEMPLE, HOUSING AND INFRASTRUCTURE CAUSED BY EARTHQUAKE IN CENTRAL JAVA, INDONESIA

Tsuneo OHSUMI¹⁾ and Koji Baba²⁾

An earthquake with a magnitude of 6.3 has occurred on May 27, 2006 and caused 5,700 casualties. Investigation on damage for the Prambanan temple, housing and infrastructure was carried out in and around Yogyakarta, in central JAVA from June 5 to 8, 2006 The Prambanan complex sustained heavy damage, even this complex is located 40 km far north east of the epicenter. It is considered that the seismic wave was amplified due to the directivity effect and attacked Prambanan complex. Extensive damaged areas are distributed in the west side of the Imogiri fault. Serious damaged areas are limited in Bantul and in Klaten Regency. Damaged areas begin in Klaten Regency between Solo and Yogyakarta. In Bantul Regency, there were more than 4,000 casualties. The infrastructure suffered comparatively light damages, however, housing sustained heavy damages and totally collapsed in Bantul Regency. In this report, reasons why the infrastructure sustained light damage while housing suffered heavily and as well as why damage areas are distri

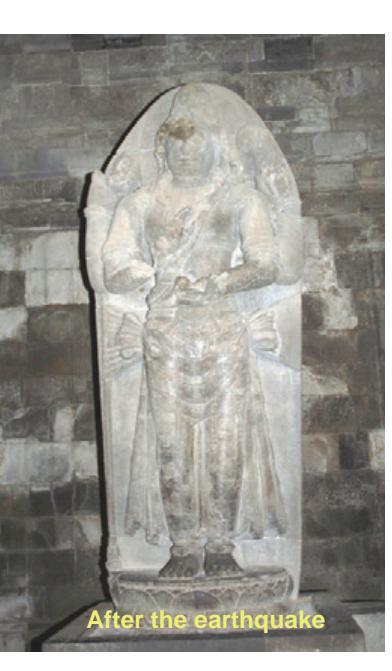
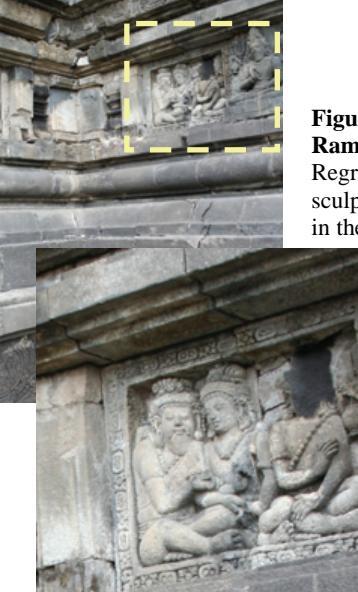
The statue of Siwa niched inside the Siwa temple was not damaged by earthquake. It is clear by comparison of before (left side of **Figure 9**) and after (right side of **Figure 9**) the earthquake. The Ramayana epic engraved on the inner wall of the Siwa temple is very well known (**Figure 10**). Regrettably, this sculpture was damaged by the earthquake (**Figure 11**). The falling stones damaged some parts of the gallery of the Siwa temple (**Figure 11,13**). Some cracks are observed in all corners of this temple. The structure of this temple is a cantilever structure supported by the base stage, then, shaking by earthquake caused a large moment at the support, consequently cracks happened. The width-wise of the cracks is deemed not so serious, and depth of crack is not clear. It is difficult to judge whether temple suffered serious damage or not. Thus, detailed diagnosis of these temples is recommended to be done.

Figure 10 Ramayana epic Regrettably, this sculpture was damaged in the earthquake.

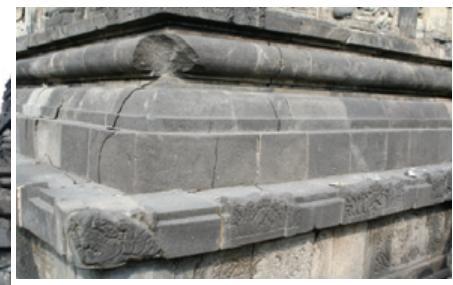
Figure11 The gallery of the Siwa temple were damaged. Some cracks appeared in the corner

section of this temple. All corner sections of the Siwa temple had cracks.

2) As the width of the cracks is not so large and the depth of the cracks is not clear in the Siwa temple, it is difficult to judge whether the temple was seriously damaged or not. In this sense, a detailed diagnosis of these temples is recommended.

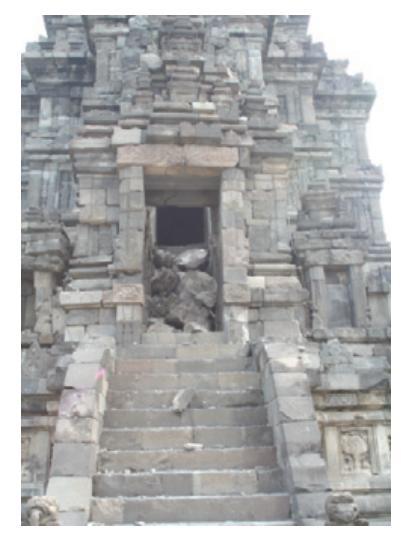
Many parts of the top of Brahma, which has a height of 37m, fell down and closed the entrance. Stone works called as Ratna (crown form decoration) fell down from the top of Brahma and are scattered around the site (**Figure 12**).

Figure 12 Falling parts from the top of the Brahma temple.

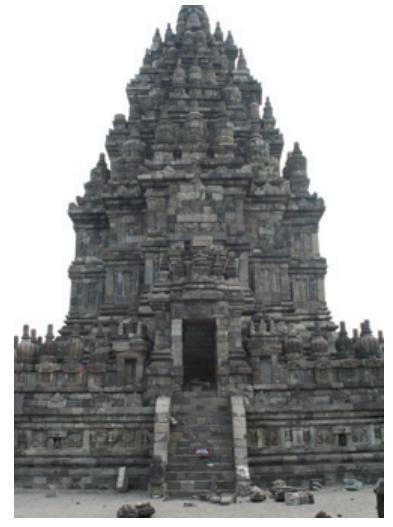
Figure 13 All corner sections of the Siwa temple had cracks.

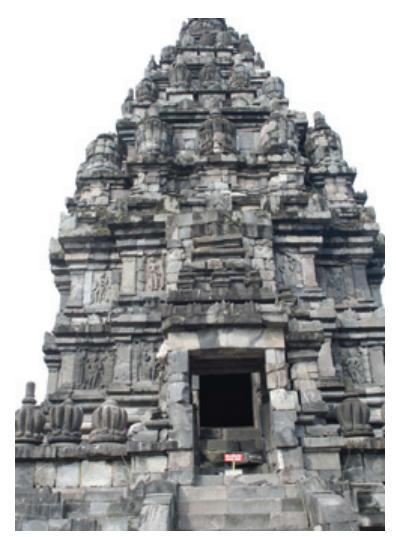
The Wisnu temple is damaged relatively light by the earthquake. Many parts of Ratna which fell from the top caused damage to the corridor (**Figure 14,15**).

Figure14 The Wisnu temple sustained relatively little damage.

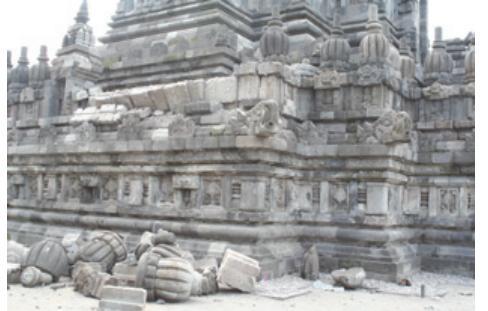
The Garuda temple was being repaired and many parts suffered serious damage. This temple is leaned slightly due to the earthquake (Figure 16).

Figure 16 The Garuda temple is leaning due to the earthquake.

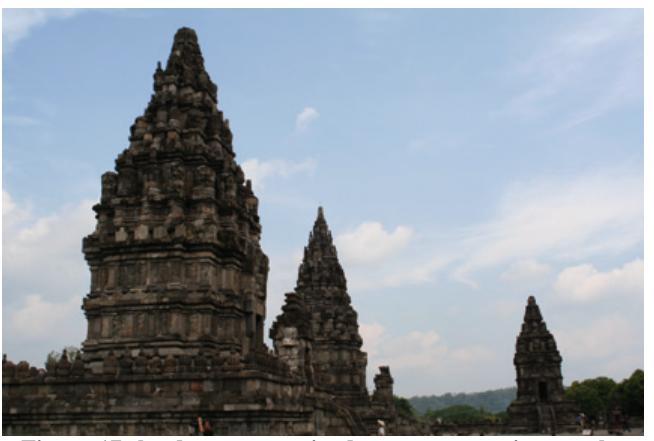
Many parts, which fell from the top of Nandi damaged the front stairs. However, the damage was not so serious (**Figure 17**).

Many parts, which fell from the top of Angsa damaged the side wall. However, the damage was not so serious (**Figure 17**). (8) How did Wahana reconstruct ?

Figure 17 the damage sustained was not so serious at the Nandi temple (right) and the Angsa temple (center).

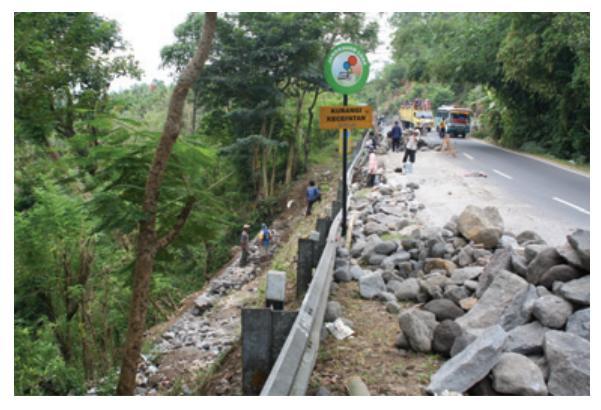
The road shoulder was collapsed by the earthquake. This site is located at the steep slope formulated by the Imogiri fault at Patuk (**Figure 19**). Jrung Peluk Bridge was collapsed in the left side of abutment, which is located near Patuk. Expansion joint of Jrung Peluk Bridge was broken at the left side of bridge (**Figure 20**).

Figure 19 The road-shoulder was collapsed at Patuk

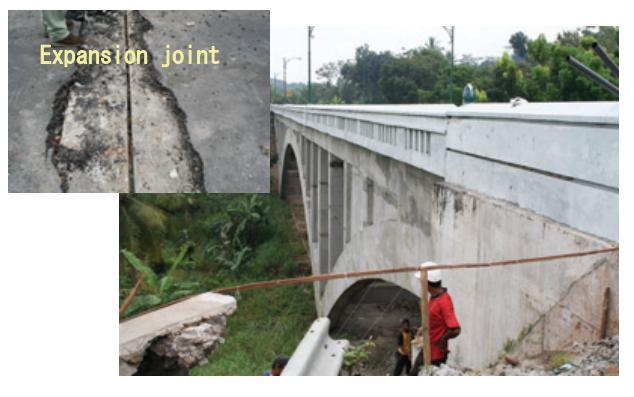
Figure20 JrungPeluk Bridge: Expansion joint was broken

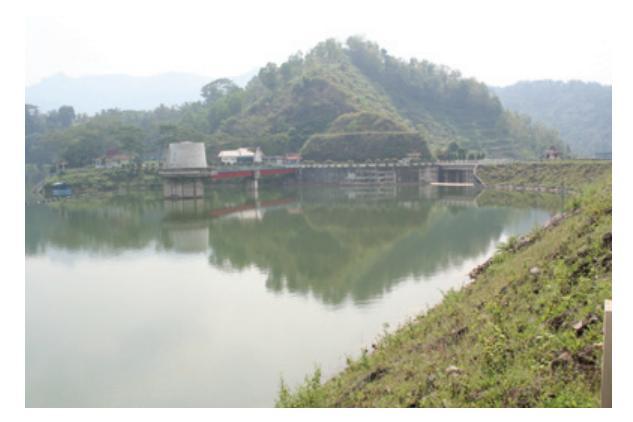
The Sermo dam (**Figure.21**) is located in 30 km west from the epicenter. Final movement is observed at 12 mm. There is no crake in this crest. A seismograph was installed on the embankment, but this instrument was out of order. The Wonogiri dam is far from the epicenter with 60 km, and there is no damage (**Figure.22**). As for neighboring people, the false rumor that a crack went into the dam and became with panic immediately after the earthquake.

Figure 21 The Sermo dam: no crake in this crest.

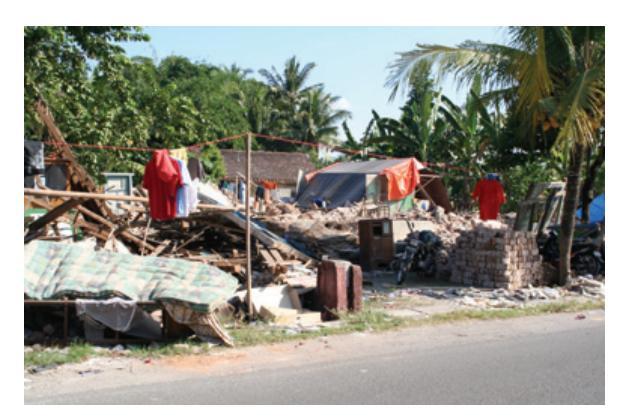
In Bantul Regency, especially at around Imogori County, housing is totally collapsed (**Figure 23**). Refugees live in the tentative tent fear the aftershock (**Figure 24**). Structure of almost all collapsed houses is made of burned brick masonry and wall infilling with cement mortar or reinforced concrete frame rarely. A roof structure is a tile-roofed on wooden mesh, which is top-heavy structure, (**Figure 25**). These structures are typical and traditional houses in Java. This is main reason of

collapsing of numerous numbers of houses. At Imogiri county, this earthquake killed 260 people (Figure.26). Among those, at Turi village, 22 people were killed in the total population of 700 persons. Emergency diagnosis of housings for public facilities, hospitals, and schools are necessary whether such damaged structures are still in use or not. Civil Engineering of Gajah Mada University (UGM) published two papers about earthquake resistant structures. These papars covered the application of vertical strengthening and use of bamboo for the construction of earthquake resistant buildings. In order to strengthen the masonry houses, three kinds of bands (Roof band, Lintel band, Plinth band) and a vertical reinforcement are introduced.. The explaination of the benefits of retrofitting, mechnisms of earthquake response of hipped roof masonry building and protection cracks at openings are shown in Figure 27.

Figure 23 Totally collapsed housing in Bantul Regency.

The high frequency waves were included in waveform as the specific character of the earthquake at this time and it created large acceleration. As a result, the low flat house, which is built with brick and top heavy roof tiles, is a typical and traditional house in Java and weak against high frequency vibration. Thus, many such houses were destroyed. On the other hand, civil infrastructures were constructed rather stiff and strong against high frequency vibration.

3) An effective earthquake resistance method for masonry structure houses should be developed.

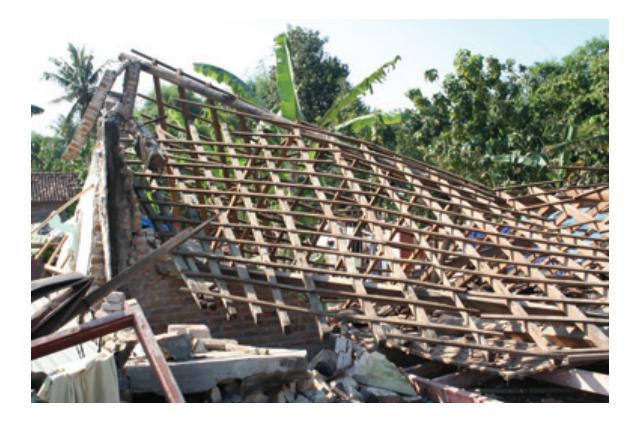
Figure 25 A roof structure is a tile-roofed on wooden mesh. Figure 26 Imogiri county: 260 casualties

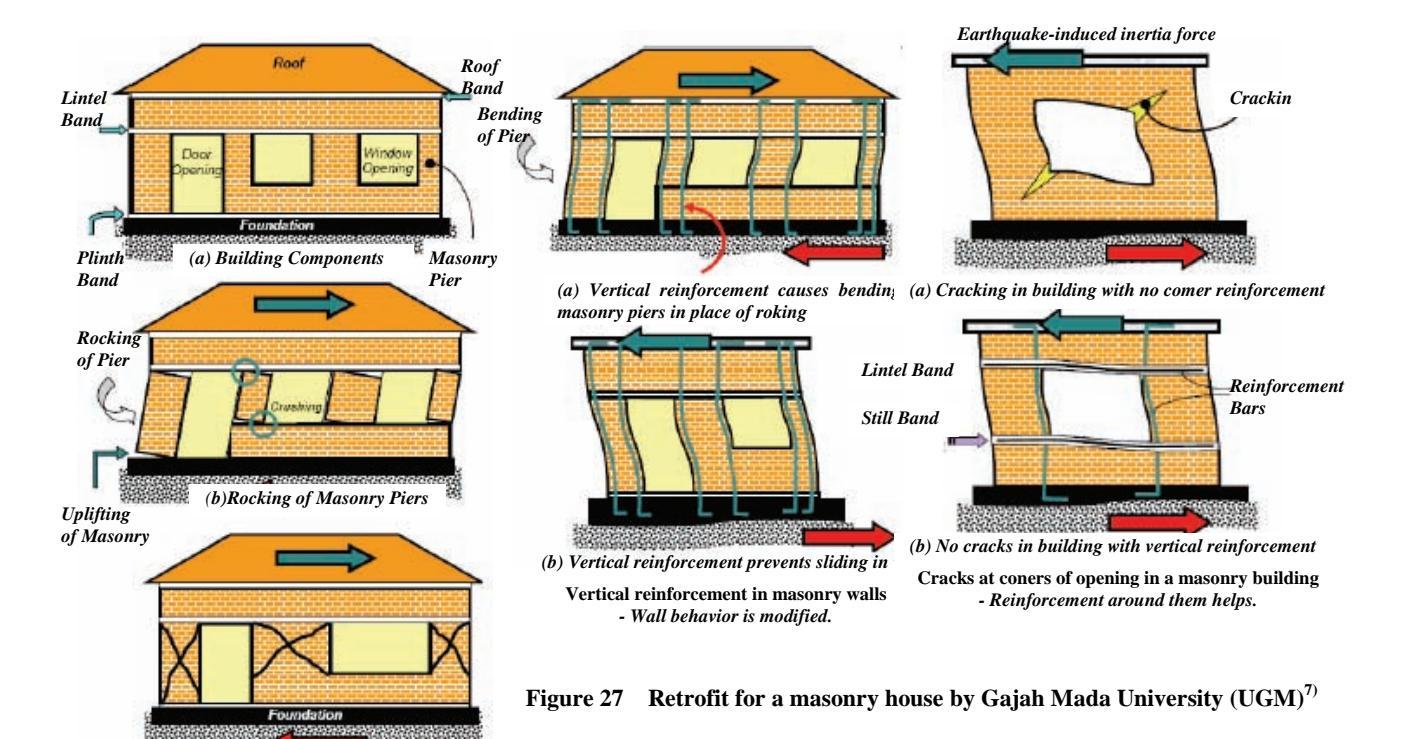
(c) X-Cracking of Masonry Piers Earthquake response of a hipped roof Masonry building - No vertical reinforcement is provided in walls.
