Evaluation of Fudai floodgate bridge damaged by tsunami

Shinichiro Mori¹ and Ratna Prasad Twayana²

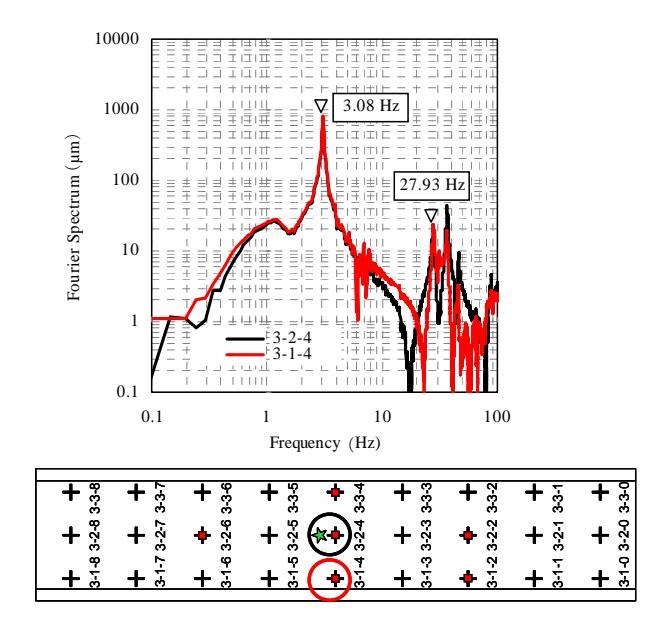
Fig.5 Fourier spectra of span 3 recorded by velocimeter at points 3-1-4 and 3-2-4 due to impact at point 3-2-4.

The velocity time histories of free vibration of span 3 recorded by the velocimeter at point 3-2-4 due to impact at point 3-2-4 is illustrated in Fig.4. The recorded waveform has the maximum amplitude of around 600 µm and vibration become steady after eight seconds. Fig.5 shows the Fourier spectra of span 3 of Fudai floodgate bridge. These spectra were recorded by velocimeter at points 3-1-4 and 3-2-4 due to impact at point 3-2-4. There is clear appearance of peaks around 3.08 Hz and 27.93 Hz in both spectra. The point 3-2-4 is central mid point of the bridge. When impact is given at mid point (3-2-4), first bending mode and third bending mode of bridge vibration are easily excited. Thus 3.08 Hz and 27.93 Hz are first bending and third bending mode of bridge vibration.

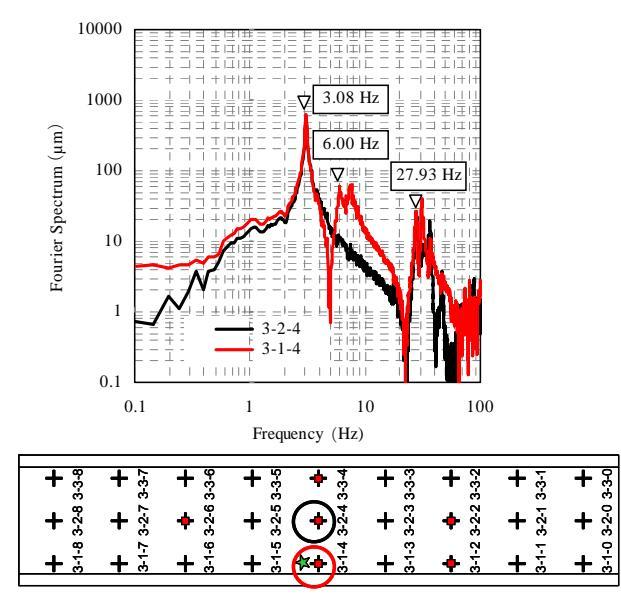
Fig.6 Fourier spectra of span 3 recorded by velocimeter at points 3-1-4 and 3-2-4 due to impact at point 3-1-4.

Fourier spectra recorded by velocimeter at points 3-1-4 and 3-2-4 due to impact at point 3-1-4 is shown in Fig. 6. The point 3-1-4 is the central downstream edge of the bridge. When the impact was given at this point (3-1-4), some difference can be seen in the Fourier spectra. There was clear appearance of

second peak around 6.00 Hz in the Fourier spectra recorded by velocimeter at point 3-1-4 while there was no peak around 6.00 Hz in the Fourier spectra recorded by velocimeter at point 3-2-4. When the point 3-1-4 is impacted, torsional mode is easily excited. Thus 6.00 Hz is corresponds to the first torsional mode of bridge vibration. For the first torsional mode, point 3-2-4 acts as a node point resulting no peak around 6.00 Hz.

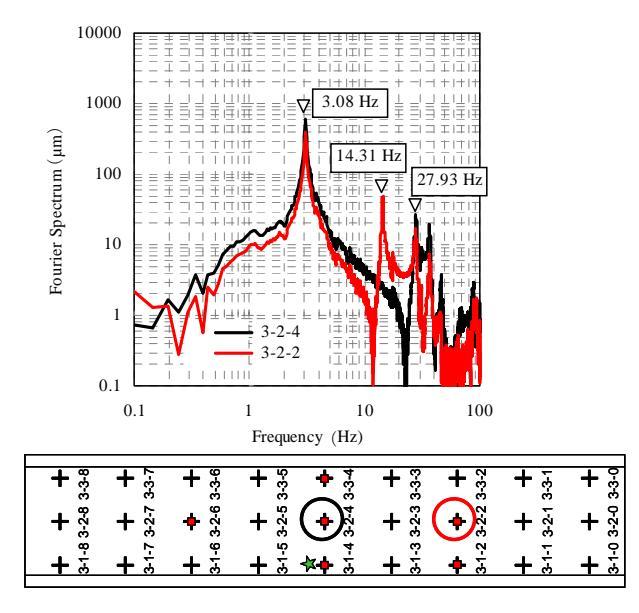
Fig.7 Fourier spectra of span 3 recorded by velocimeter at points 3-2-2 and 3-2-4 due to impact at point 3-1-4.

Fig.7 shows the Fourier spectra recorded by velocimeters at points 3-2-2 and 3-2-4 due to

impact at point 3-1-4. In these spectra, there is no appearance peak around 6.00 Hz as the both points are node points in the case of torsional mode of vibration. A clear peak can be seen around 14.31 Hz in the spectra recorded by the velocimeter at point 3-2-2 while there is no peak around 14.31 Hz in the spectra recorded by velocimeter at point 3-2-4 although impacted point is same. So, it can be said that 14.31 Hz corresponds to the second bending mode of vibration. In second bending mode, quarter span is easily excited while mid span acts as node point.

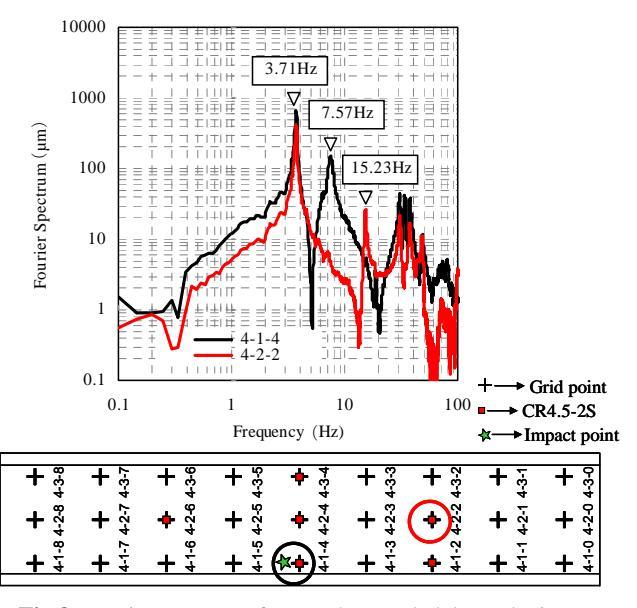
Fig.8 Fourier spectra of span 4 recorded by velocimeter at points 4-1-4 and 4-2-2 due to impact at point 4-1-4.

The typical Fourier spectra of span 4 of Fudai floodgate bridge is shown in Fig.8. These are the

spectra recorded by the velocimeter at points 4-1-4 and 4-2-2 due to impact at point 4-1-4. The first bending, first torsional and second bending modes were found to be 3.71 Hz, 7.57 Hz and 15.23 Hz respectively.

The first bending mode of span 3 and span 4 were found to be 3.08 Hz and 3.71 Hz respectively. Although the span lengths of both spans are same, obtained frequencies are very different. This difference in frequency may be due to difference in level of damages caused by tsunami in these spans. From this figures, it can be said that level of damages in span 3 was higher than that in span 4. The residual static deflection of span 3 was found to be 30 cm while that of span 4 was found to be 7 cm only as shown in Fig.9. Since the frequency is proportional to the square root of flexural stiffness, the flexural stiffness of span 3 was found to be about 30% less than that of span 4.

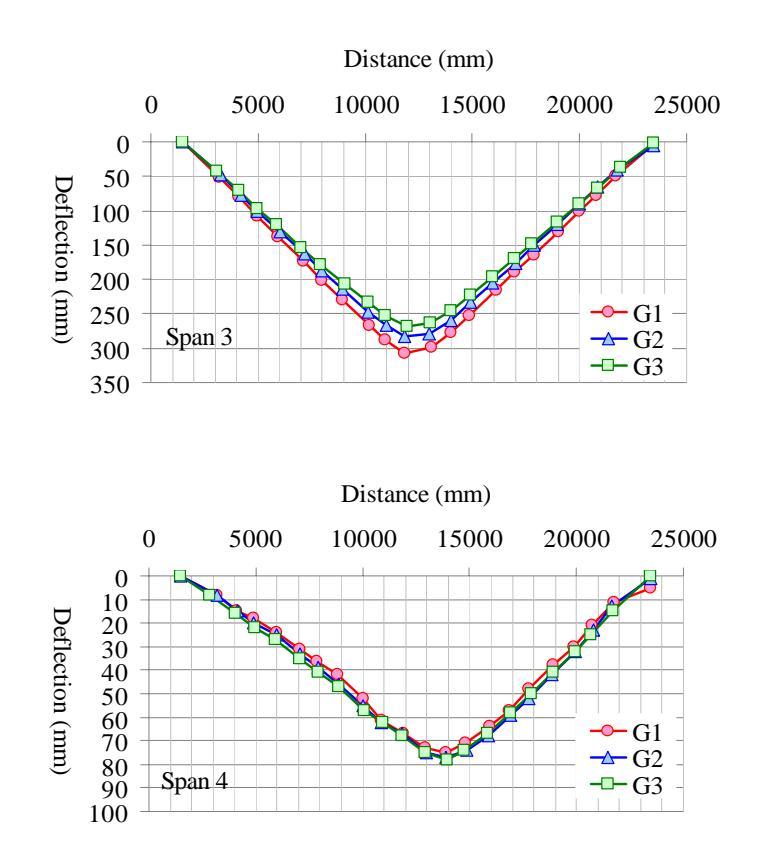
S1(span 1): Totally collapsed

S2 (span 2): Totally collapsed

S3 (span 3): Severely damaged with residual vertical deflection of 30 cm

S4 (span 4): Severely damaged with residual vertical deflection of 7 $\rm cm$

Fig.9 Residual deflection profile of girders of span 3 and span 4 of Fudai floodgate bridge after tsunami. (Source: CAESAR, PWRI)

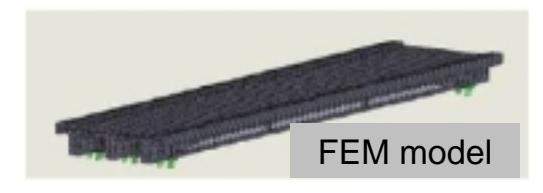
Fig.10 FEM model analysis of Fudai floodgate bridge. (Source: CASER, PWRI)

Finite Element Model (FEM) of this bridge was generated to know the frequencies of undamaged state. This bridge was model as simply supported beam with rubber bearing as shown in Fig.10. The first bending and second bending modes of undamaged state were found to be 4.22 Hz and 16.88 Hz respectively. The summary of frequencies obtained from FEM model and actual measurement were listed in the Table 1. By comparing the frequency of undamaged and damaged state, it was found the measured frequency was 27% less than FEM frequency (undamaged state) in the case of span 3 while it was 12% less than FEM frequency (undamaged state) in the case of span 4 with regards to first mode of vibration. In the span 3, the maximum reduction in frequency was found to about 27 % which is the case of first bending mode. However, In the span 4, the maximum reduction in frequency was found to be about 19 % which is the case of third bending mode. From this results, it can be also concluded that not only first mode, higher modes of vibration are also sensitive to the level of damages in the girders.
