# THE DAMAGE TO ABANDONED QUARRIES AND MINES BY THE M 9.0 EAST JAPAN MEGA EARTHQUAKE ON MARCH 11, 2011

The East Japan Mega Earthquake with a moment magnitude 9.0 occurred on March 11, 2011. There are many abandoned lignite mines in the close vicinity of the epicentral area such as Miyagi and Iwate Prefectures. The Ministry of Economy, Trade and Industry of Japan reported that collapses occurred at 32 locations in Miyagi Prefecture and 21 locations in Iwate Prefecture. In addition some collapses occurred in Oya of Tochigi Prefecture and in Yoshima coal field in Iwaki City of Fukushima Prefecture. The authors present their investigations results and discuss their implications in short and long-term performance of abandoned mines and quarries in this article.

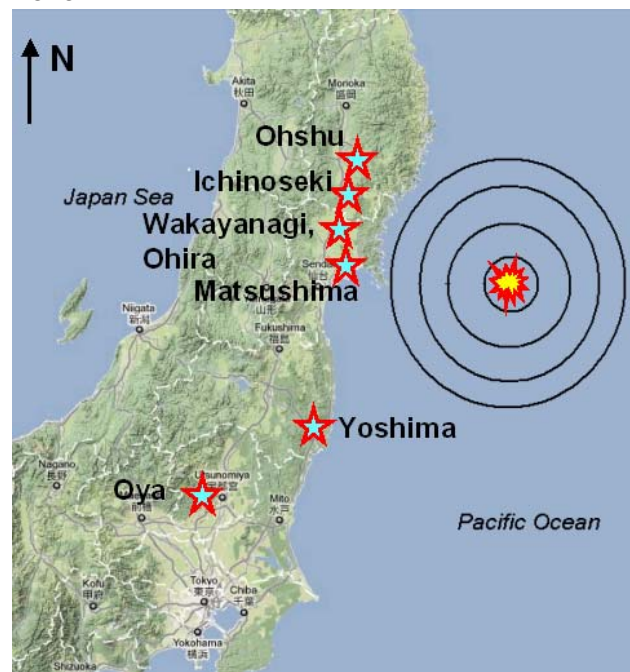
Figure 1. Investigation locations

The East Japan Mega Earthquake with a moment magnitude 9.0 took place at 14:46 (JST) on March 11, 2011<sup>1</sup>. The earthquake was a subduction plate-boundary earthquake and the rupture area was 450 km long and 200 km wide<sup>2</sup>. This earthquake caused gigantic tsunami waves, which destroyed many cities and towns along the shores of Tohoku and Kanto Regions of Japan. The casualties caused by this tsunami exceed 20,000 people. The tsunami destroyed and heavily damaged buildings of various type, transportation facilities and infrastructures<sup>3</sup>. The authors visited Oya (Tochigi) in Kanto region and Iwaki (Fukushima), Wakayanagi, Ohira (Miyagi) and Ichinoseki (Iwate) in Tohoku region and made observations on the collapsed abandoned lignite and coal mines and underground stone quarries and associated damage to super structures (Figure 1).

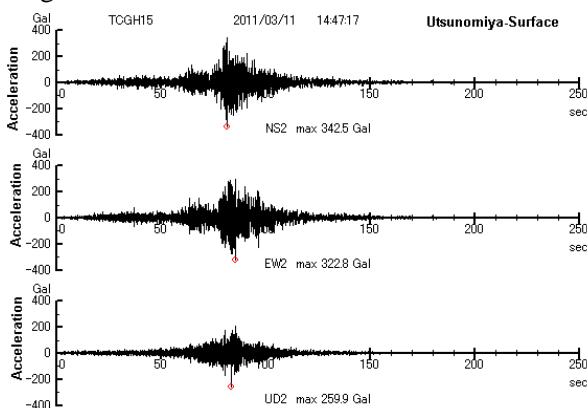
Figure 3. Acceleration records at Utsunomiya

Although ground motions recorded in the vicinity of abandoned underground quarries in Oya, the instruments are mainly velocity based and they do not measure three components of the ground motions. Figure 3 shows the acceleration record at Utsunomiya strong motion station of KNET near Oya. The maximum ground acceleration at Utsunomiya strong motions station of KNET was 358 gals at the ground surface.

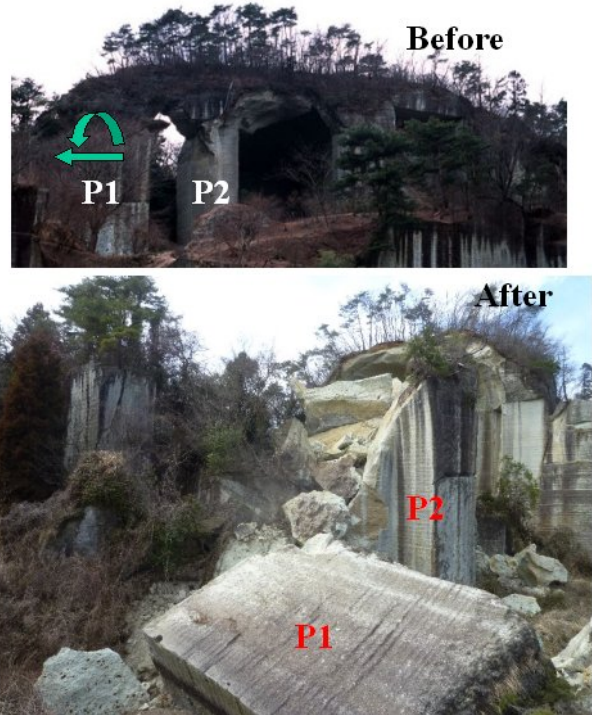
Figure 4. Totally collapsed semi-underground opening

Total or partial collapse of semi-underground quarries occurred as seen in Figures 4 and 5. The toppling of pillar (P1) caused the collapse of thin roof of the abandoned quarry as seen in Figure 4. In some cases, partial collapses of the overhanging parts occurred as seen in Figure 5.

- 1) Strong ground shaking induced the collapses of semi-underground openings in the abandoned Oya quarries, which are relatively high and having overhanging configurations.

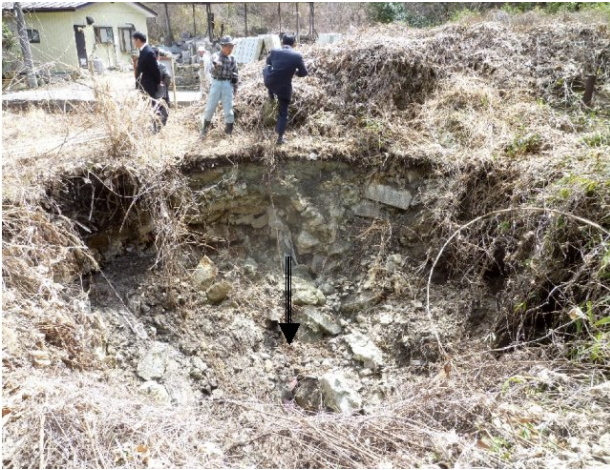
Figure 6. the settlement of back-filling material of the shaft

The settlement of back-filling material of three shafts of abandoned quarries occurred. In the example shown in Figure 6, the settlement of back-filling material was more than 5 m and the diameter of the shaft was about 7 m. The back-filling material was non-cohesive.

- 3) When the filling material of shafts of abandoned mines is non-cohesive, the filling material would settle in the shafts due to its flow into adjacent openings when ground shaking is strong enough to induce the flow of filling material particles.

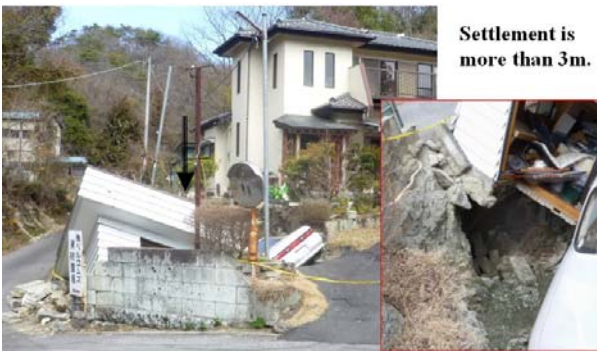
Figure 7. The settlement of back-filling material of the shaft and the fall of the hut and car into the shaft

The back-filling material of the abandoned shaft settled more than 3 m as seen in Figure 7. There was a hut on top of this shaft. The hut and the car parked next to the hut was fallen into the settled shaft. These observations are very similar to those observed in Yamoto town during the 2003 Miyagi-Hokubu earthquake<sup>6,7)</sup>.

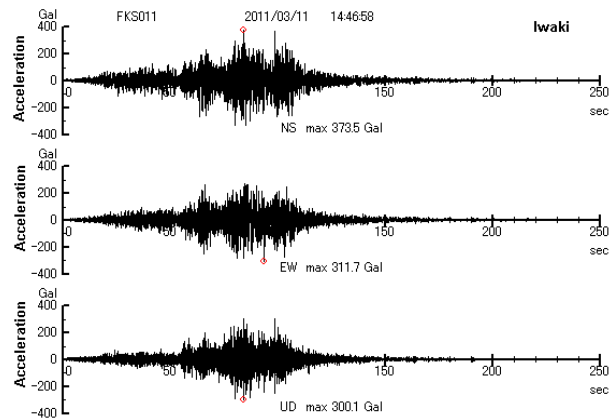
Figure 9. Acceleration records at Iwaki station

Figure 9 shows the acceleration record at Iwaki strong motion station of KIKNET. The maximum ground acceleration at Iwaki strong motions station of KIKNET was 481 gals at the ground surface.

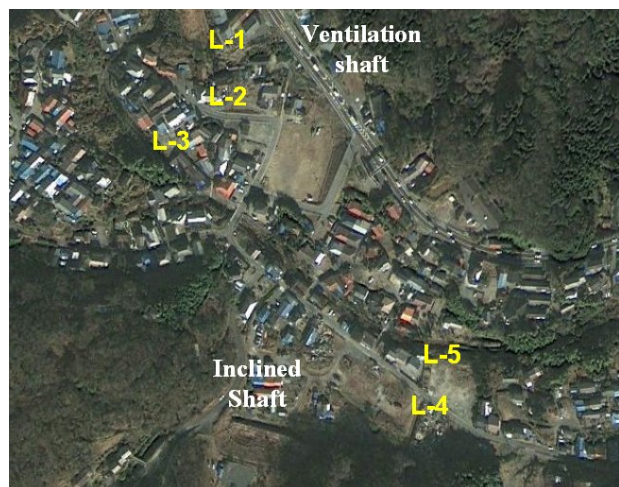
Figure 10: Locations of sinkholes at the abandoned Yoshima Coal mine

There were 5 sinkholes at the abandoned Yoshima mine of Jobando coal field as shown in Figure 10. The collapses were associated with inclined shafts. The sloshing of the underground water in inclined shafts caused the failure of roof rock resulting in sinkholes as seen in Figures 11 and 12.

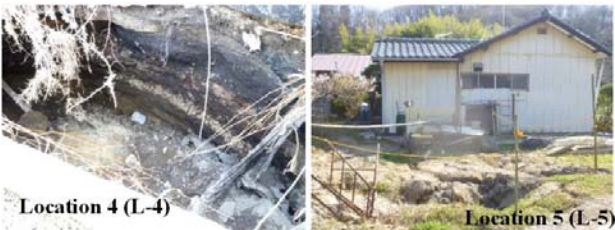
Figure 12. Views of sinkholes locations L4-L5

Inclined shaft

Ventilation shaft

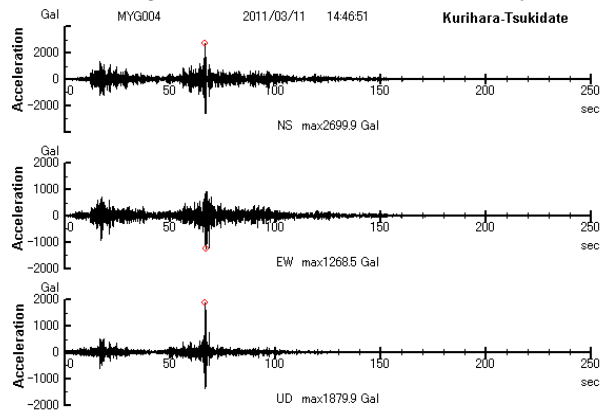
Figure 13. Acceleration records at Tsukidate station

The ground motions records differ from place to place. The largest ground motions were recorded at the Tsukidate strong motion station of KNET. Except top 1 m thick clay layer, this station is based on sedimentary rocks, which are commonly observed in lignite mines. Figure 13 shows the acceleration record at the Tsukidate strong motion station of KNET. The maximum ground acceleration at Tsukidate strong motion station of KIKNET was 2933 gals at the ground surface.

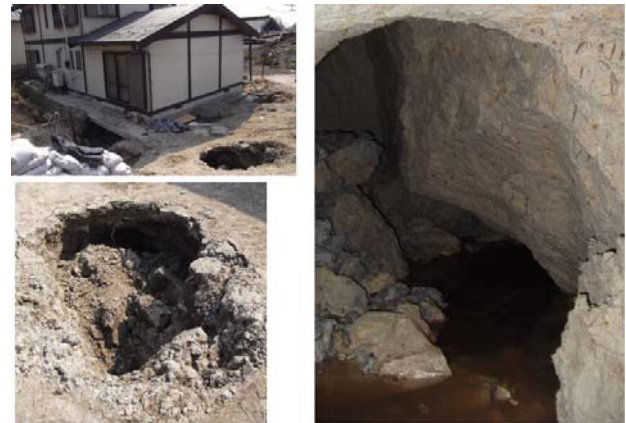
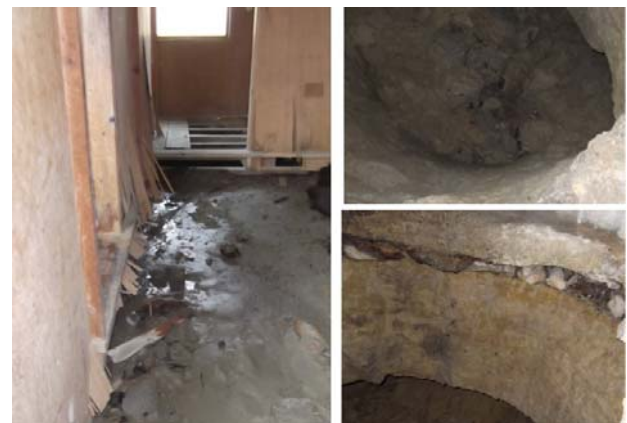
Figure 14: Some views of sinkholes in Wakayanagi town

In Wakayanagi town of Kurihara City, 5 sinkholes occurred in residential area as seen in Figure 14. Luckily, these sinkholes did not cause the collapse of the residential houses on the ground surface. However, the fracturing of the

base concrete occurred and one corner of the building was overhanging with a slight tilting. The overburden of the sinkholes ranged between 1 m to 3 m at this locality.

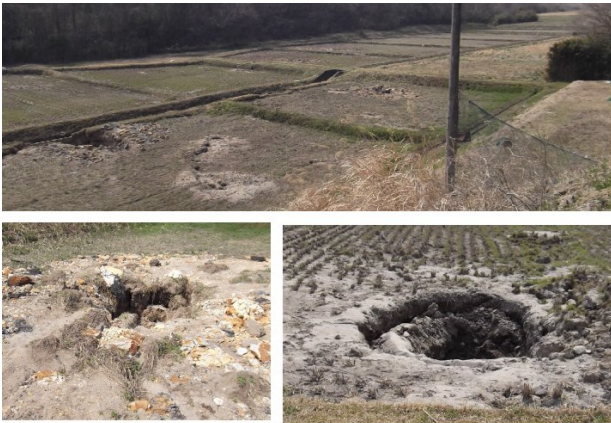
Figure 15. Views of sinkholes in a rice field near Ohira Village

In a large rice field near Ohira Village of Kurihara City, more than 10 sinkholes with a diameter ranging from 1 m to 5 m were observed as seen in Figure 15. Besides ground shaking, the sloshing phenomenon of ground water in the underground openings abandoned lignite mine areas contributed to the collapse of the roof layers. As a result of this phenomenon, sandy material together with fragments of rocks and lignite appeared on the ground surface and this ejected sandy material is sometimes mis-interpreted as ground liquefaction

by soil-mechanics researchers and engineers. The overburden of the sinkholes ranged between 2 to 4 m at this locality.

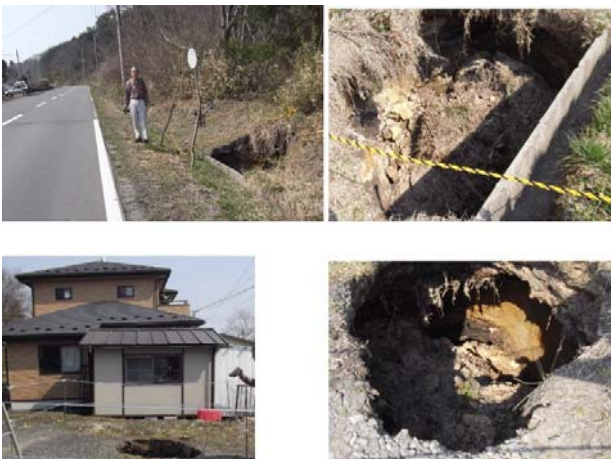
Figure 16. Views of sinkholes along a roadway and parking lot near Ohira Village

Besides sinkholes in the rice field, some sinkholes were observed along the roadway and in the parking lot next to residential buildings as seen in Figure 16. The overburden of the sinkholes with a diameter of 2-3 m ranged between 1 to 2 m at this locality. The collapse was caused by the ground shaking.

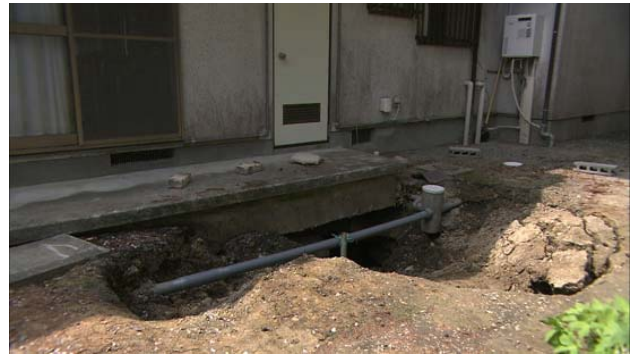
A number of sinkholes in both residential areas and fields caused in Ichinoseki by the 2011 East Japan Mega Earthquake. The sinkholes were enlarged in size after each large aftershock. Figure 17 and 18 shows the sinkholes beneath or close vicinity of houses in Ichinoseki City. Figure 19 shows a sinkhole along a roadway in Ichinoseki City. In addition to these there were sinkholes in rice fields.

Figure 17: A sinkhole beneath a house in Ichinoseki. (L1). The size of the sinkhole enlarged after the April 7, 2011 aftershock.

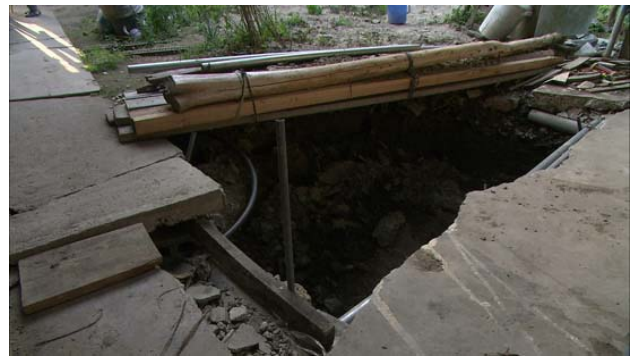
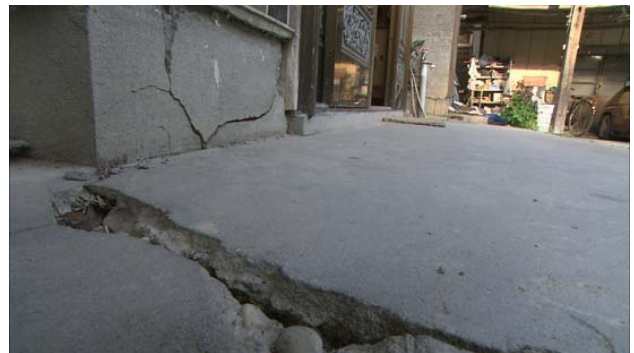
Figure 18: A sinkhole beneath a house in Ichinoseki. (L2).

(a) A large sinkhole extending below the storage room and the main building

(b) Cracking of the concrete base and walls in the main building.
